## MEMORANDUM

**FROM:** Burned Watershed Geohazards Program  
California Geological Survey

**SUBJECT:** Summary of field reconnaissance  
Feliz Fire, Mendocino County (CA-MEU-008929)

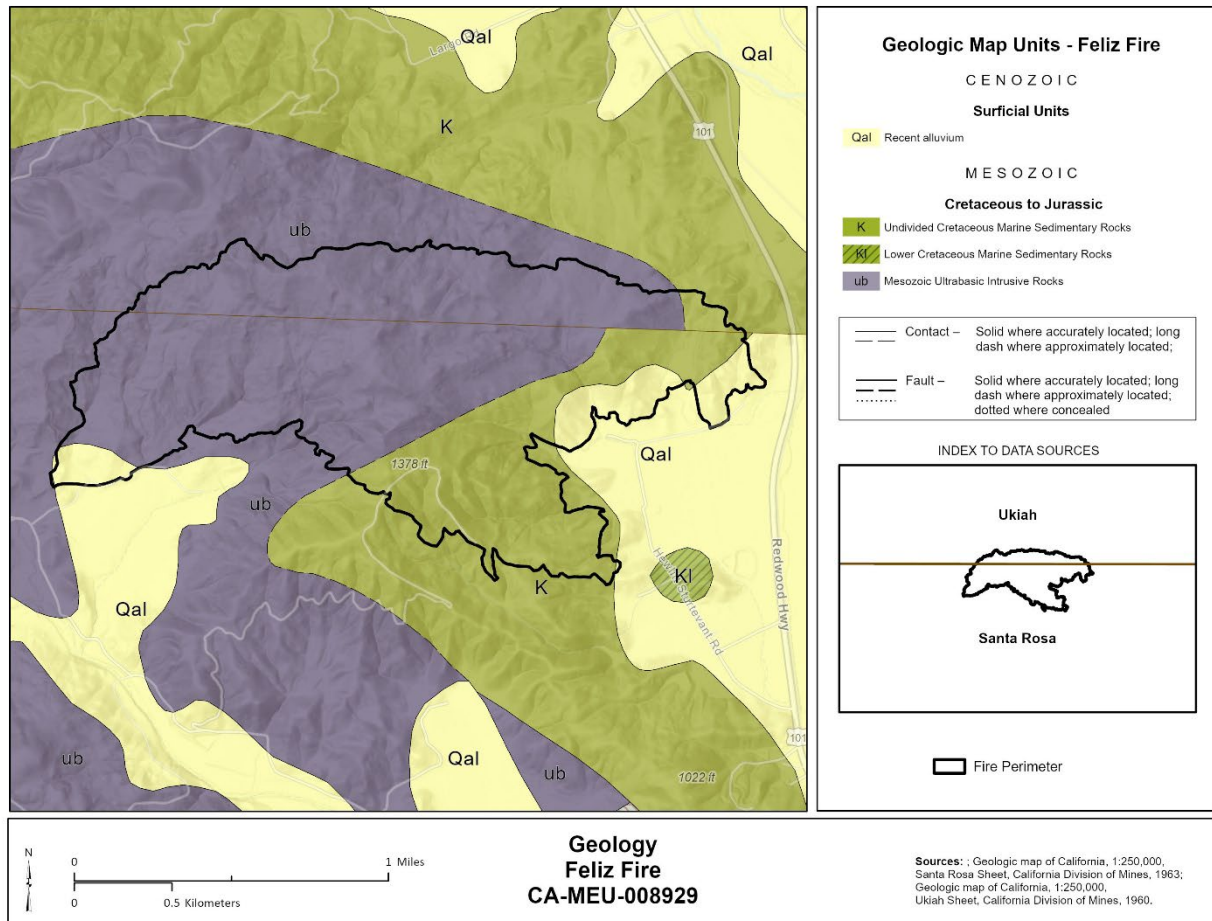
The area impacted by the Feliz Fire is underlain primarily by ultramafic rocks (mapped as "ub" in Fig. 1), with the eastern third of the fire underlain by marine sedimentary rocks (mapped as "K" in Fig. 1). Ultramafic rocks underlying the northeastern portion of the burned area are classified in recent regional mapping by Rubin (2021) as serpentinite. These underlying bedrocks may contain naturally occurring asbestos and other metals with the ultramafic rocks, particularly serpentinite, posing the highest risk (Fig. 1, 2). Fires disturb soil, increasing dust production and potential exposure to mineral toxicants. Asbestos is classified as a known carcinogen by state, federal and international agencies. Although the rocks in the Feliz Fire burn area may produce mineral toxicants, analysis was not completed to determine the type and quantity of mineral toxicants present.

**Figure 1.** Geologic map overlaid on a shaded relief map.

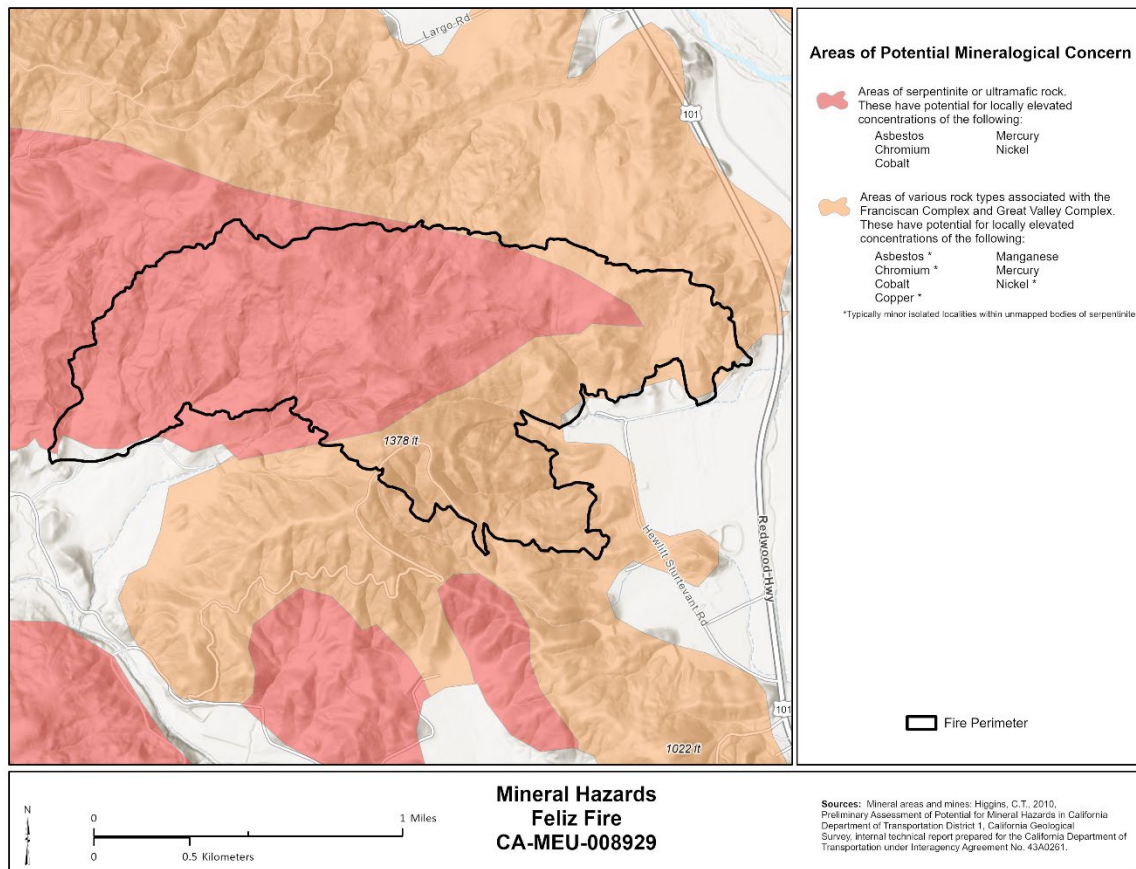
**Figure 2.** Map showing areas of mineralogical concern overlaid on a shaded relief map.

Information regarding hazardous minerals can be found at the California Office of Environmental Health Hazard Assessment (<https://oehha.ca.gov/chemicals/>). We recommend consultation with the Mendocino County Air Quality Management District (<https://www.mendocinocounty.gov/government/affiliated-agencies/air-quality-management-district>) to develop mitigations that are centered on limiting dust generation and exposure.

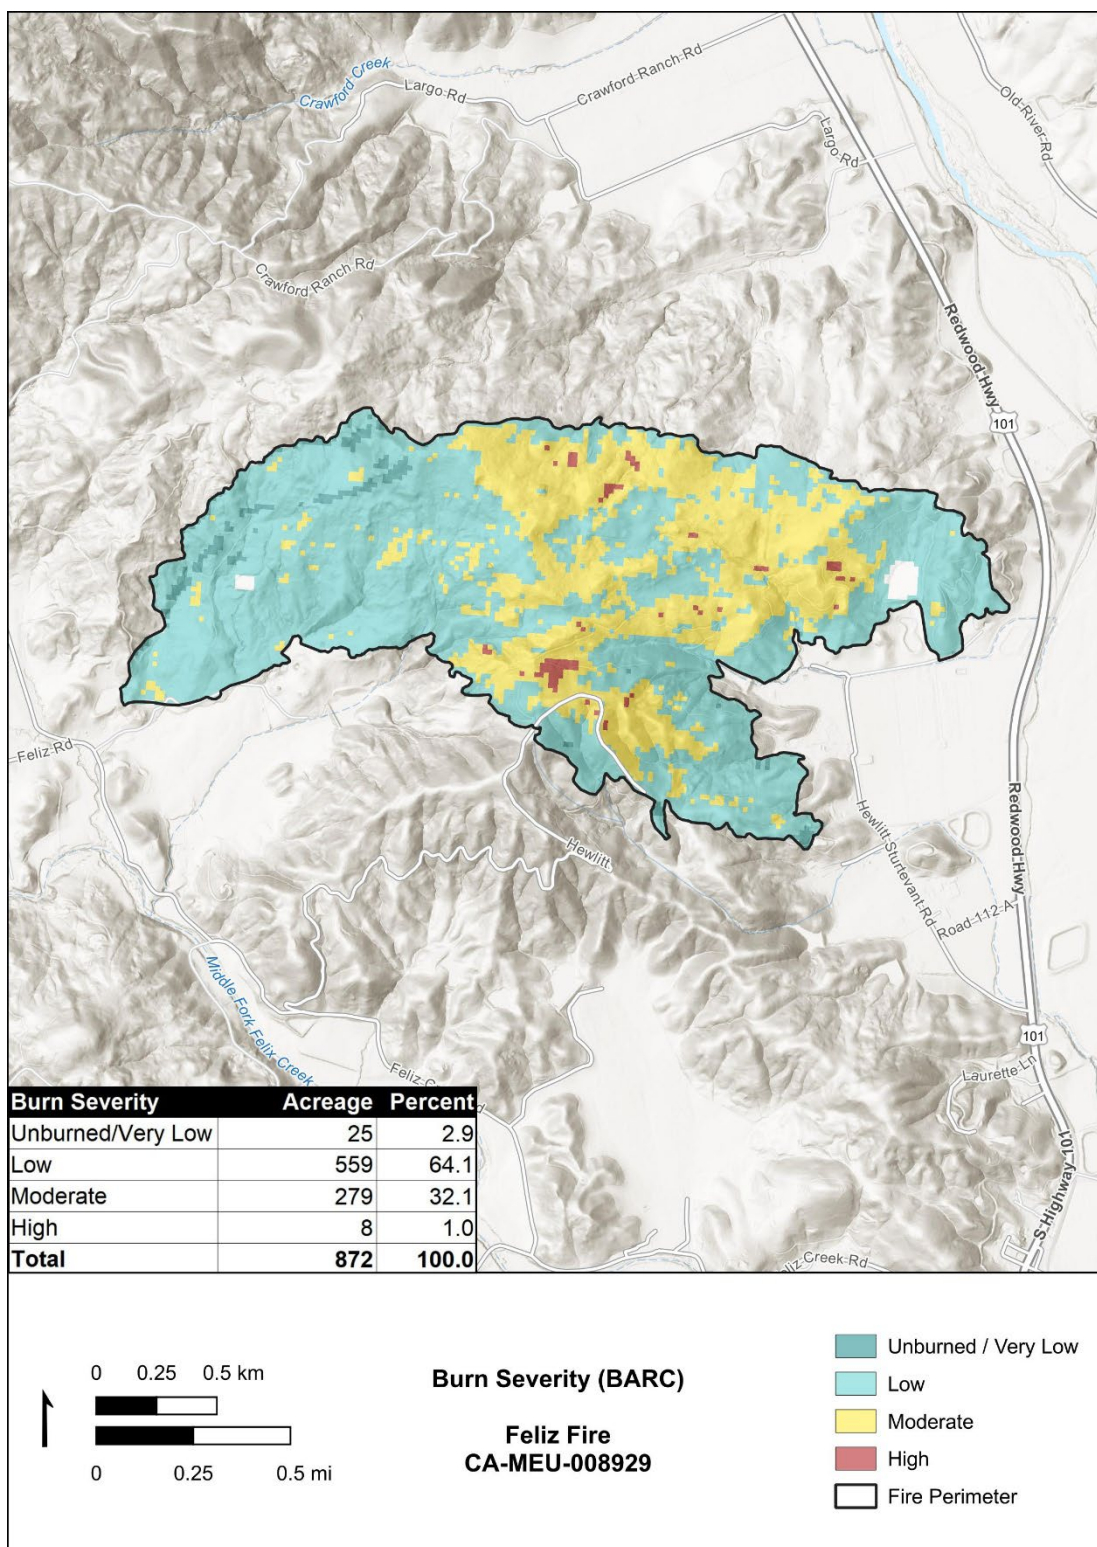
Prefire vegetation was primarily dense oak woodland with grass understory. Small clusters of pine were present on steep, north-facing slopes. A burned area reflectance classification (BARC) map was provided by the USGS's Earth Resource Observation & Science Center. The BARC map indicates the fire severity was mostly low on the west-draining portion of the burn area, with the east-draining portion consisting of a mix of low and moderate, with isolated patches of high (Fig. 3). The transition from low to moderate burn severity was validated in the field and evidenced by increased consumption of surficial organic material in the area mapped as moderate.

**Figure 3.** Feliz Fire burn severity (Burned Area Reflectance Class) map overlaid on a shaded relief map. BARC map produced by US Geological Survey Earth Resources Observation and Science (EROS) center.

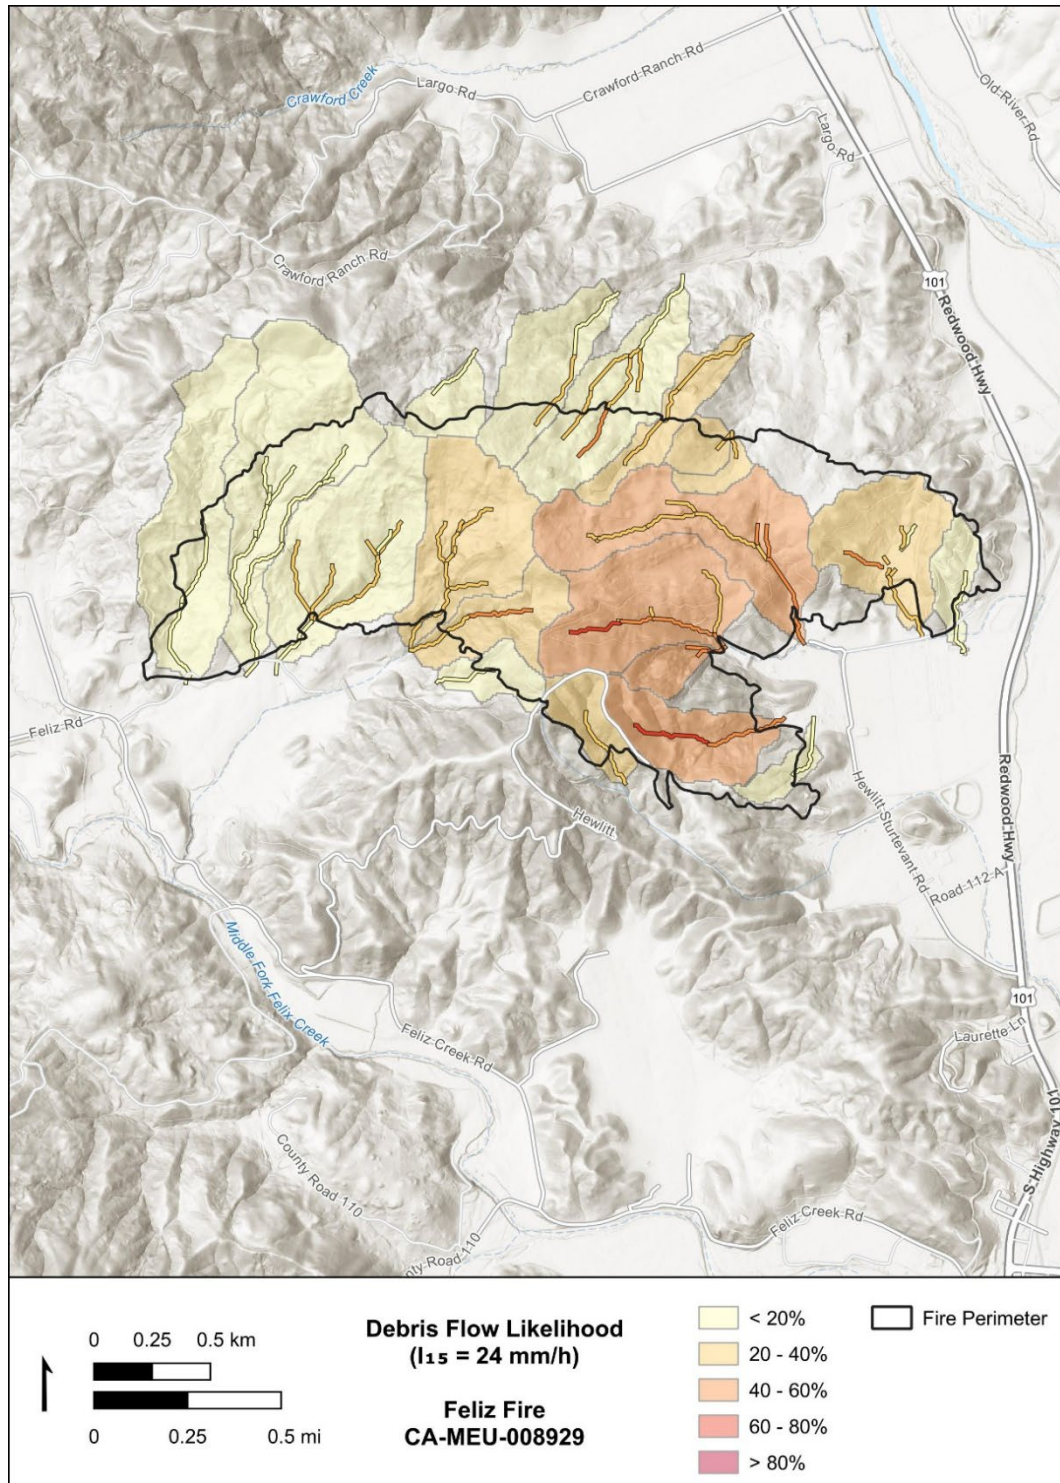
**Figure 4.** Postfire debris flow likelihood map overlaid on a shaded relief map. Debris flow likelihood determined by the US Geological Survey Landslide Hazards Program using methods described by Staley et al. (2017).

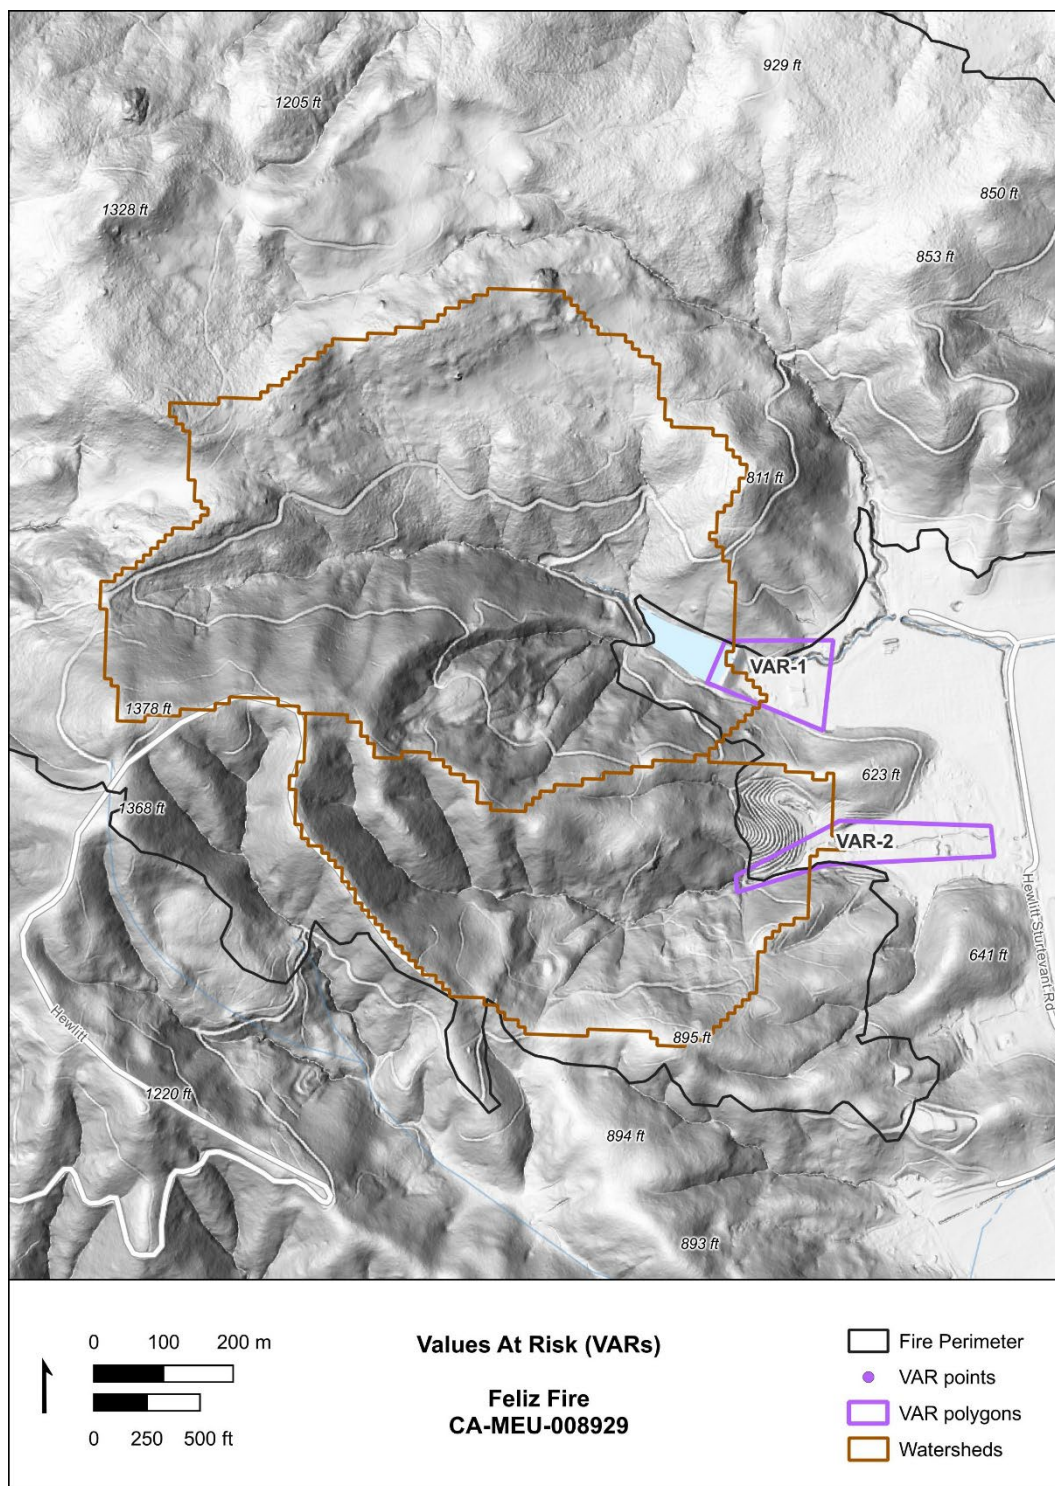
Some slopes within the burn area exhibit irregular, hummocky or bench-step topography indicative of landslide activity from deep-seated, well-rounded dormant landslides to more recent, shallow, translational failures, particularly within steep concave colluvial hollows at the head of drainages. Recent and well-defined landslide features are visible in high-resolution shaded relief maps, especially along northeast aspect slopes (e.g., Fig. 5).

Values-at-risk (VARs) composed of homes, outbuildings, culverts, roads, and a pond and associated dam/spillway were assessed for postfire geohazard risks following the Feliz Fire. VARs and property along the western portion of the fire perimeter were located behind locked gates and assessed remotely by reviewing map data. They were deemed to be of low concern due to the relatively gentle slopes and low burn severity in the area. However, where the burn severity and slope gradient are higher on the east side of the fire, the potential risk of geohazards increase and two VARs (Fig. 5; Table 1) were identified.

**Figure 5.** Shaded relief map focused on the area with the two values-at-risk (VARs) and upstream watersheds.

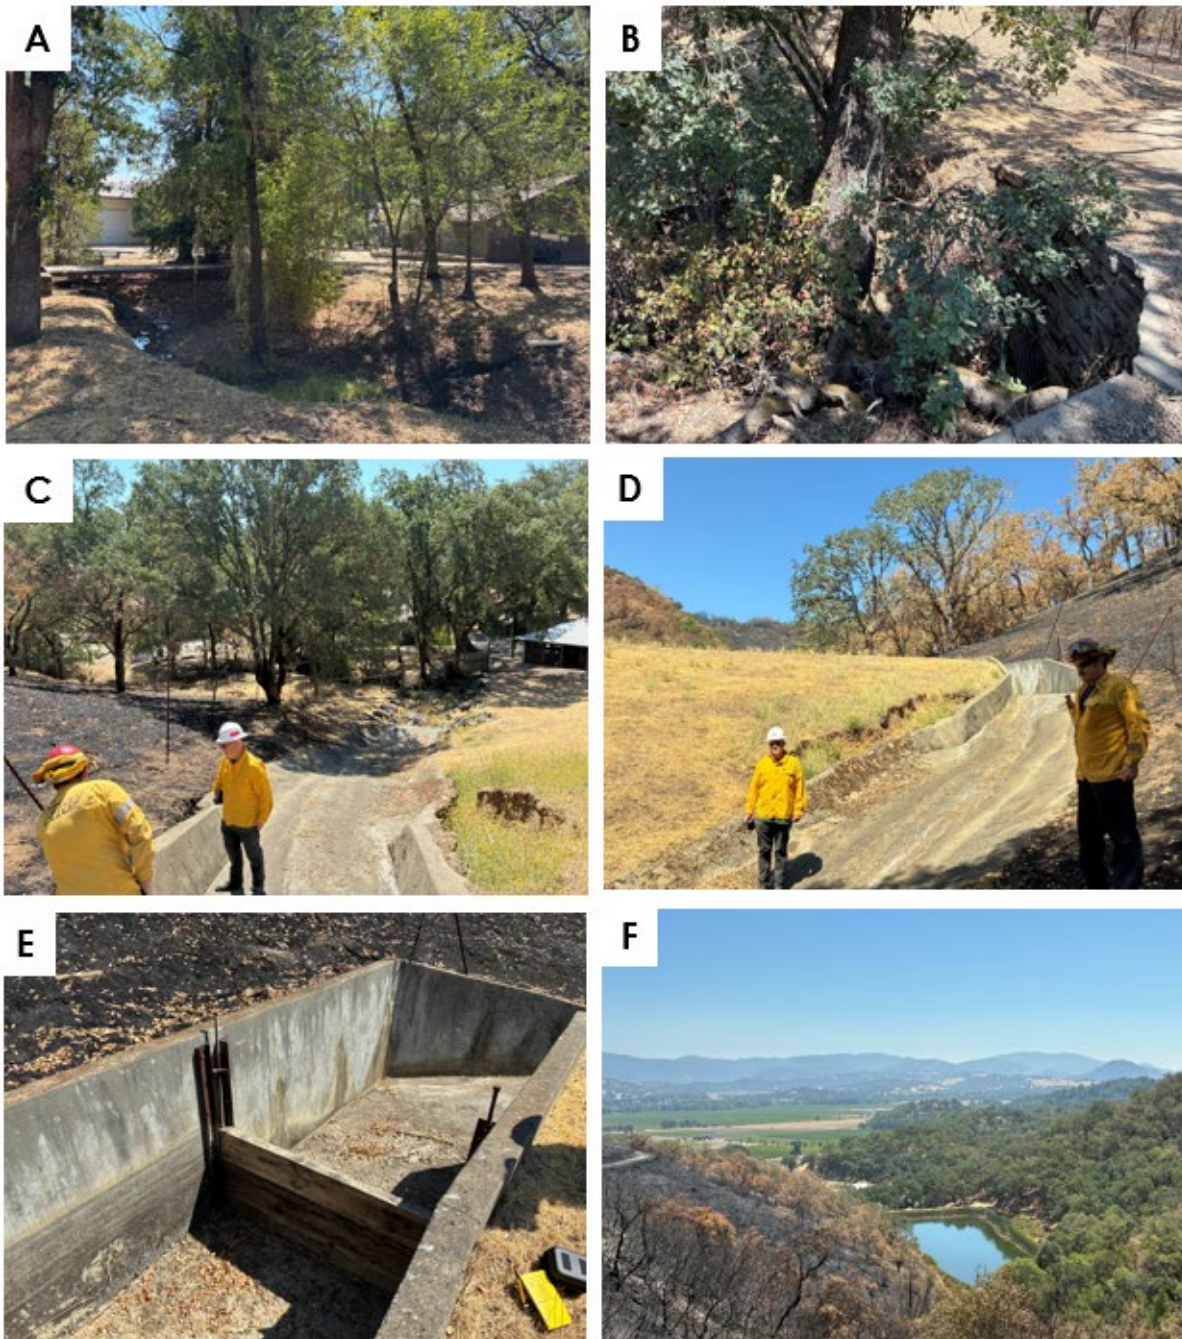
VAR #1 consists of an agricultural pond impounded by an earthen dam with a concrete spillway, with infrastructure, agricultural outbuildings, and garages downslope of the dam. The watershed upstream of the pond is 118 acres (0.48 km<sup>2</sup>) in area and was burned at 47% low, 45% moderate, and 3% high severity. The concrete spillway and an adjustable wood floodgate structure are located on the north side of the dam. Directly below the dam is a pumping station used for irrigation purposes. Downstream of the spillway, the channel makes a sharp left turn as it transitions to a natural channel that runs adjacent to the buildings and driveway before passing under a roadway via a 48" corrugated metal pipe (CMP). The main anticipated hazard is increased postfire runoff filling the natural channel and creating thin overbank flood flows that could impact the driveway and buildings. The potential of plugging of the CMP due to woody

material may increase the likelihood of nuisance flooding in the driveway area. An additional hazard at this VAR is related to the dam and spillway. Overtopping of the dam crest is unlikely even under increased postfire discharge, provided the wood floodgate structure is managed effectively in anticipation of large rainfall events. Prior scour of the earthen dam face was observed in multiple areas immediately adjacent to the downstream portion of the spillway and may be related to cracks in the concrete spillway. Increased postfire discharge may accelerate this scour. Additionally, increased postfire sedimentation into the pond may affect the overall capacity of the pond.

| VAR | VAR description | Potential hazard type | Field assessment of potential hazard | Latitude, Longitude |
|---|---|---|---|---|
| 1 | Dam and outbuildings | Flood | Primary concern is the proximity of the outbuildings to a channel. The channel may overtop and cause nuisance flooding in the driveway area that may impact the outbuildings. Secondary concern is scour of the earthen dam surface adjacent to the concrete spillway. | 38.99407°, -123.13101° |

**Figure 6.** Photographs of VAR #1. **A)** View looking downstream at channel and outbuildings. **B)** 48" CMP at road crossing downstream of Photo A. **C)** Spillway transitioning to natural channel, with sharp left-hand turn in channel next to pumping station (right). Note scour of dam material adjacent to spillway. **D)** Dam face and spillway. Note scour of dam material. **E)** Wooden floodgate structure consisting of removable planks at crest of spillway. Notebook at right of image is located on dam crest. **F)** View of pond, dam, and structures from upper watershed.

Postfire impacts will most likely be localized flooding and debris flood activity. Residents and workers in the area should be cautious of flooding near the outbuildings and residential structures and along driveways and roadways. Nuisance flooding and erosion may occur inside and immediately downstream of the burned area. Culverted crossings should be regularly inspected for potential plugging, and the dam and associated spillway should be regularly monitored for evidence of scour. The wood floodgate structure of the dam should be managed in anticipation of increased runoff response during rainfall events.

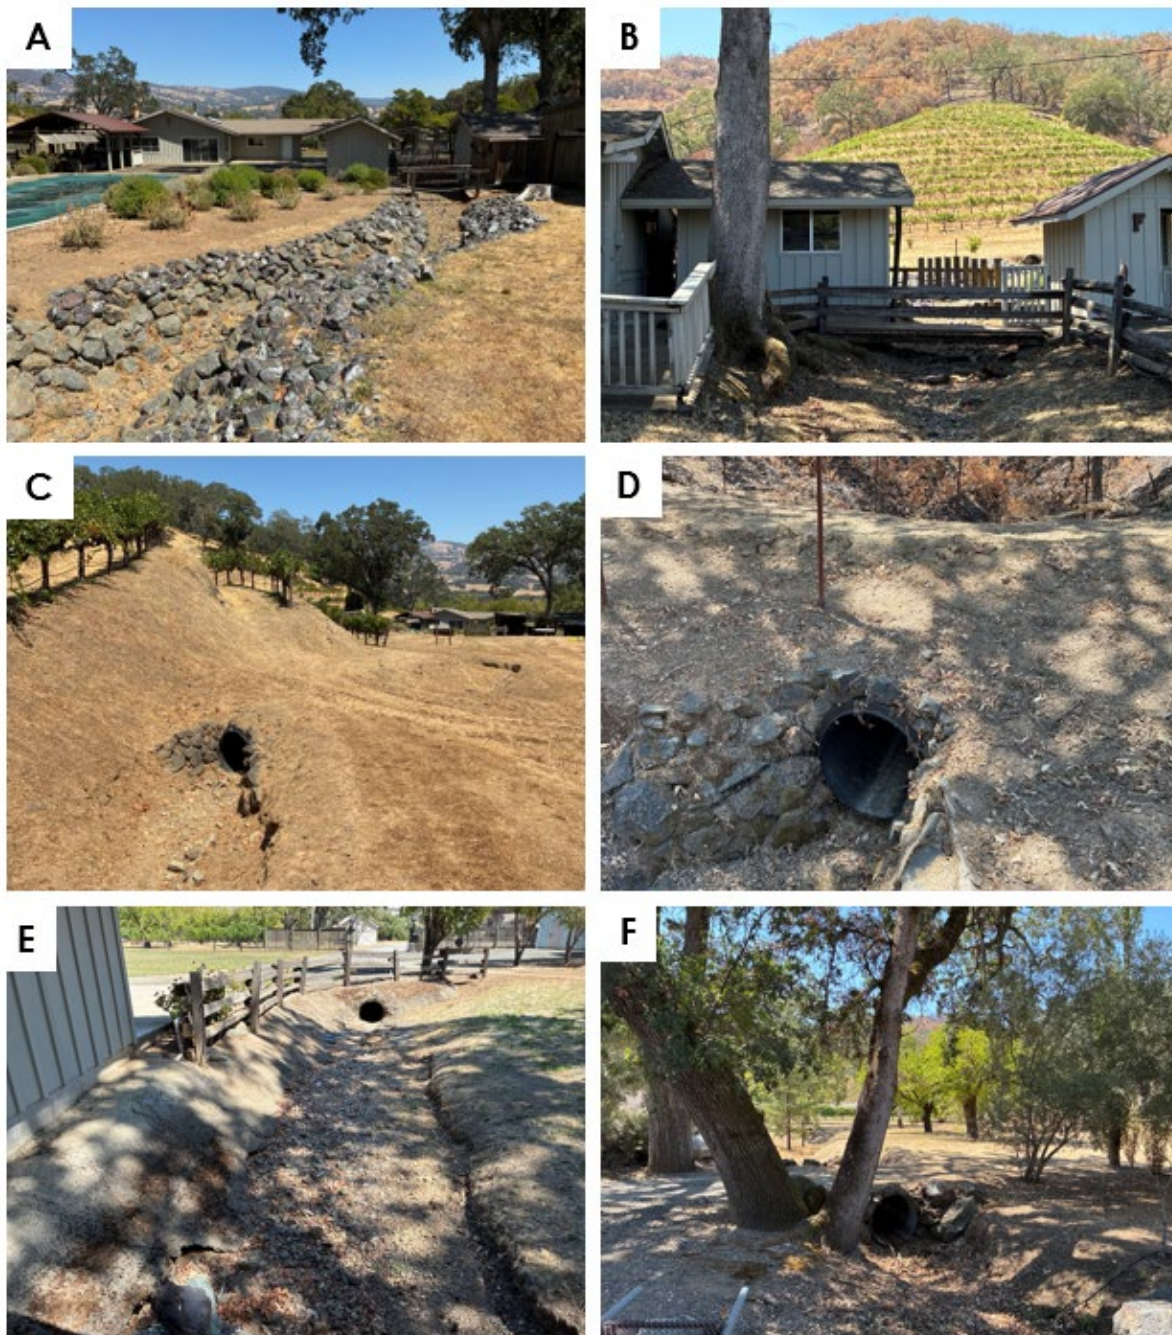
VAR #2 consists of a set of homes and outbuildings along a watercourse, with multiple culverted crossings that access vineyard areas upstream and downstream of the buildings. The upstream watershed is 57 acres (0.23 km<sup>2</sup>) in area and was burned at 58% low, 33% moderate, and 0.3% high severity and much of its headwater area exists at slopes of 30° to 40°. The modified channel below the first culverted crossing was observed to be substantially smaller in cross-sectional area compared with the natural channel above the crossing and directed between two residential structures. Thus, the main anticipated hazard is flood and debris flood flows filling this modified channel and causing overbank flood flows upstream of the buildings, potentially impacting the buildings, footbridges, and decks adjacent to the channel. This hazard may be influenced by woody material from the upstream watershed potentially plugging the multiple culverts upstream of the buildings. In the area immediately upstream of the buildings, the channel has been reinforced with riprap indicating possible erosional concerns during past storms.

| VAR | VAR description | Potential hazard type | Field assessment of potential hazard | Latitude, Longitude |
|---|---|---|---|---|
| 2 | Residential structures and outbuildings | Flood / Debris Flood | A channel runs adjacent to several residential structures and outbuildings and appears to have limited conveyance capacity relative to the natural channel further upstream. Primary concern is flood or debris flood impacting the area and potential plugging of the many stream crossings upstream of and within the cluster of buildings. | 38.991855°, -123.129568° |

**Figure 7.** Photographs of VAR #2. **A)** Reinforced channel upstream of buildings. **B)** Channel between buildings. **C)** Modified channel upstream of Photo A showing multiple culverted crossings. **D)** Furthest-upstream culverted crossing at transition from natural to modified channel, upstream of Photo C. **E)** Culverted crossing immediately downstream of Photo B, which would cause backwater effects around buildings if plugged. **F)** Culverted crossing adjacent to buildings further downstream of Photo E.
