## MEMORANDUM

**SUBJECT:** Summary of field reconnaissance  
Gann Fire, Calaveras County (CA-TCU-011483)

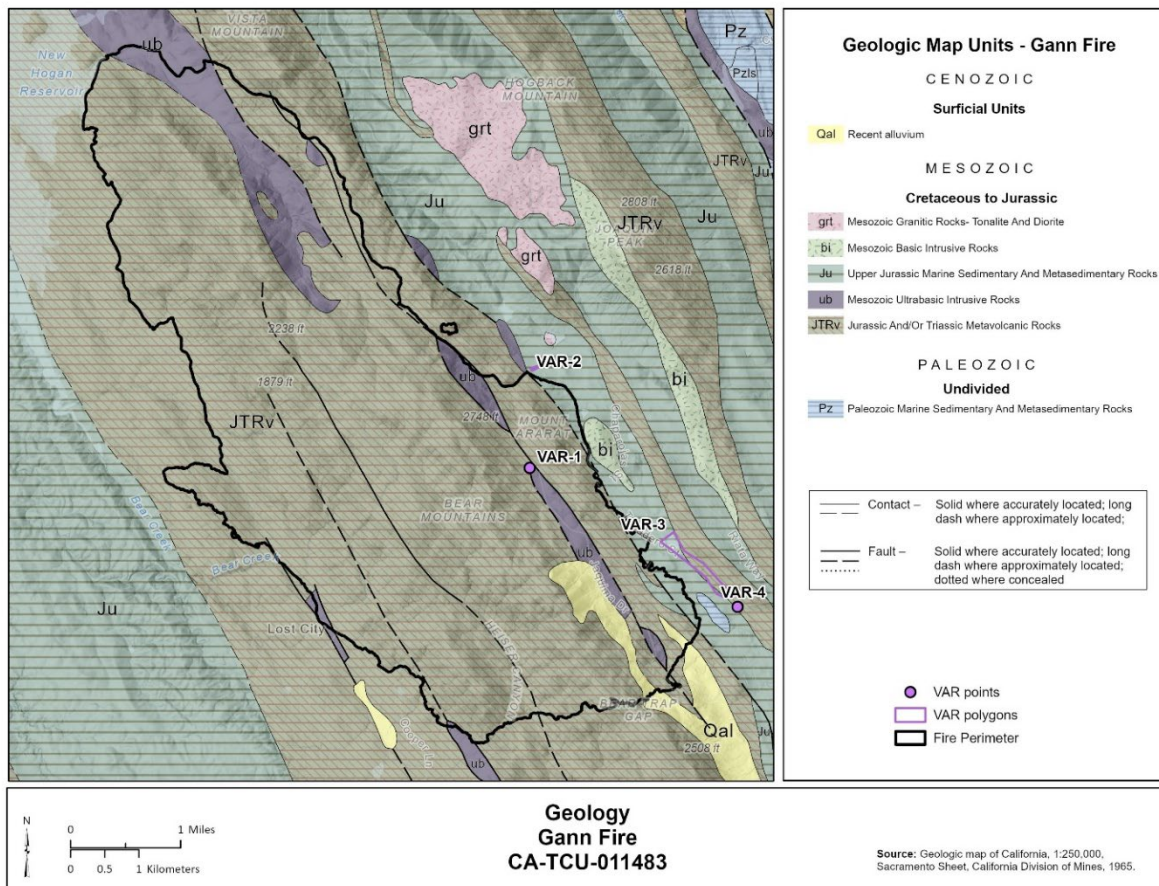
The area impacted by the fire is underlain primarily by metavolcanic rocks with some isolated zones of ultramafic rocks (mapped as "ub" in Fig. 1). These rocks may contain naturally occurring asbestos and other metals with the ultramafic rocks posing the highest risk (Fig. 1, 2). Fires disturb soil, increasing dust production and potential exposure to mineral toxicants. Asbestos is classified as a known carcinogen by state, federal and international agencies. Although the rocks in the Gann Fire burned area may produce mineral toxicants, analysis was not completed to determine the type and quantity of mineral toxicants present.

**Figure 1.** Geologic map overlaid on a shaded relief map.

Information regarding hazardous minerals can be found at the California Office of Environmental Health Hazard Assessment (<https://oehha.ca.gov/chemicals/>). We recommend consultation with the Calaveras County Air Pollution Control District (<https://ema.calaverasgov.us/Air-Pollution-Control>) to develop mitigations that are centered on limiting dust generation and exposure.

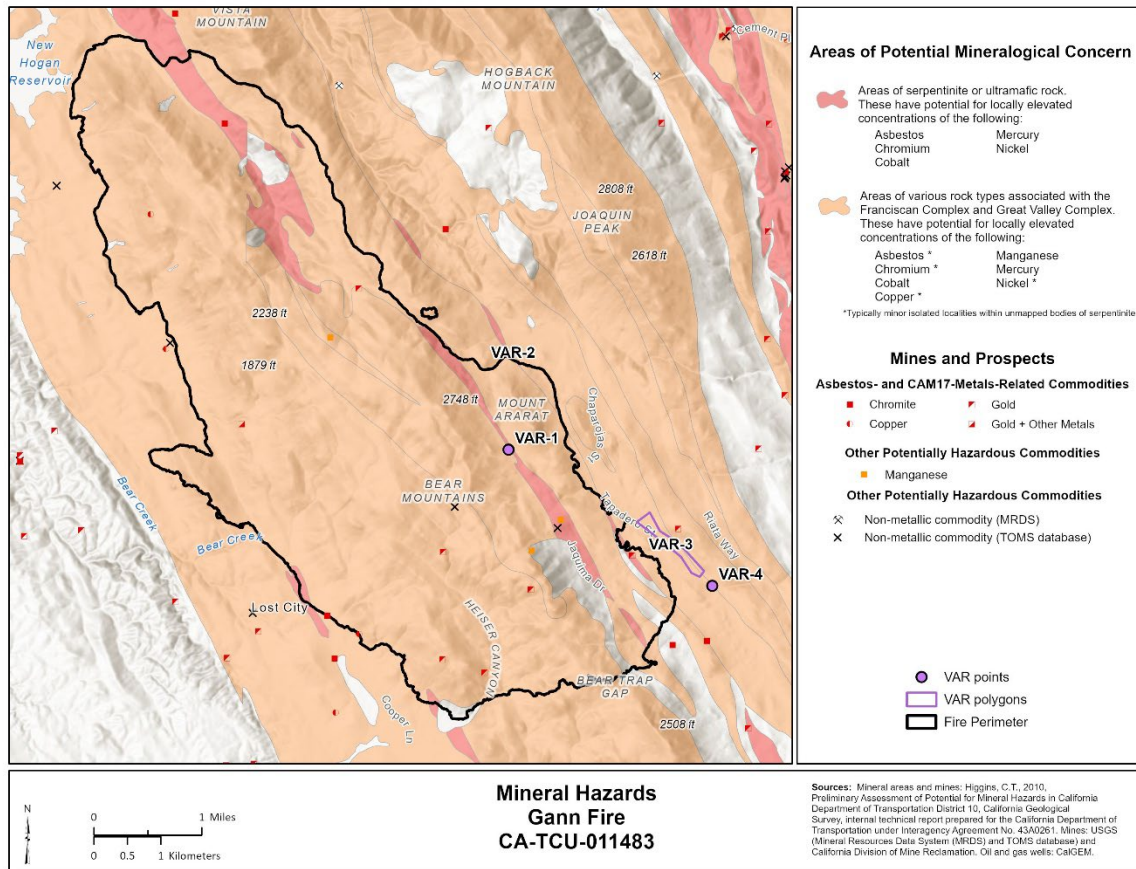
**Figure 2.** Map showing areas of mineralogical concern overlaid on a shaded relief map.

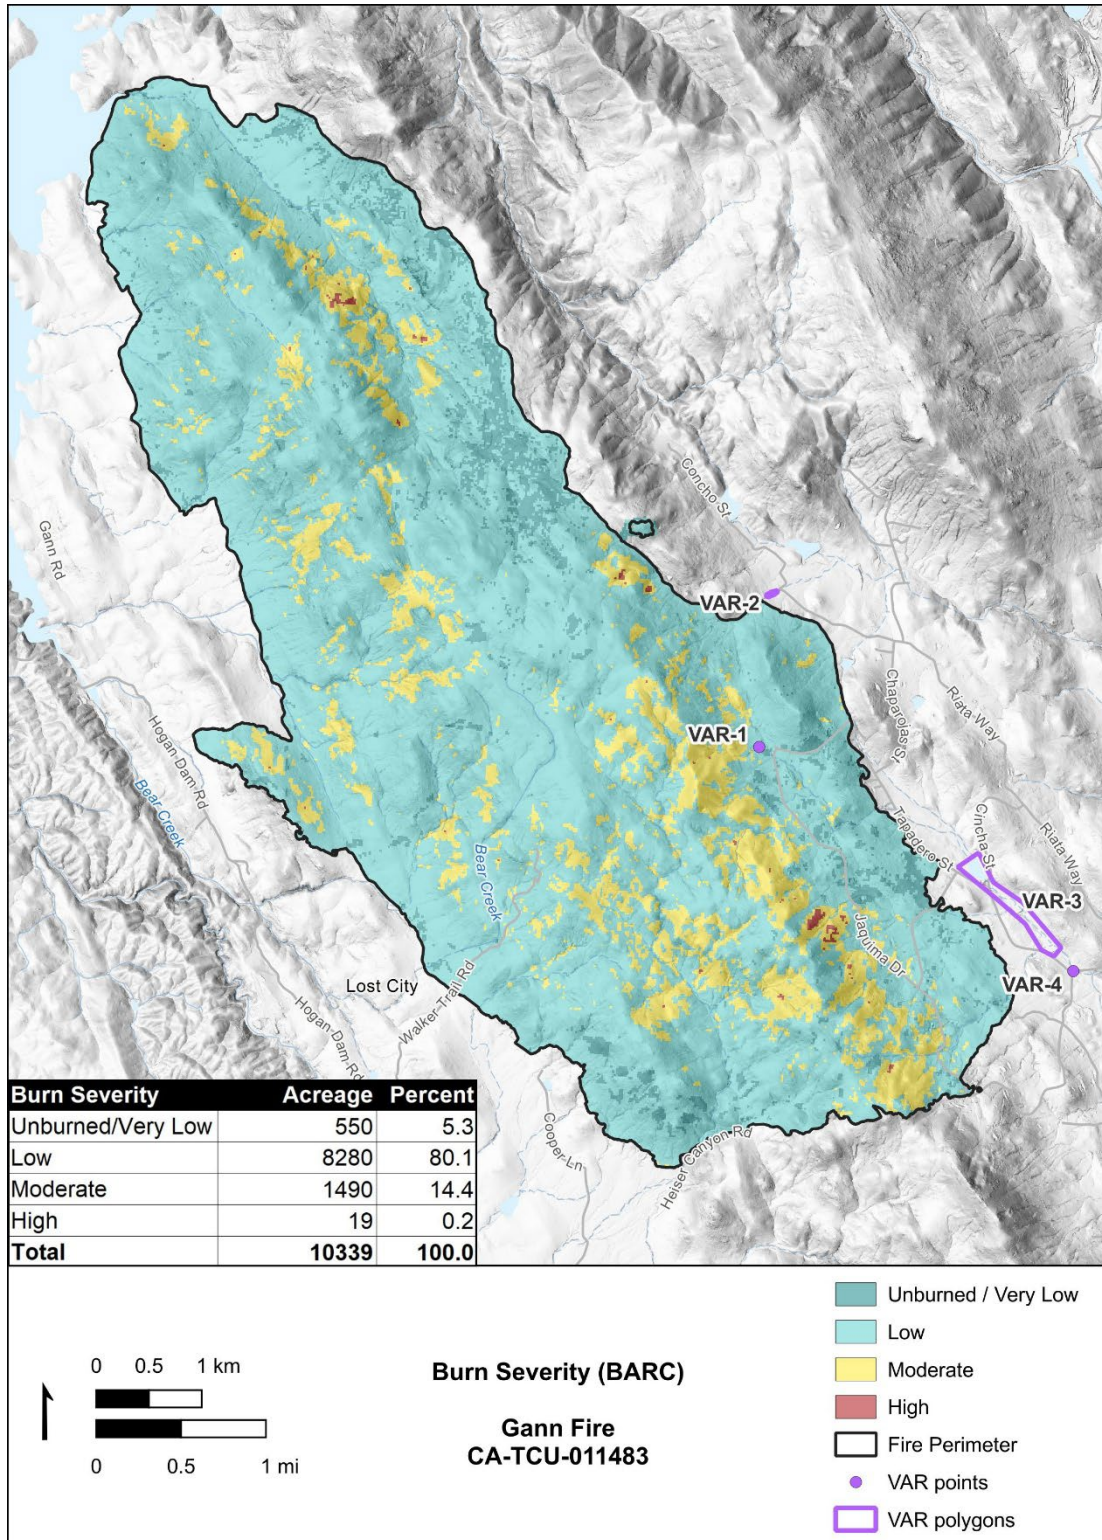
Pre-fire vegetation was primarily pine, oak, chaparral, and grasses with denser vegetation along watercourses. A burned area reflectance classification (BARC) map was provided by the USGS's Earth Resource Observation & Science Center. The BARC map indicates the fire severity was mostly low with some moderate (Fig. 3), indicating mostly low soil burn severity. Soil burn severity was validated at one site location with moderate burn severity. Strong water repellency was noted at ~1 to 2 cm depth at the boundary between burned and unburned soil.

**Figure 3.** Gann Fire burn severity (Burned Area Reflectance Class) map overlaid on a shaded relief map. BARC map produced by US Geological Survey Earth Resources Observation and Science (EROS) center.

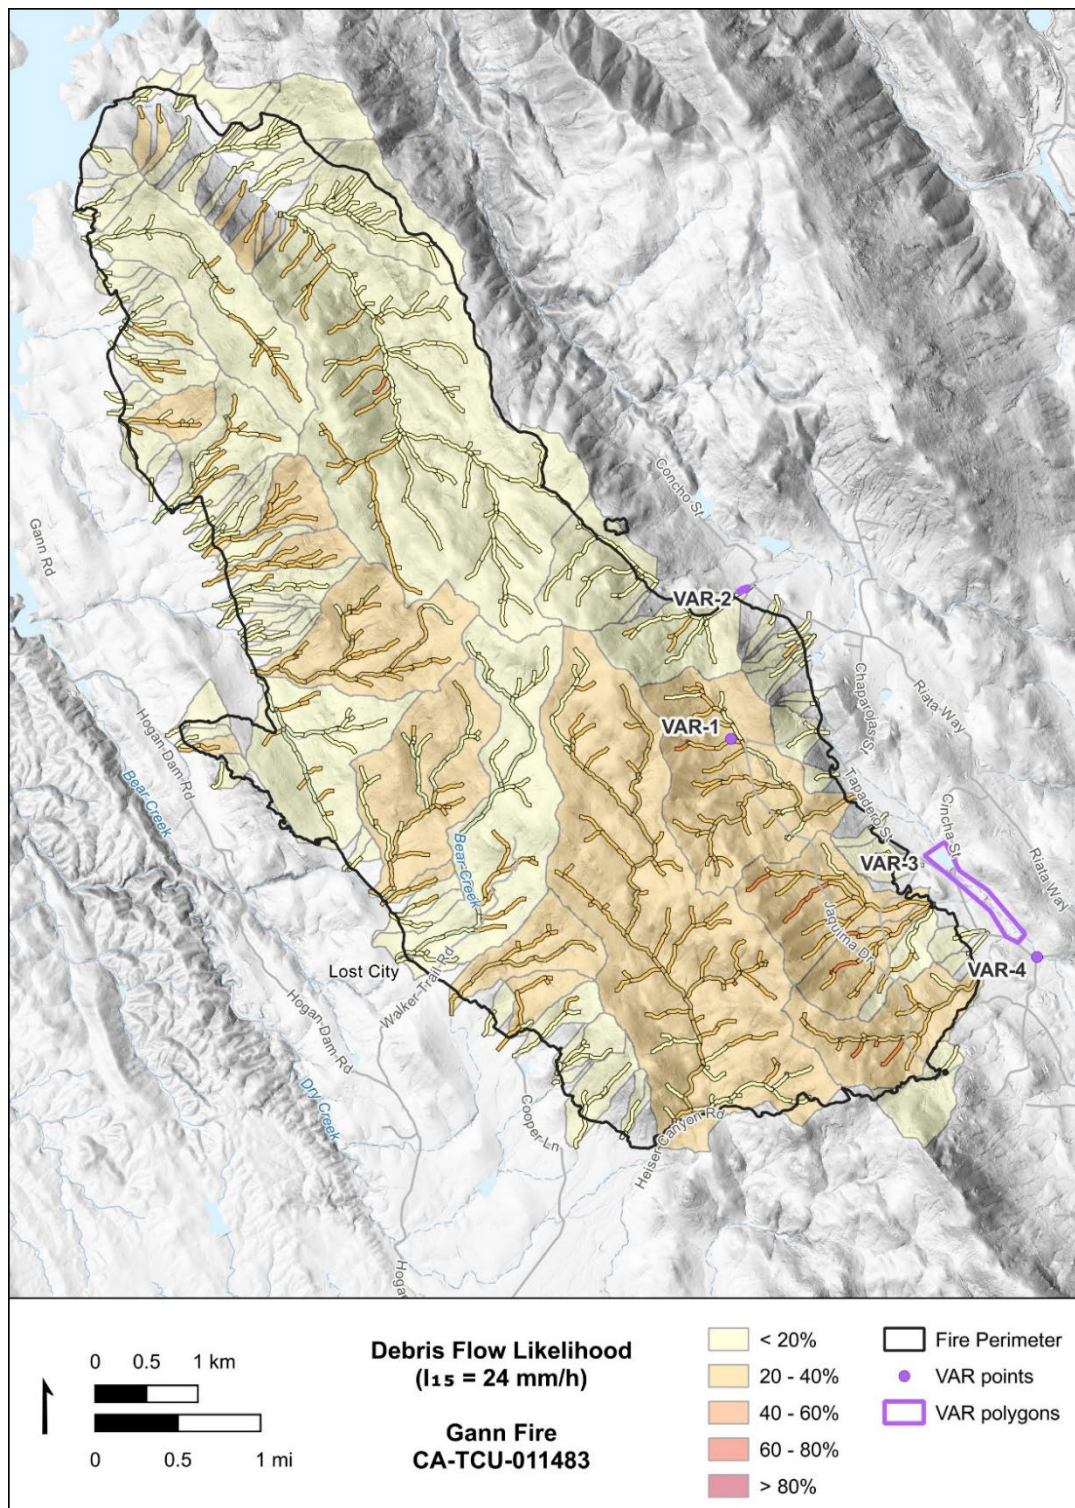
Postfire debris flow likelihood was modeled by the USGS (e.g., Staley et al., 2016) and found to be mostly low across the burned area due to the presence of gentle and moderately steep slopes and low burn severity (Fig. 4). The 2015 Butte Fire north of Bear Mountain produced multiple small to moderately-sized debris flows but includes steeper terrain.

**Figure 4.** Postfire debris flow likelihood map overlaid on a shaded relief map. Debris flow likelihood determined by the US Geological Survey Landslide Hazards Program.

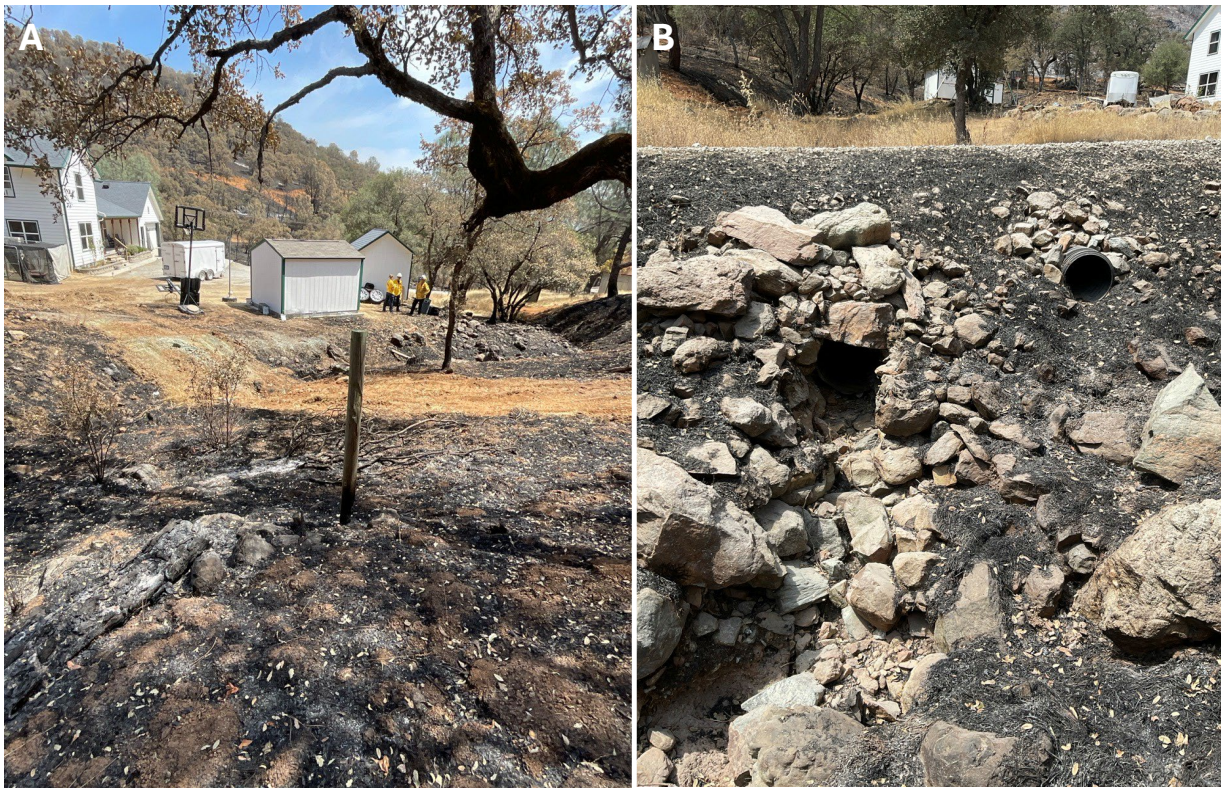
VAR #1 is a house adjacent to a watercourse with multiple small outbuildings that is accessed by a driveway with a watercourse crossing (Fig. 6). The slopes immediately behind the house and within the upgradient watershed were burned at mostly low and moderate severity. Nuisance runoff and erosion is possible from the slopes behind the house and may lead to minor impacts. The watercourse has a well-defined channel and is approximately 70 feet from the southwest corner of the house. The house is setback from the watercourse but debris floods and transport of large wood and other material capable of rerouting streamflow may create opportunities for the house to be impacted by postfire flooding. Two plastic culverts (12" and 16") were observed within the driveway watercourse crossing. These culverts may become plugged and overtopped during a storm.

| VAR | VAR description | Potential hazard type | Field assessment of potential hazard | Latitude, Longitude |
|---|---|---|---|---|
| 1 | House | Debris flood | Primary concern is the proximity of the house and outbuildings to a channel. The channel may become blocked and overtopped, limiting access to the house and property. In extreme cases, the house and outbuildings may be impacted by debris floods. Increased hillslope erosion and runoff on slopes behind home could become a nuisance. | 38.10926°, -120.70611° |

**Figure 6.** Photographs of VAR #1. **A)** View looking downstream at channel, house, and outbuildings. Dirt road crossing is a potential location where streamflow could overtop the stream left channel bank and flood the house and outbuildings. **B)** Looking upstream at outlets of 16" (left) and 12" (right) culverts downstream of the house. These culverts may become plugged, and the driveway could become flooded and damaged.

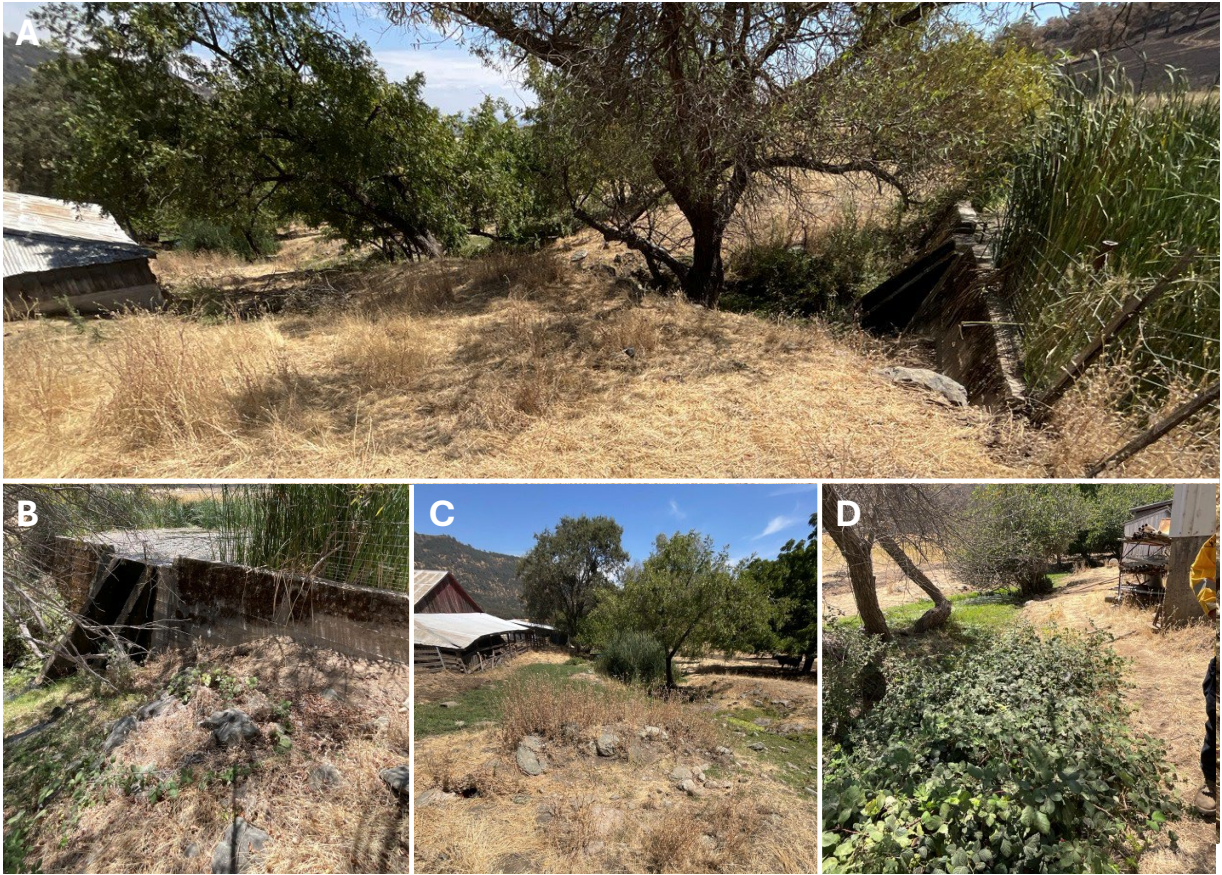
VAR #2 is a property with multiple outbuildings near a channel (Fig. 7). A pond with a concrete weir is immediately upstream of these buildings. If the concrete weir and dam overtop, there is potential for downstream buildings to be impacted. Partially draining and maintaining flow from the pond will decrease flood risks. The most downstream building is near the channel and may be impacted by flooding. The building is supported by a concrete foundation that would likely minimize flood impacts.

| 2 | Outbuildings | Flood | Multiple buildings are located near a channel and may be impacted by flooding. A small pond upstream of the buildings may be overtopped during intense storms. | 38.12243°,<br>-120.70544° |

**Figure 7.** Photographs of VAR #2. **A)** View looking downstream of **B)** concrete weir structure. **C)** View looking downstream showing barn that may be impacted by flooding. **D)** View looking upstream below most downstream building, which may be impacted by flooding.

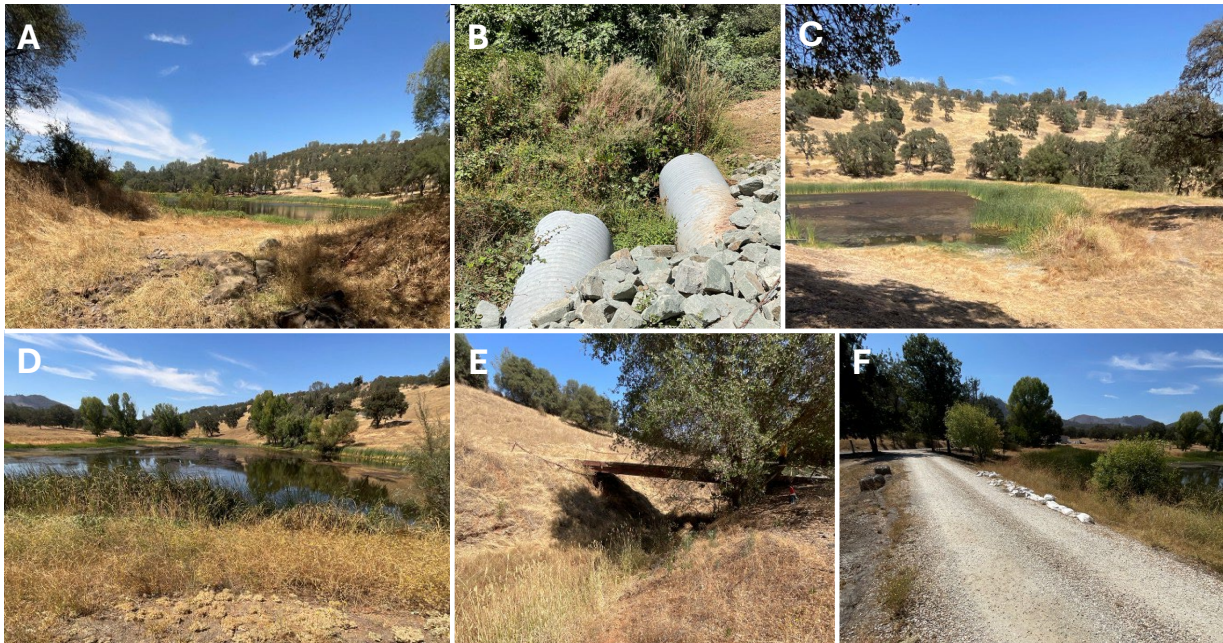
VAR #3 is a series of ponds connected by a creek (Fig. 8). Cincha St. crosses the channel between the most upstream pond and the middle pond. Culverts along Cincha St. may plug and be overtopped during a storm, causing flooding along Cincha St. For the most downstream pond, a road on the dam is at risk of overtopping and serves as the only ingress and egress to multiple residences. Sandbags and evidence of overtopping of the road on the dam are evidence that flooding along this road has occurred previously.

| 3 | Ponds and nearby roads | Flood | A series of ponds may be overtopped, impacting nearby roads and damaging earthen dams. The downstream pond is likely at highest risk as evidence of overtopping was present. | 38.09568°,<br>-120.67677° |

**Figure 8.** Photographs of VAR #3, which includes three ponds and two roads. **A)** View of upstream pond and outlet channel. **B)** View of inlets for two 36" culverts that connect the upstream and middle ponds and cross underneath Cincha St. **C)** Middle pond with outlet. **D)** Downstream pond with **E)** outlet with bridge and **F)** road on the earthen dam and sandbags that may have been deployed to limit prior flooding over the dam.

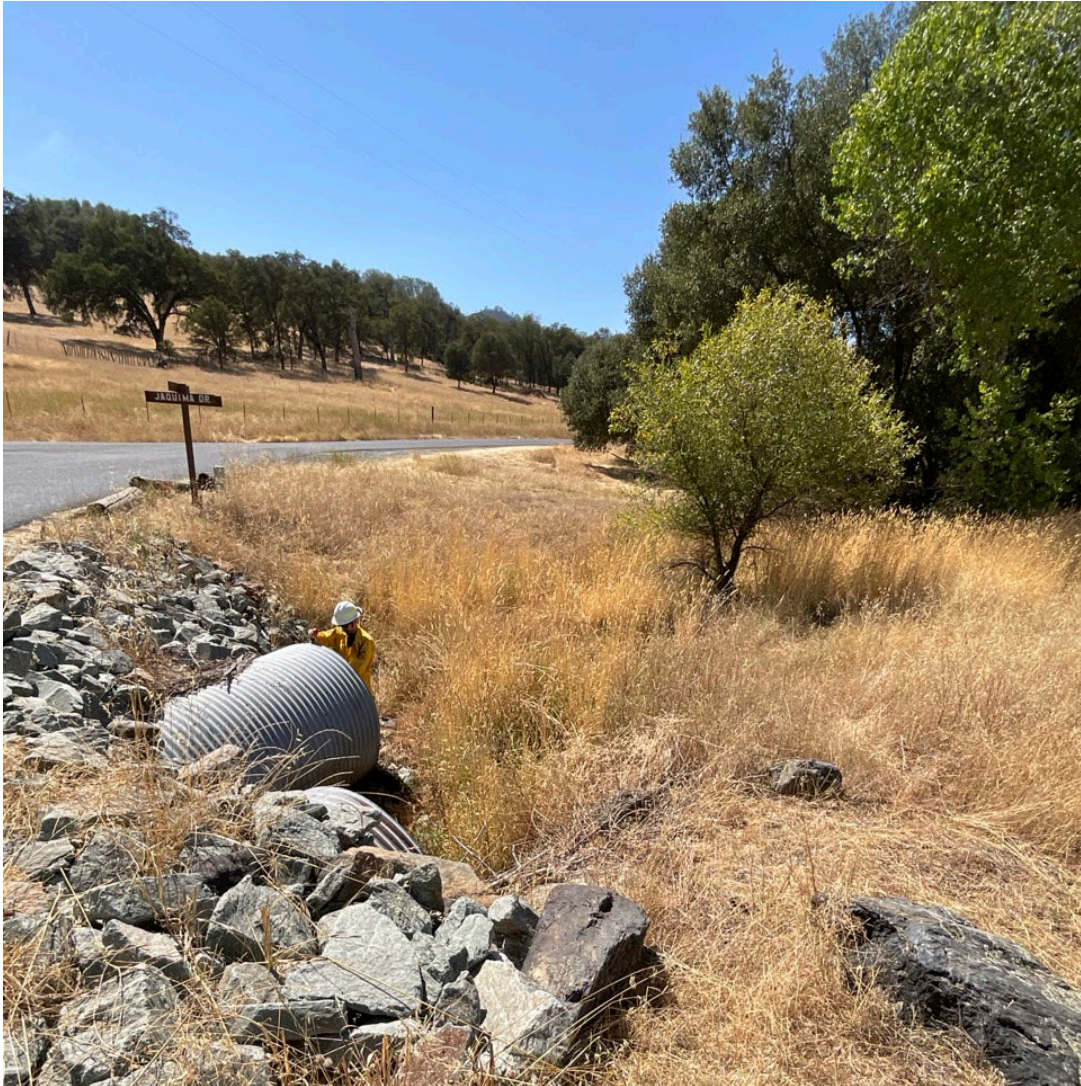
VAR #4 is a double-barreled culvert located near the intersection of Tapadero St. and Jaquima Dr. (Fig. 9). A resident living nearby said this stream crossing has experienced prior flooding and evidence of flow overtopping a channel bank and flowing along a ditch on Tapadero St. was observed. These culverts are located at an intersection of major roads in the area. These culverts could plug or overtop, flooding Tapadero St.

| 4 | Stream crossing | Flood | This crossing is immediately downstream of VAR #3 (ponds). Plugging and overtopping of the culverts is possible, which would result in Tapadero St. being flooded. | 38.09119°,<br>-120.67122° |

**Figure 9.** Photographs of VAR #4 showing inlets of two 60" culverts. There was evidence that flooding had previously occurred at this location.

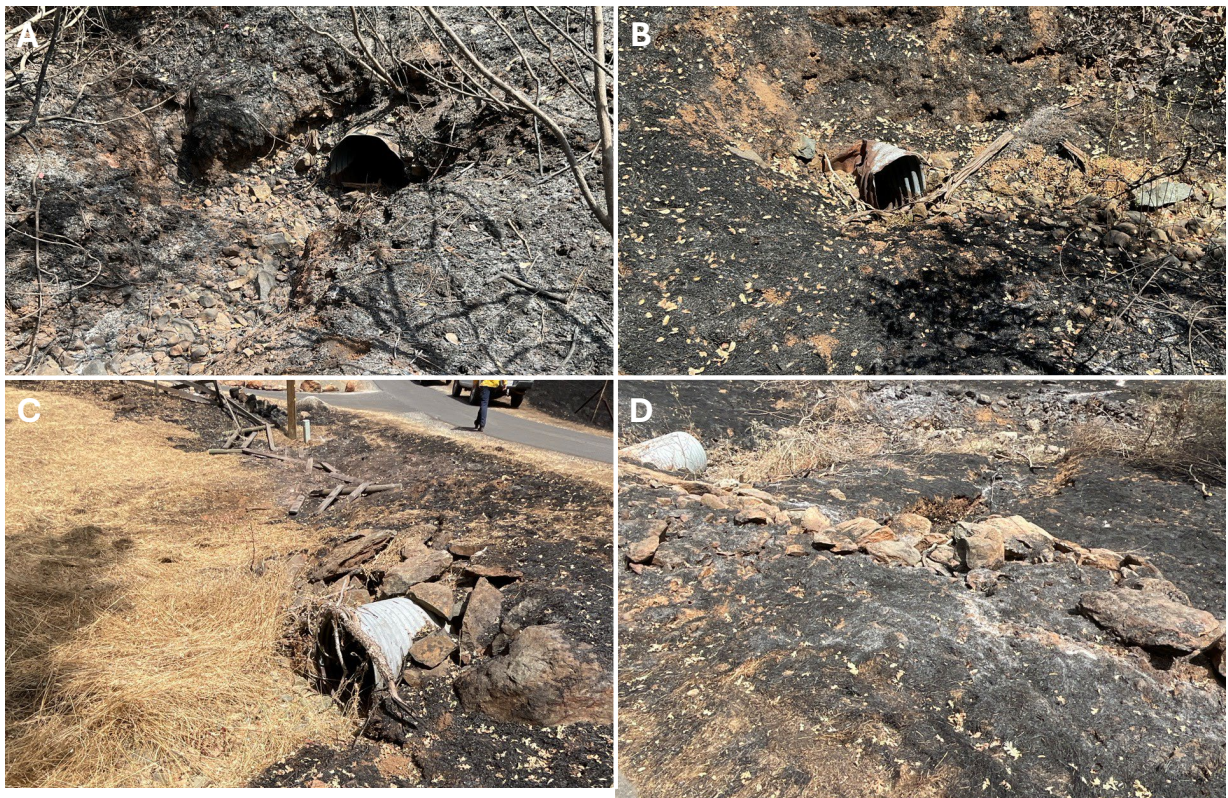
In addition to these VARs, multiple roads inside or near the fire boundary are at risk of being impacted by floods and debris floods. Jaquima Dr., Latigo St., and Tapadero St. are at the highest risk of being impacted by flooding and debris floods (Fig. 10).

**Figure 10.** Examples of culverts that are at risk of plugging or overtopping. **A)** Inlet of 28" culvert on Jaquima Dr. that is partially plugged and at risk of becoming fully plugged. Fill depth above culvert is approximately 6 feet (38.10557°, -120.703586°). **B)** Inlet of 16" culvert on Latigo St. that is partially collapsed and at risk of becoming plugged (38.09219°, -120.68825°). **C)** Inlet of 36" culvert with debris and **D)** evidence of overtopping the road and rock armoring (middle of photo) near the outlet (38.09219°, -120.68825°).

Postfire impacts will most likely be flooding, limited road access, and damage to the road network (especially Jaquima Dr., Latigo St., and Tapadero St.). Residents in the area should be cautious of flooded roadways and be aware of weather forecasts and the potential of storms that may trigger flooding and debris floods. Ingress/egress may be impacted, especially to the homes accessed by the road located on the dam of the most downstream pond marked as VAR #3. Culverts should be monitored and maintained with frequent inspections between storms. Nuisance flooding and erosion may occur inside and immediately downstream of the burned area.
