Watershed Emergency Response Team (WERT) 2025 Pickett Fire

CA-LNU-015521

September 17, 2025

REPORT TITLE: Watershed Emergency Response Team (WERT) Evaluation – 2025 Pickett Fire

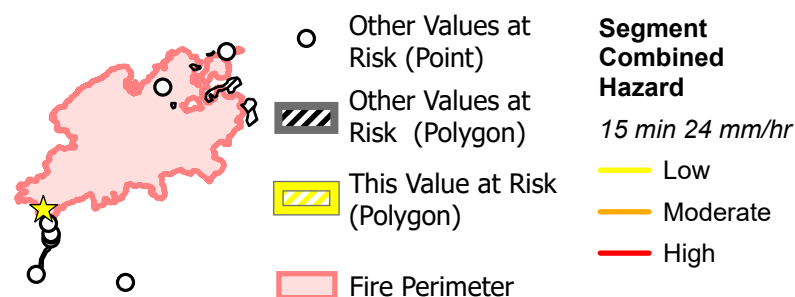
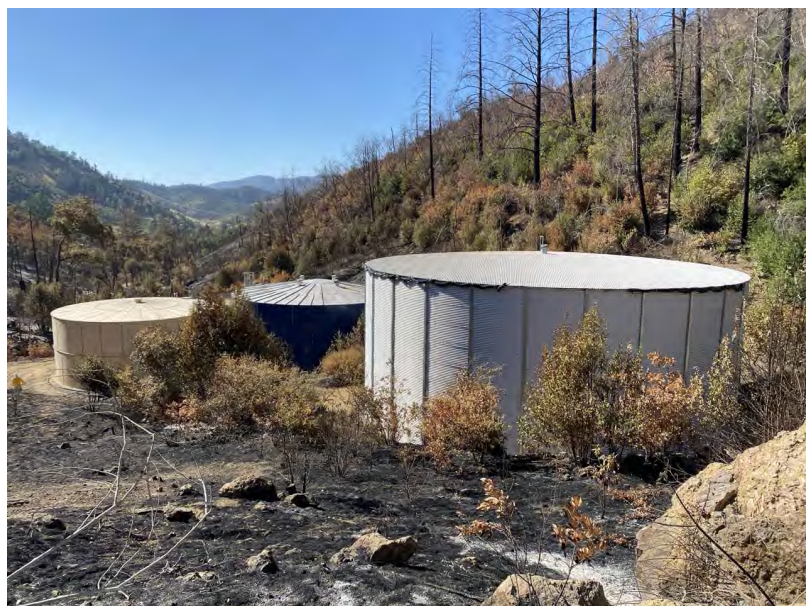
Upstream catchment burned at moderate. Potential for large woody debris, cobbles, and sediment in channel to be mobilized. Tanks are elevated and removed from larger adjacent drainages to the east and west. Tanks access road has potential to be impacted at low water crossings during storm events.

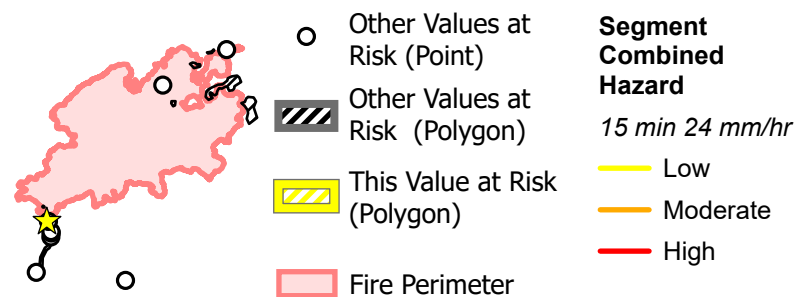
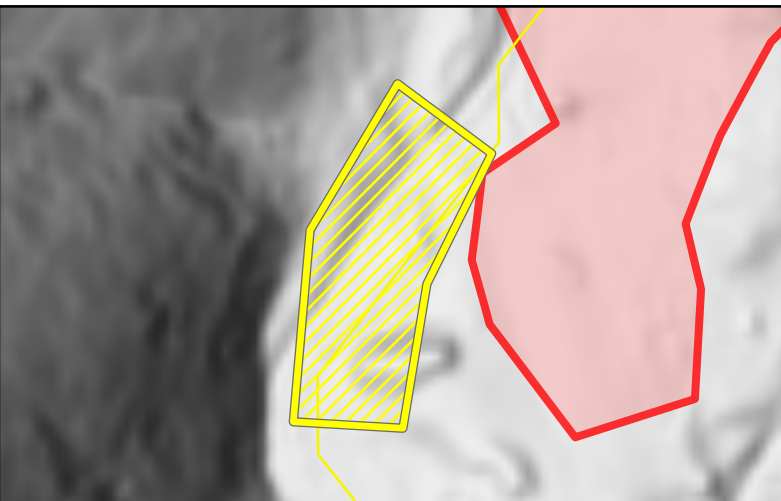
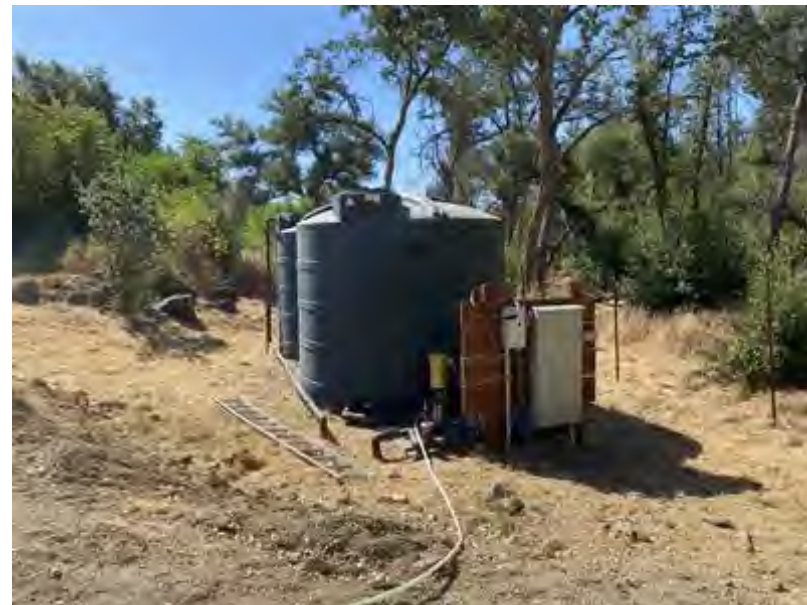
Water tank improvements are located adjacent to shallow, narrow watercourse. Just upstream, and 8" plastic pipe that houses two smaller pipes (2.5" and 3.5") crosses over channel. Upstream drainage partially burned at low and moderate. USGS model indicates low likelihood (16%) of debris flow with low combined hazard.

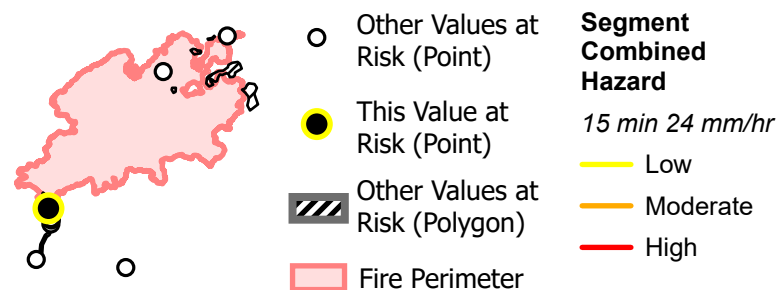
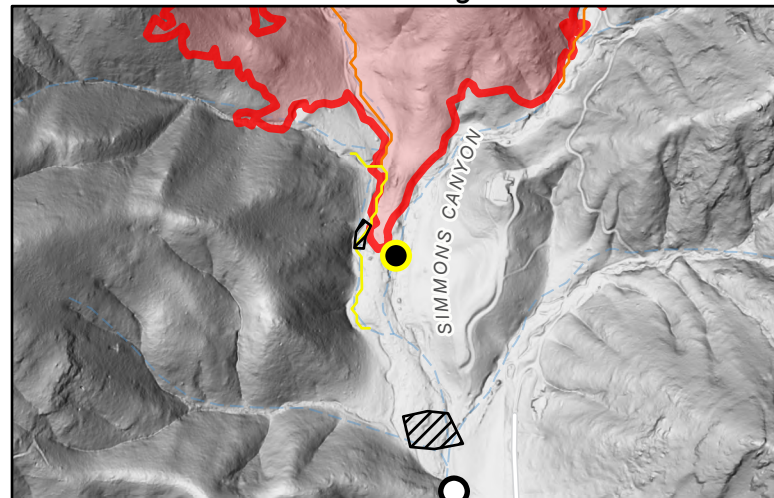
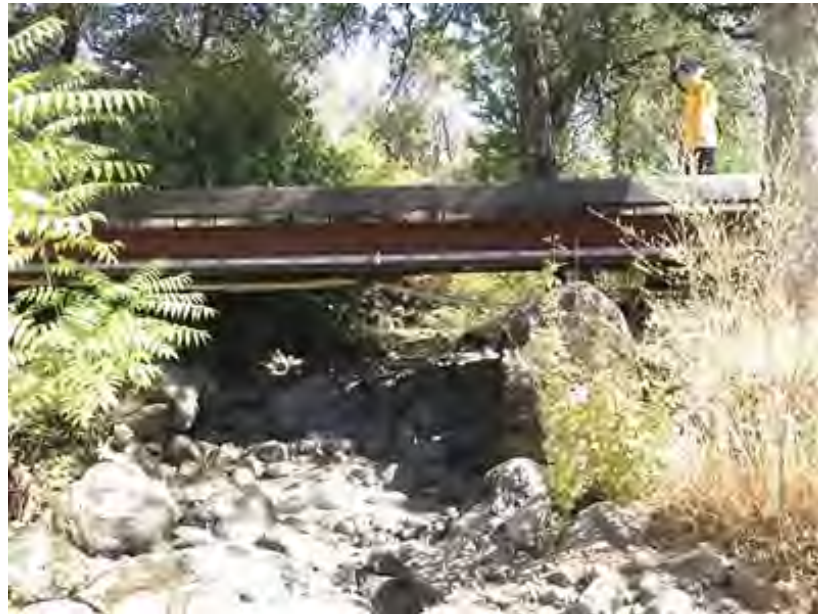
Bridge with wood deck and steel I-beam supports span 35-40' across channel with plastic and metal pipes strung below the bridge deck. Bridge provides access to water tanks. Upstream basin burned mostly at moderate with some low and some high. USGS model indicates moderate likelihood (42%) of debris flow in upstream drainage with moderate combined hazard for the basin. Large cobbles and boulders are prevalent in channel at bridge location.

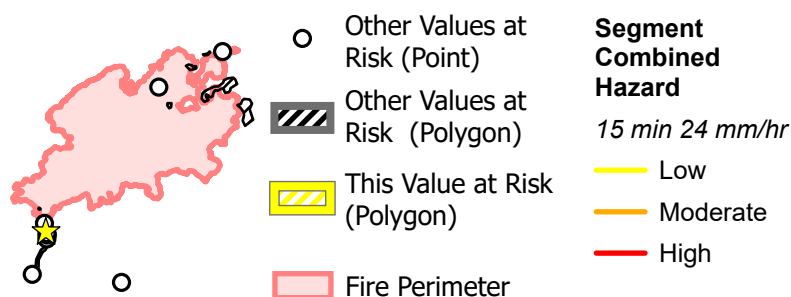
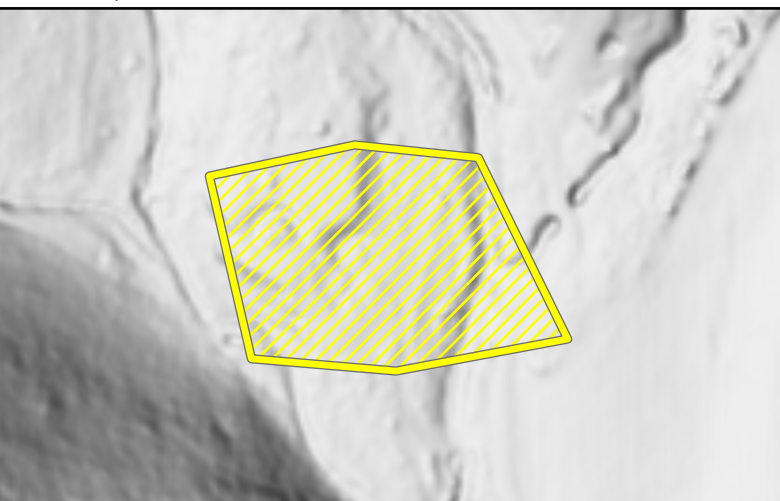
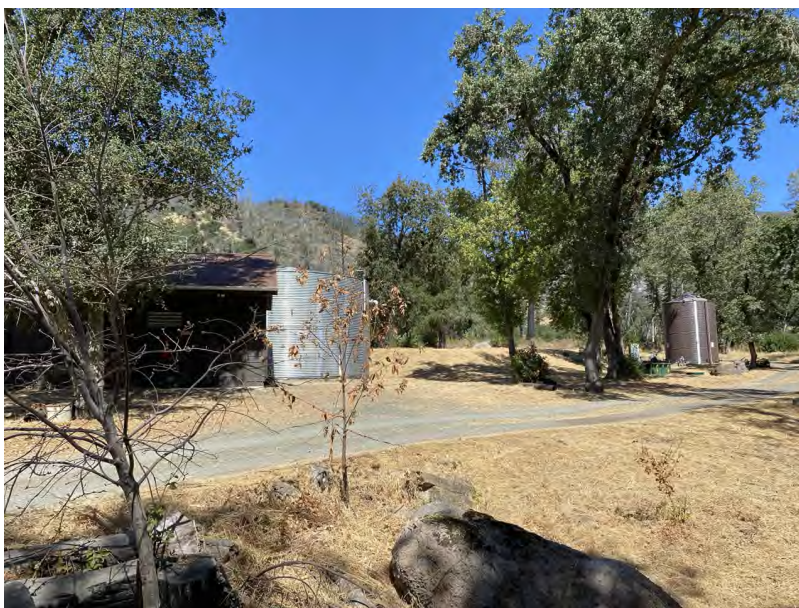
Structures slightly elevated on terrace above two watercourses that drain moderately sized basins burned at low and moderate, with some unburned contributing area. 8-inch water line and electrical lines encased in steel pipes (two 12" and one 16") cross over channel about 5' above channel bottom. Soft bottom crossing to improvements at risk of washing out. USGS model indicates low and moderate combined hazards for the two contributing basins.

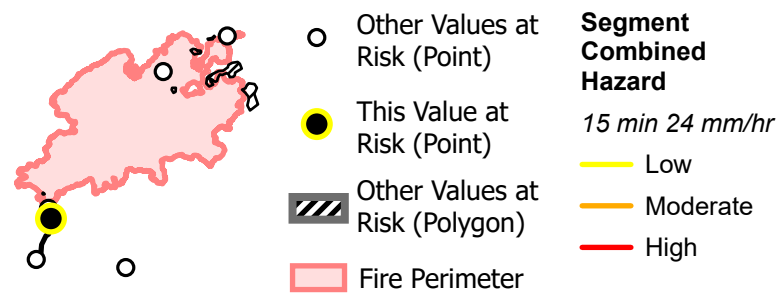
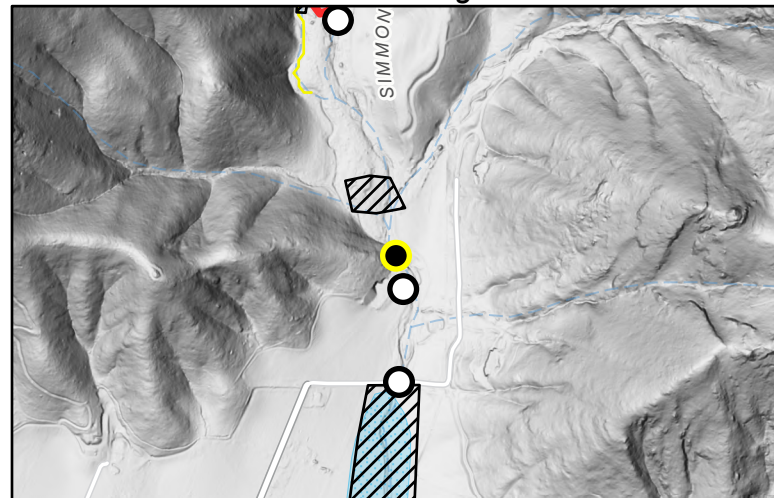
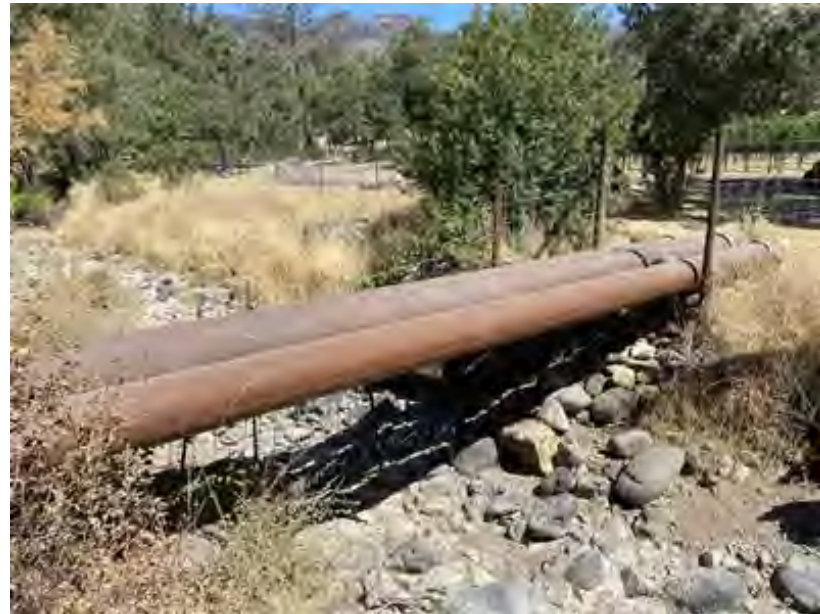
Several water line and electrical lines encased in steel pipes (two 12" and one 16") cross over channel about 5.5' above channel bottom. USGS model indicates low and moderate combined hazards for the two contributing burned basins, which account for about 40% of watershed at this location.

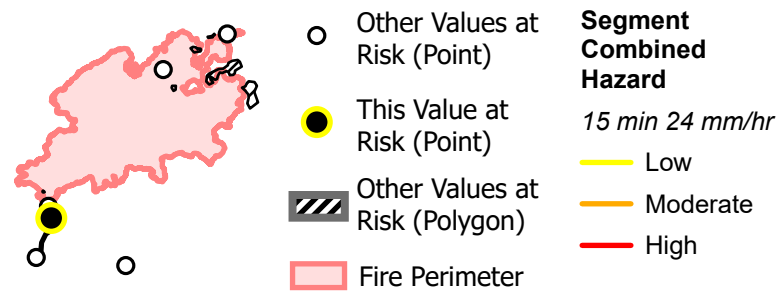
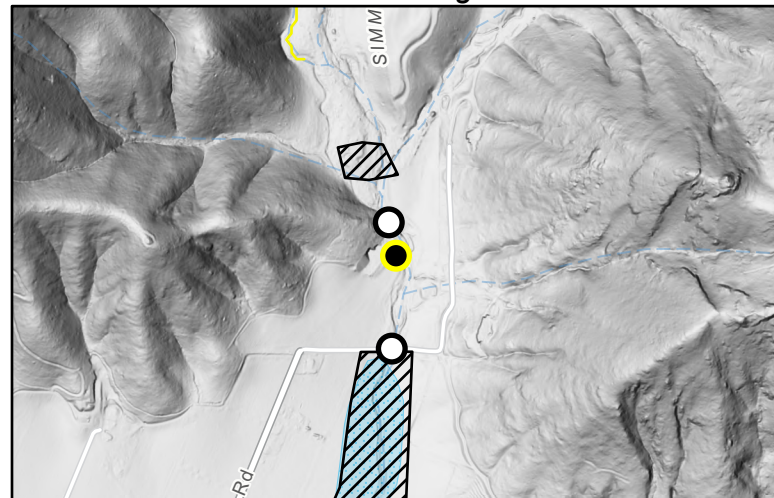
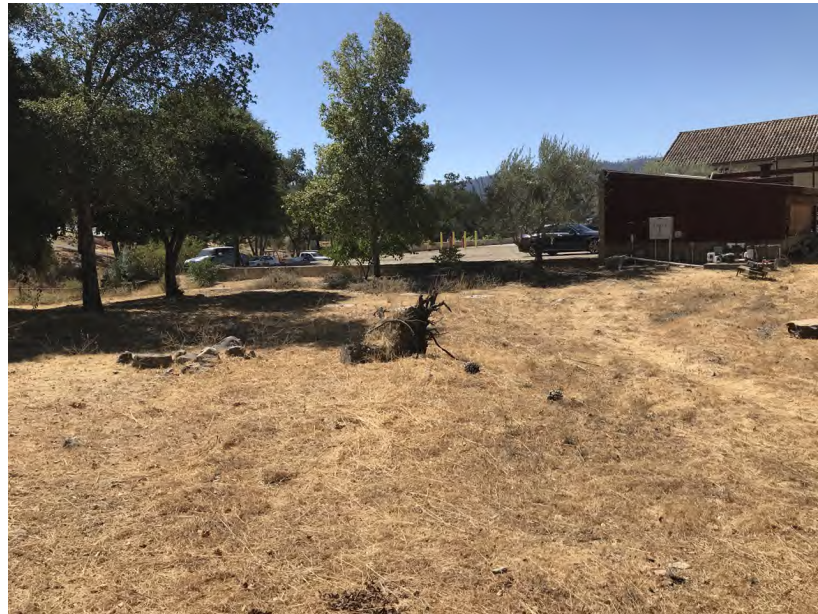
Low lying parking lot, low point at head of terrace is potential avulsion point. Upstream watershed partially burned at low and moderate.

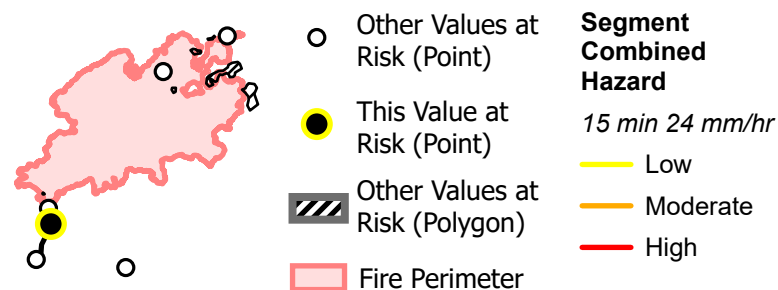
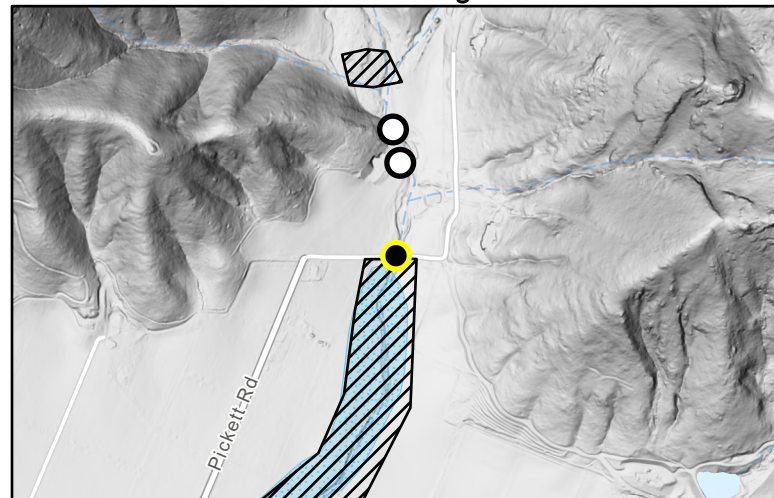
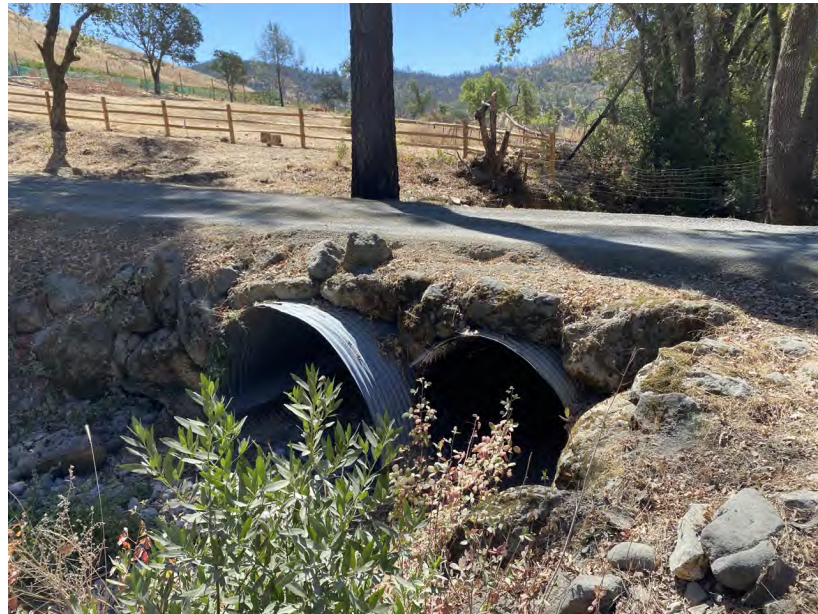
5' diameter CMP and 5' x 8.5' squashed CMP with about 18" freeboard. Backwater effects could locally impact adjacent vineyards with nuisance flooding. Just downstream of crossing the right bank has been modified with a levee consisting of cobble and boulder piles, which suggests that the watercourse has been prone to overtopping in the past. Presumably the levee was constructed to help protect adjacent vineyards from flood hazard. About 58% of the contributing watershed was burned (32% at moderate). A 1.4 flow multiplier is estimated at this crossing.

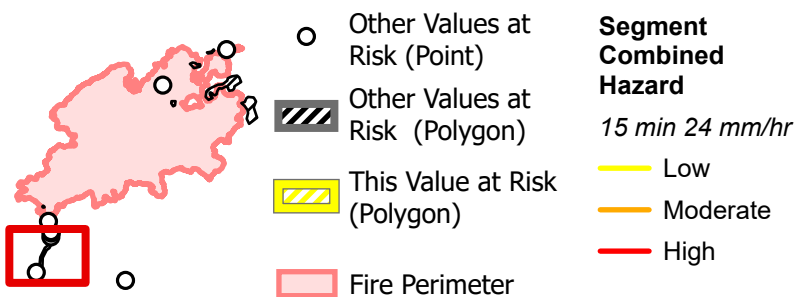
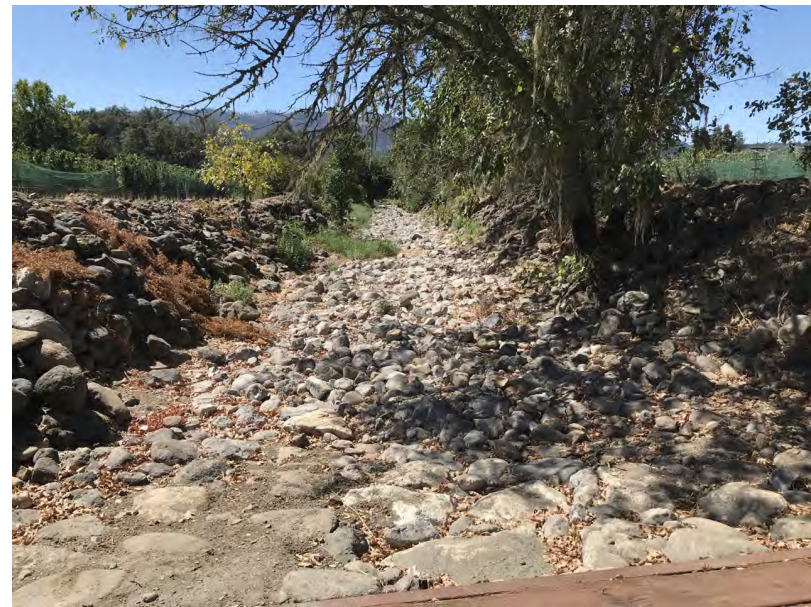
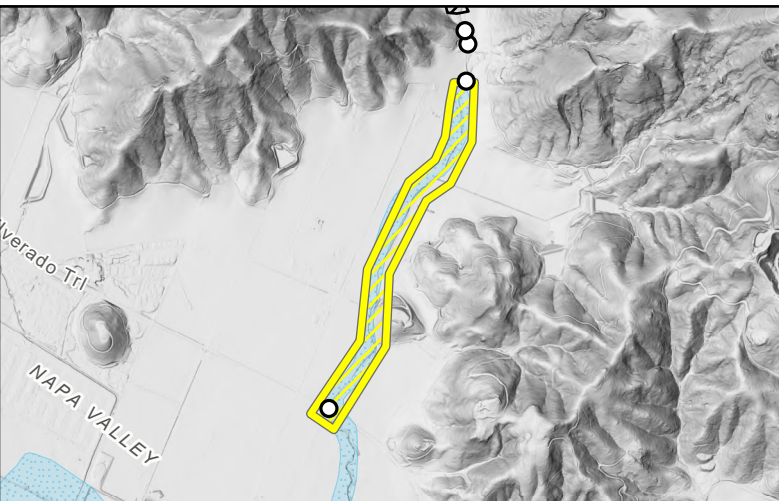
Channel is armored, north side of channel has rock levee at double barreled crossing, channel is 18-20' wide and 6' deep, residential structure along lower channel bank, channel is 8' deep and 20' wide.

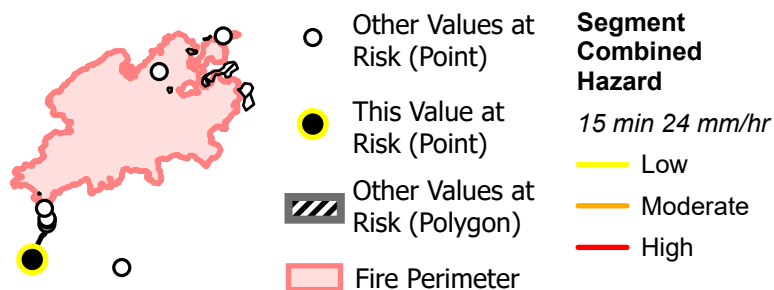
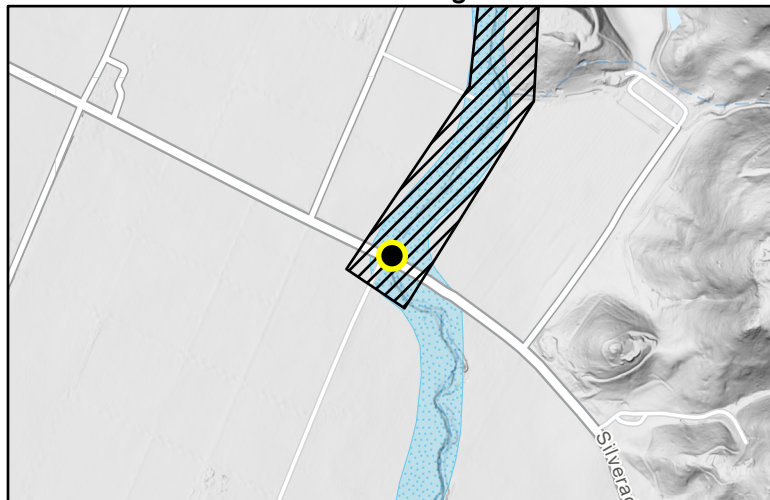
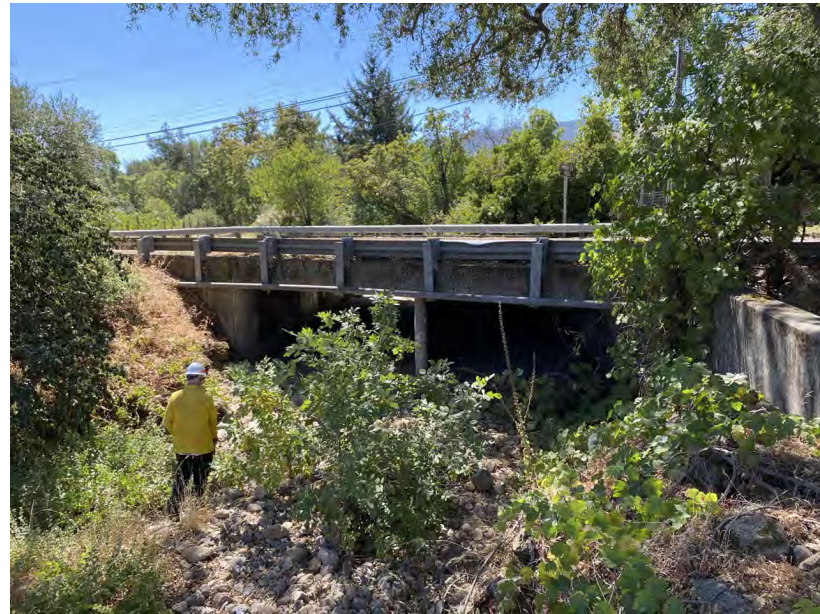
Box culvert is located at a bend in the channel. Right bank box includes up to a about 1' of sediment with a tree partially blocking outlet. Left side clear. Each box 6.5' H x 12'W. Homeowner on south side of road has owned since the 70s with no history of flooding.

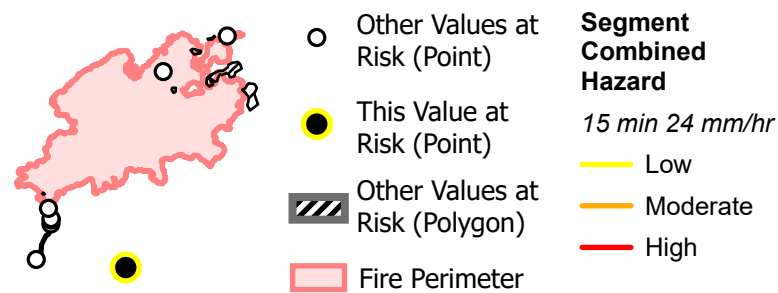
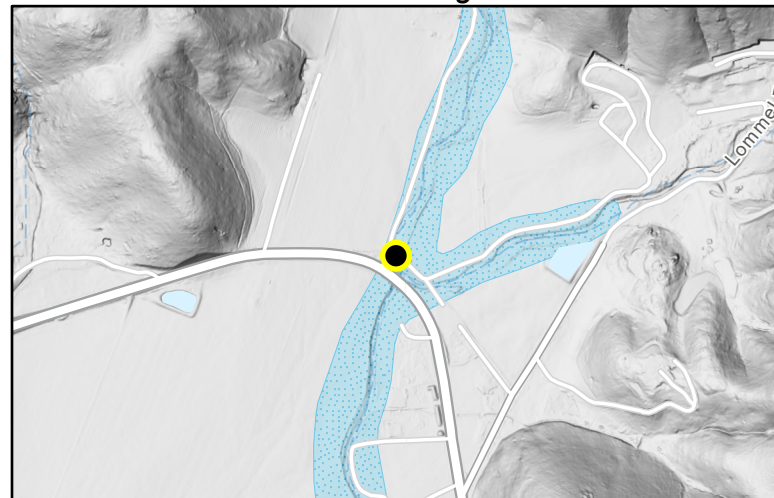
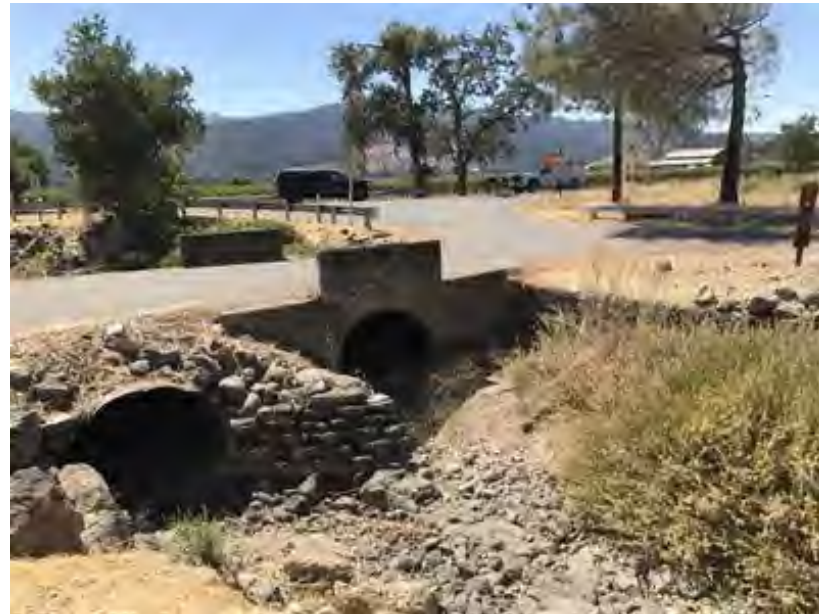
Squashed 4' x 6' CMP and 6' diameter steel pipe. Sediment accumulation at inlet and scour at outlet suggests undersized culvert. Potential for avulsion is very low but may be directed to Silverado Trail 40-50' downstream. This crossing is 100' upstream of Silverado Trail crossing, which drains both subject and adjacent basins. Some backwater likely occurs. A long rock berm is present along rural road to restrict backwater, and dried wood/sticks seem to indicate past overtopping. 37% of tributary area was burned (4% at moderate). Increase in flood flow as a result of fire is predicted to be very low.

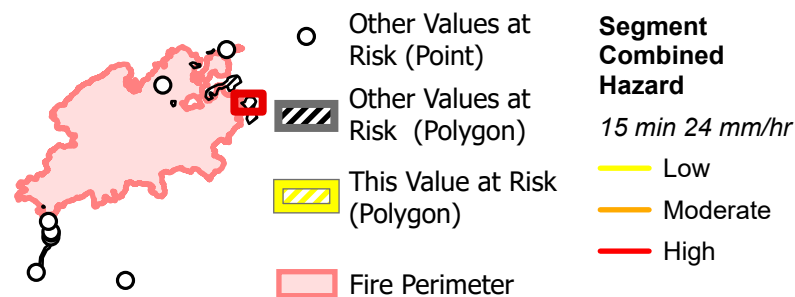
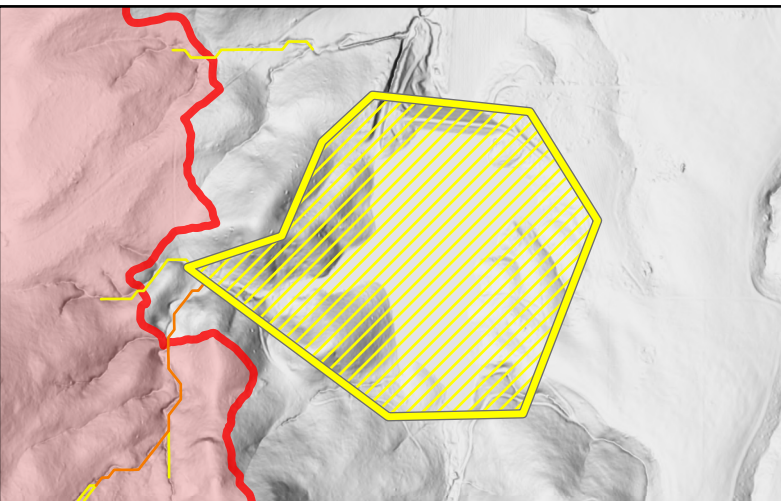
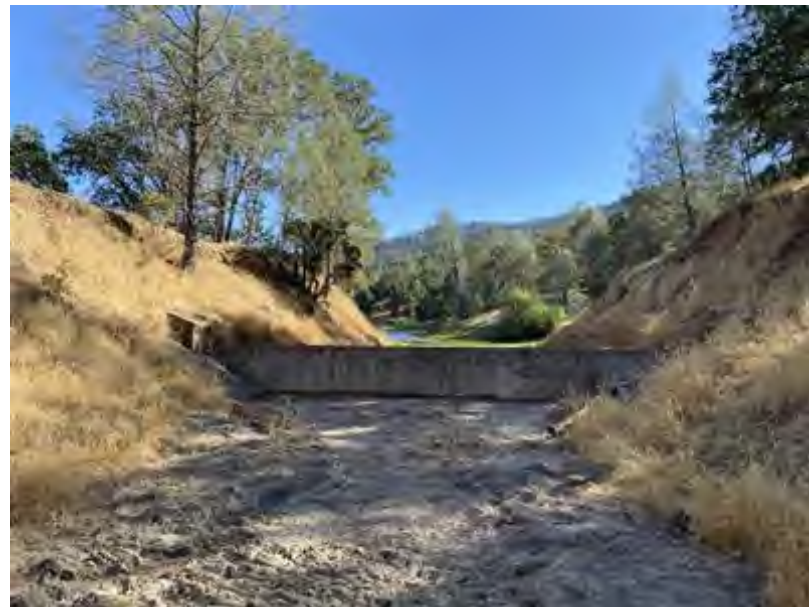
Downstream pond in a system of two ponds; tributary area to upstream pond was minimally impacted by fire. Lower pond is about 3 ft from capacity. Outlet includes a trapezoidal spillway with 2.5'H by 27'W check dam and 0.5:1 side slopes to ~8' above check dam. About 38% of tributary area is within the burn perimeter, with only 8.5% burned at moderate. USGS model indicates a 30% likelihood of debris flow with a moderate combined hazard for a primary tributary basin.

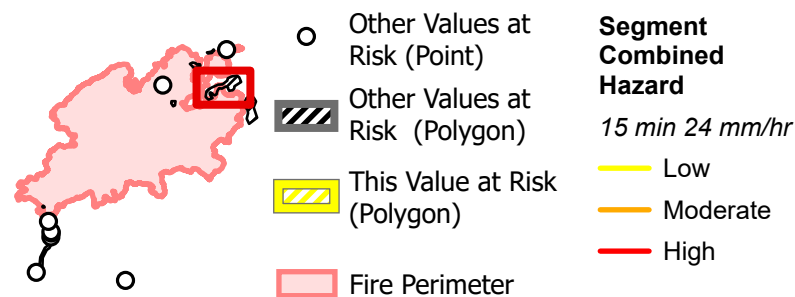
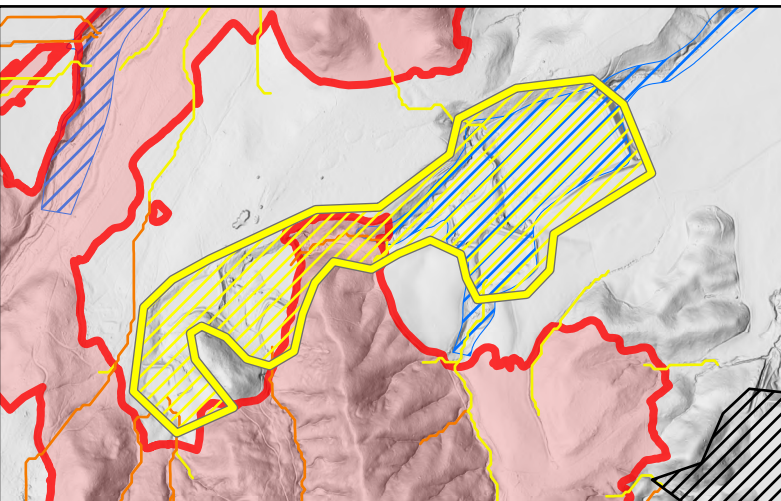
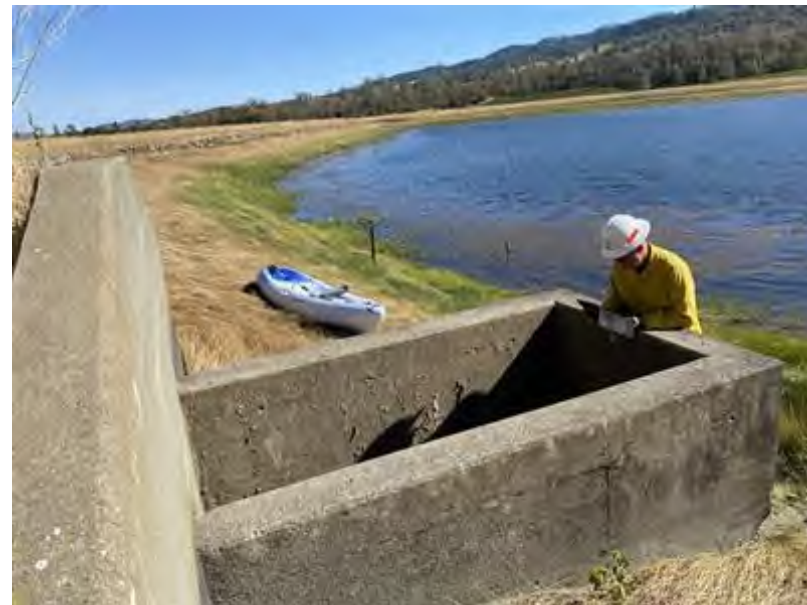
Outlet of lower pond includes a concrete inlet structure on dam face 4'x 8' dropdown to a 4' x 4' lateral box, which outlets to a spillway. About 82% of tributary area is within the burn perimeter, with 20% burned at moderate. USGS model indicates a 32% likelihood of debris flow with a moderate combined hazard for primary tributaries to the upper ponds.

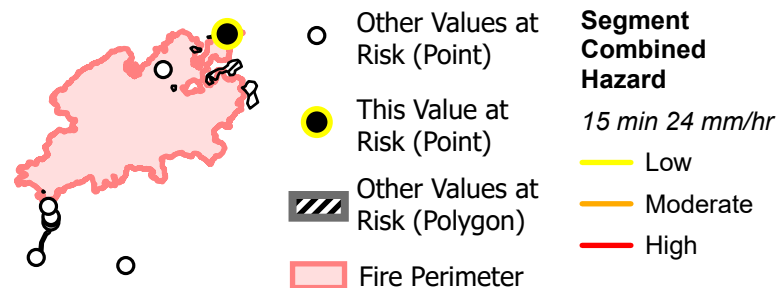
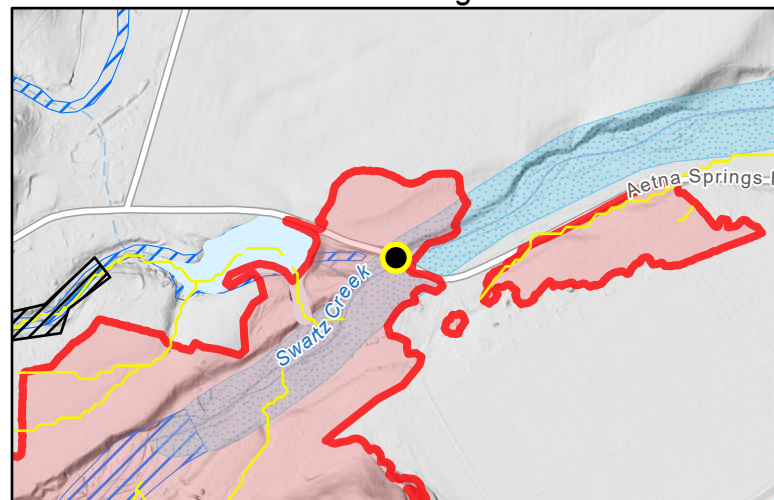
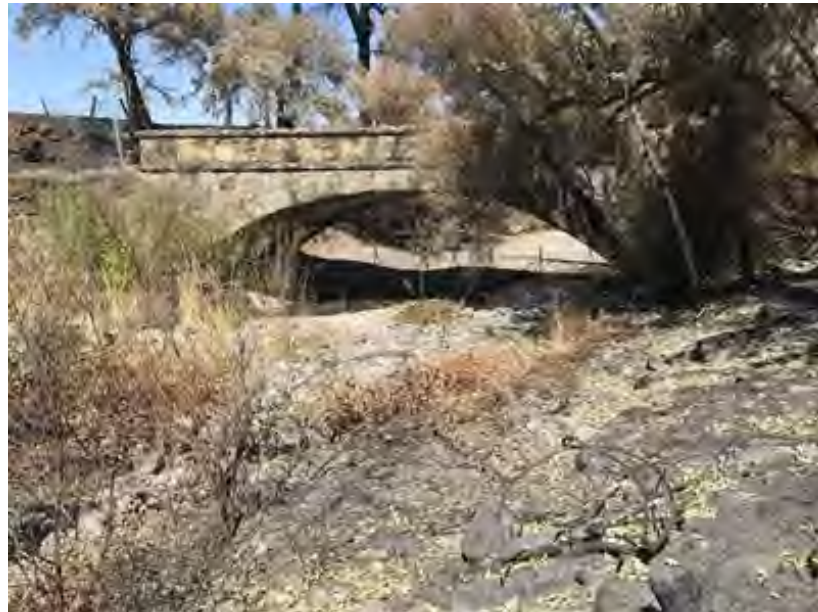
Swartz Creek Bridge (built 1912) is 42' W x 11'H with arched opening. Sediment deposition observed under bridge and in approaches. Large watershed extends through the fire footprint and is burned at low mod and high. Potential for backwater to inundate areas adjacent to upstream side of bridge, with low potential to reach road surface. About 77% of tributary area is within the burn perimeter, with 18% burned at moderate and high.

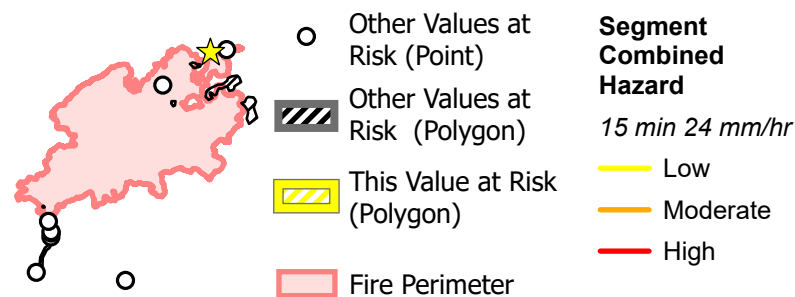
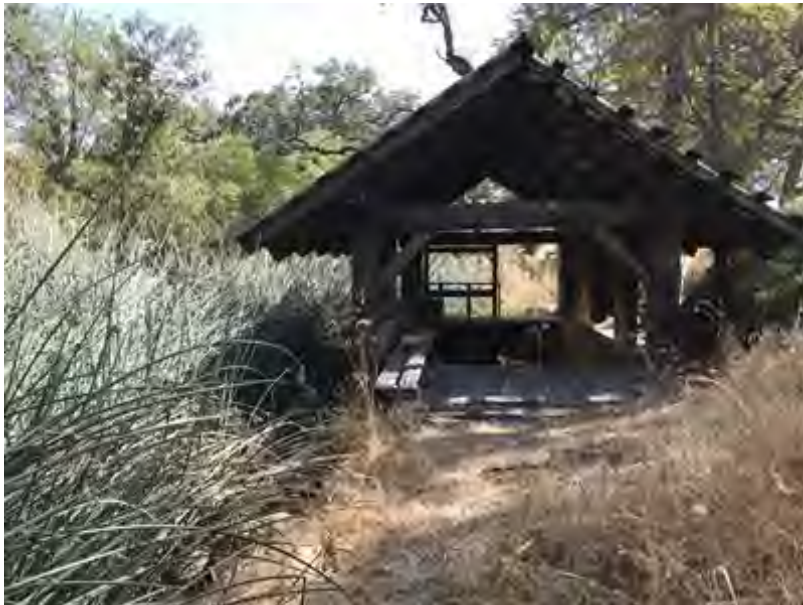
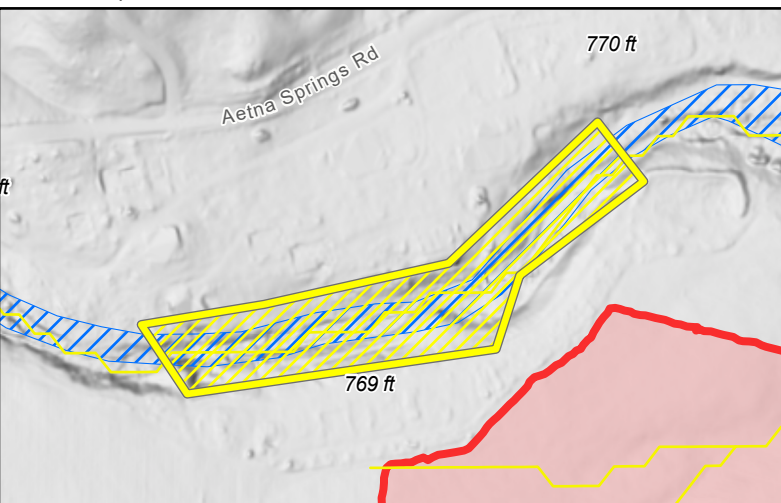
Historic spa buildings are located in and adjacent to watercourse. Access is easy and appears maintained but unknown if actively used. Hot tub structure is in within the channel. The upstream basin has been partially burned, mostly at low severity.

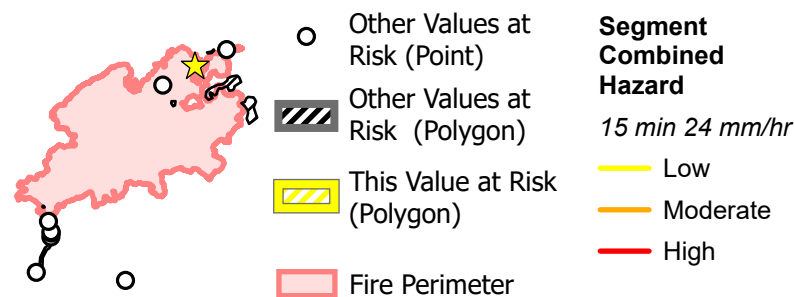
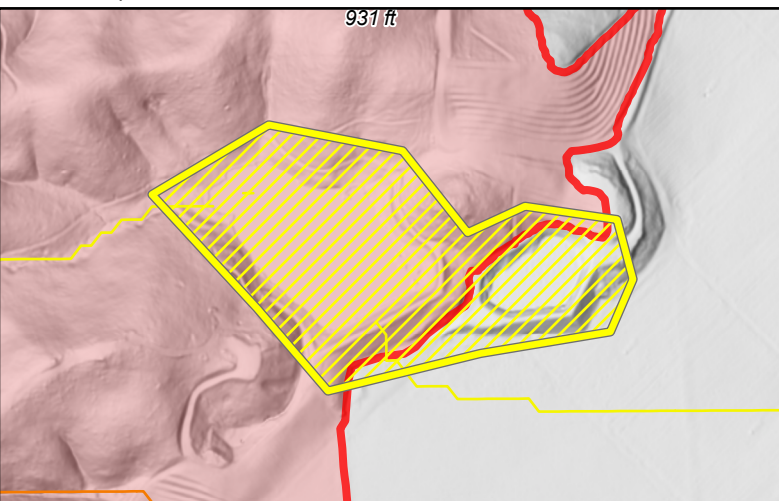
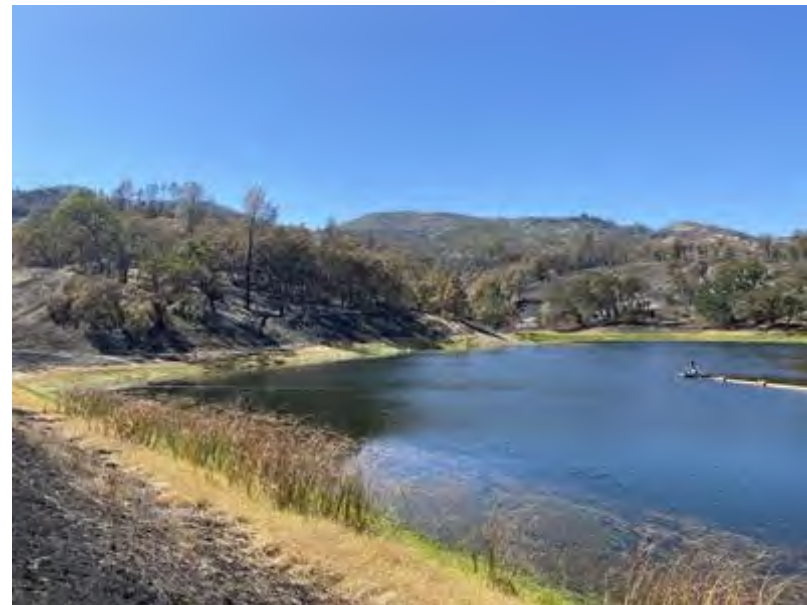
Low upstream relief. Small basin burned at moderate with some low. Unarmored spillway drains to smaller pond to the southwest. Misc equipment and large shed structure on downstream side of dam. About 10 ft of remaining capacity. Trapezoidal spillway measures about 4'D x 14"W.

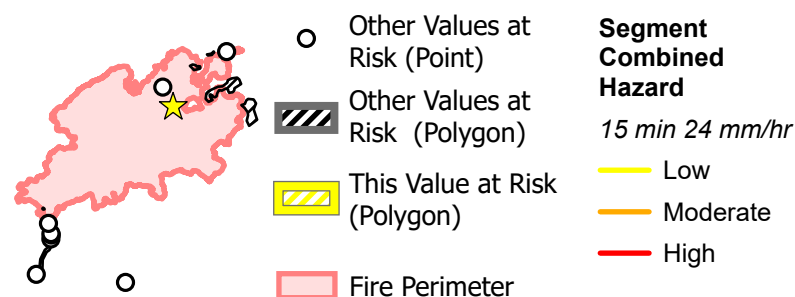
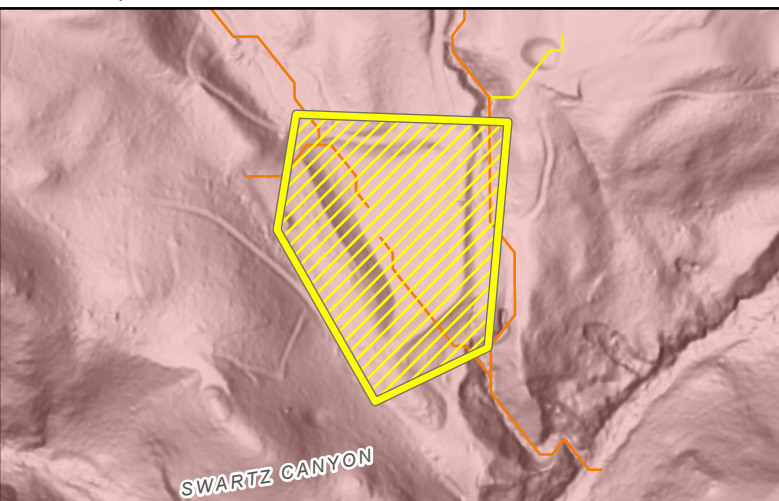
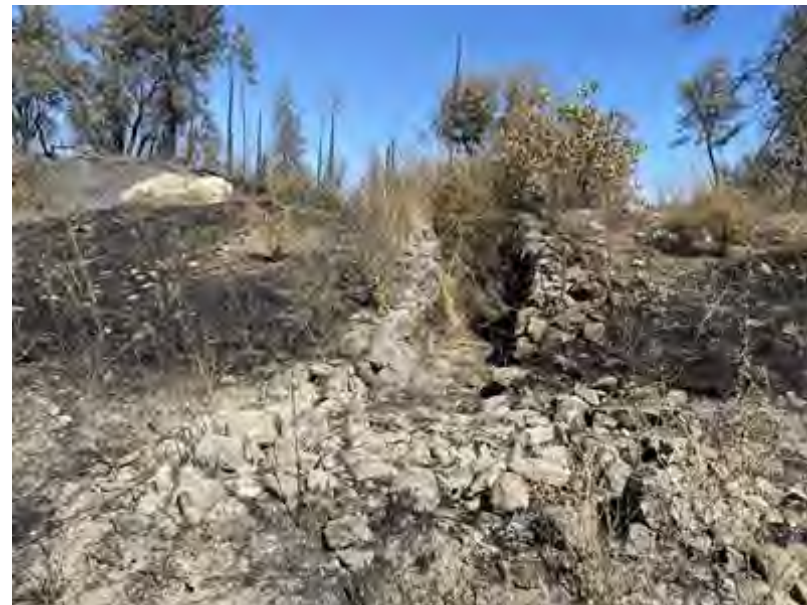
Pond outlet includes a rock-lined notch at top of dam with spillway measuring 48"D x 20"W at base and 42"W at crest. Drains to tributary to Swartz Creek. About 98% of tributary area is within the burn perimeter, with 73% burned at moderate and high. USGS model indicates a 33% likelihood of debris flow with a moderate combined hazard for the primary tributary basin.

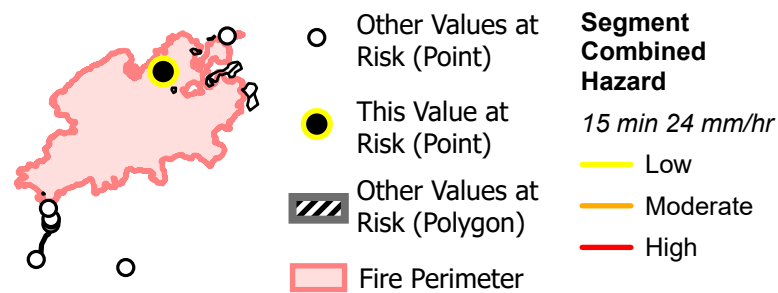
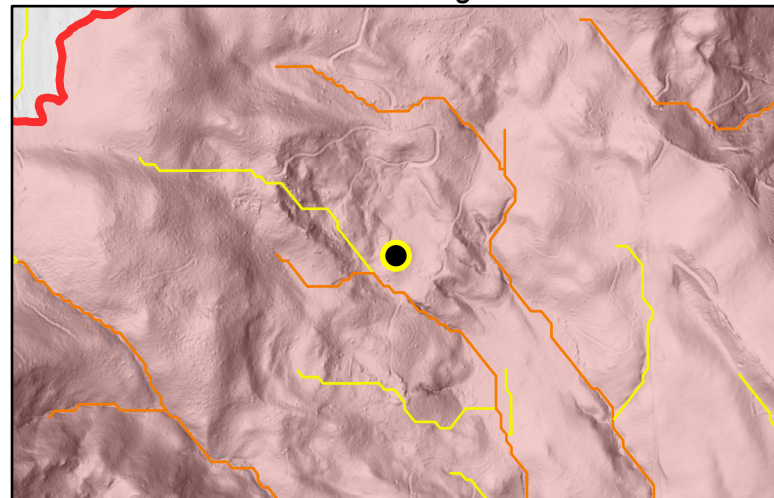
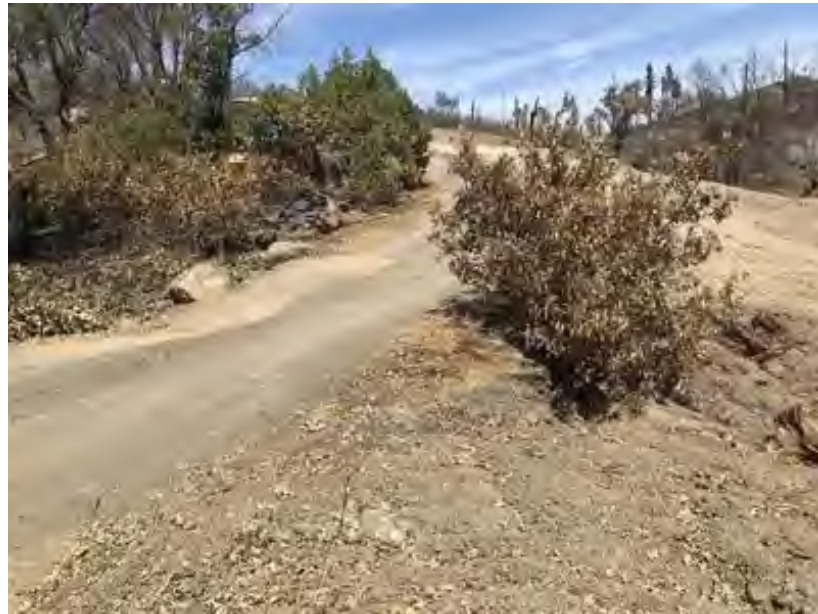
Residence is located on a bench within deep seated landslide. Drainage channels generated from the slide appear on both sides of bench, with the home and pool elevated above channels. Occupant said higher flows in drainages were observed after the 2020 glass fire. A water pump/well is located at top of slope just below burned slope/head of drainage, and small pond adjacent to the west side of house where tributary drainages converge. East drainage is smaller but flows past access road via 12" CMP that is at risk for overtopping and damage, which could restrict ingress/egress to home.
