Geology and Slope Stability Along Highway 50

El Dorado County

THOMAS E. SPITTLER and DAVID L. WAGNER
California Department of Conservation, Division of Mines and Geology

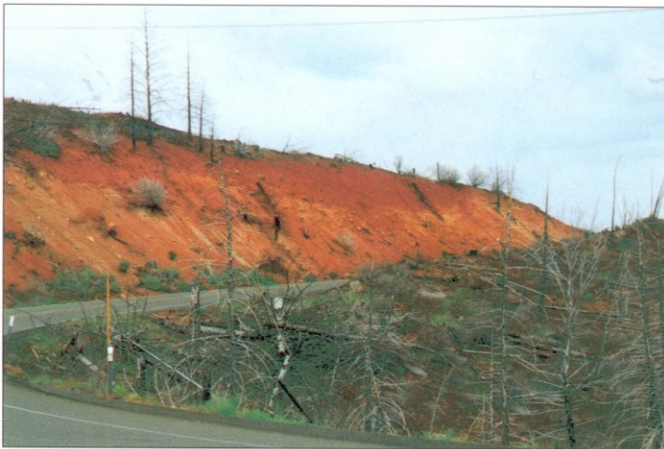
Photo 3. Exposure of the deeply weathered, reddish metamorphic rock. The reddish color is due to iron oxidation of biotite in the rock. Photo by Dave Wagner.

Schweickert, 1981). They are highly deformed, especially along contacts with the granitic rocks, with a strong **foliation** defined by alignment of platy minerals and compositional layering. Near contacts with the granitic rocks, the metamorphic rocks are highly weathered which may weaken them and explain this unit's moderate-to-high susceptibility to slope failure observed in those areas. Both the Cleveland Corral and Silver Fire landslides occur along such contacts (Figure 2a). Outcrops are sparse except in roadcuts (Photo 3).

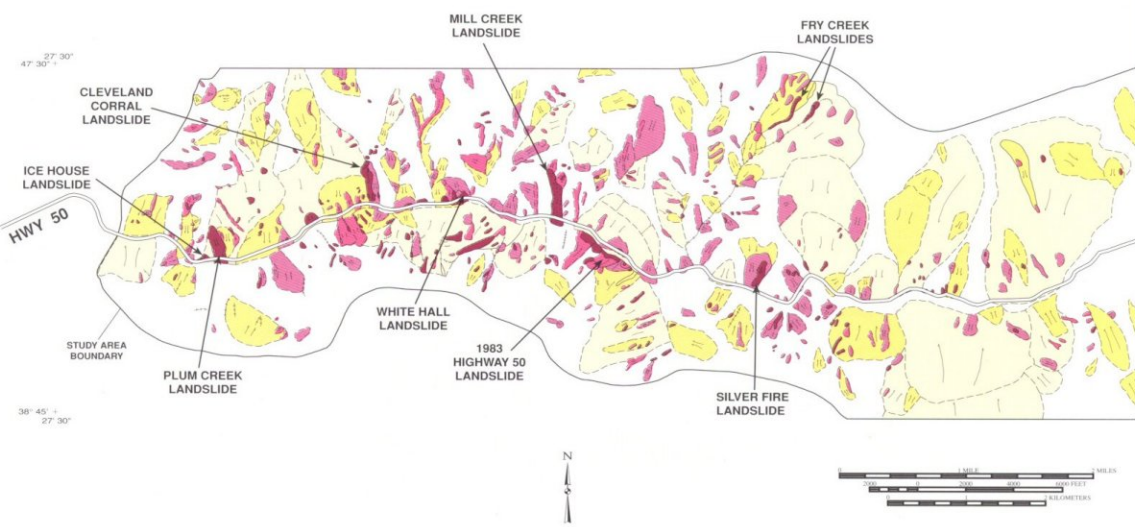
Figure 2b. Landslide map. Modified from Wagner and Spittler (1997) Plate 3.

Over 600 landslides have been identified along the Highway 50 corridor between Riverton and Strawberry (Figure 2b). These landslides range from small, recently active **debris slides** and debris flows (Photo 6) to dormant **rotational landslide** complexes, perhaps inactive for thousands of years. The mapped landslides include rapid debris slides and debris flows, such as the 1997 Mill Creek landslide, relatively slow-moving rotational or translational landslides, such as the 1983 Highway 50 landslide (Photos 7 and 8), and highly viscous, slow moving **earthflows**. Potential debris flow source areas, accumulations of colluvium on relatively steep and concave slopes, are also mapped within the corridor.

In addition to landslides (Figure 2b), potential debris flow source areas were identified. These are areas of colluvial accumulation on steep slopes with local areas of topographic convergence that could concentrate runoff or ground water. Although these features are not in themselves landslides, they represent areas where debris flows or debris slides are most likely to occur. Stream channels or topographic draws below potential debris flow source areas are most likely to be impacted by debris flows.

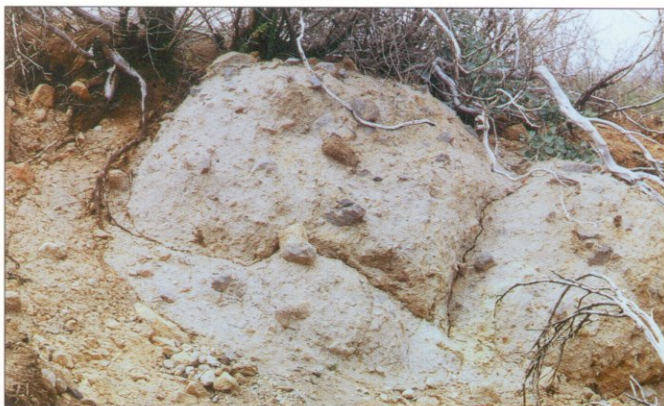
Photo 4. Exposure of volcanic mudflow deposits (lahars) of the Mehrten Formation. Photo by Dave Wagner.

Andesitic volcanic breccias, mudflows, and associated **volcaniclastic** sand and gravel of the Miocene to Pliocene age Mehrten Formation (Photo 4) are part of the voluminous andesitic material that erupted from volcanoes along the crest of the Sierra Nevada from 18 to 4 or 5 million years ago. The volcanic material flowed westward into the ancestral Great Valley, inundating most of the landscape of the northern and central Sierra Nevada. New drainages were established, while the rivers cut new canyons and left remnants of the volcanic rock as caprocks on the ridges.

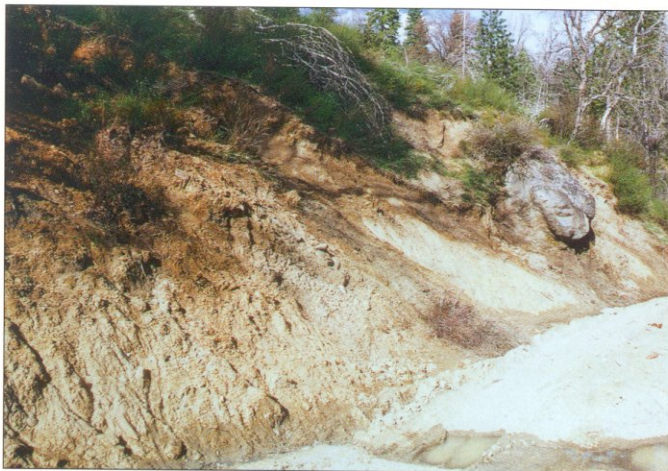
Photo 5. Outcrop of unconsolidated colluvium and landslide deposits. These deposits are composed of decomposed granite, granitic colluvial sand as in this outcrop, thick soil horizons, and debris flow deposits. *Photo by Dave Wagner.*

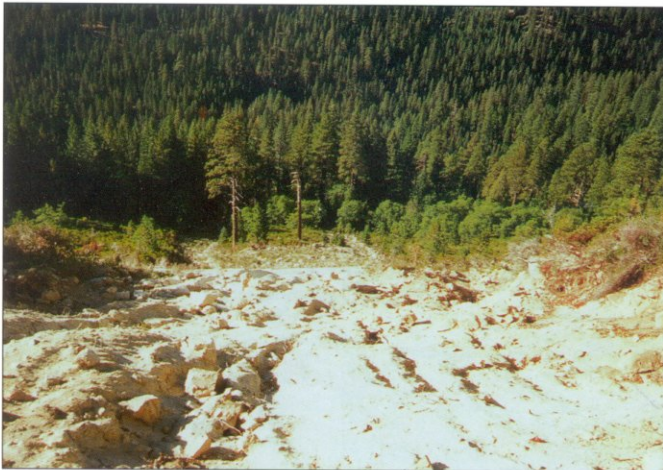
Photo 6. View looking downslope of a debris flow. It is derived from granitic colluvium and traveled at speeds of several feet per second. *Photo by Tom Spittler.*

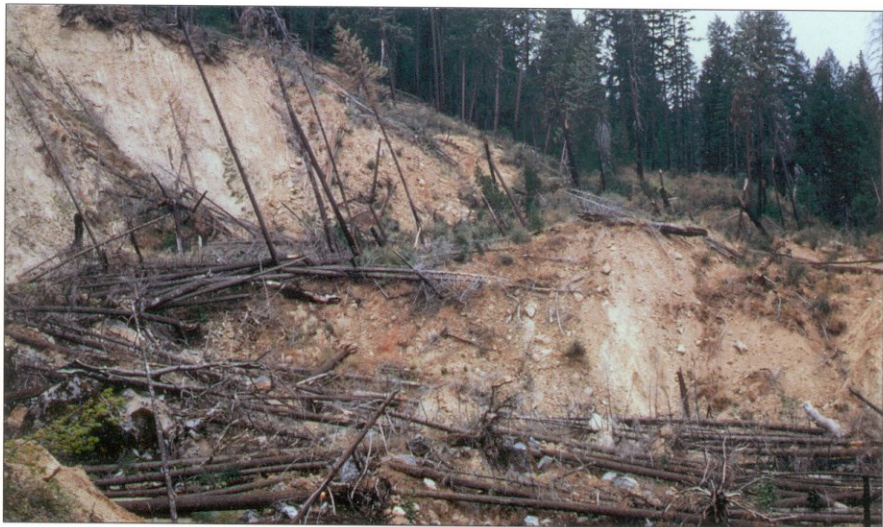
Photo 7. The 1983 Highway 50 landslide pushed slowly into the South Fork of the American River and up over the highway damming the river. The landslide, which closed Highway 50 for 75 days, was a 1 million cubic yard, 22 acre, rotational failure originating in decomposed granitic rock. Trees up to 4 feet in diameter were toppled and splintered. *Photo by Trinda Bedrossian.*

The Silver Fire landslide is a rotational slump within deeply weathered granitic bedrock. Recent failure has been episodic and relatively minor in extent. The 1983 Highway 50 landslide is also a rotational landslide that failed within deeply weathered granitic bedrock from the toe of a much larger ancient landslide complex on the north-

facing slope south of the American River. Kuehn and Bedrossian (1987) report that movement was relatively slow and occurred following 40 inches of precipitation during the preceding 2 months.

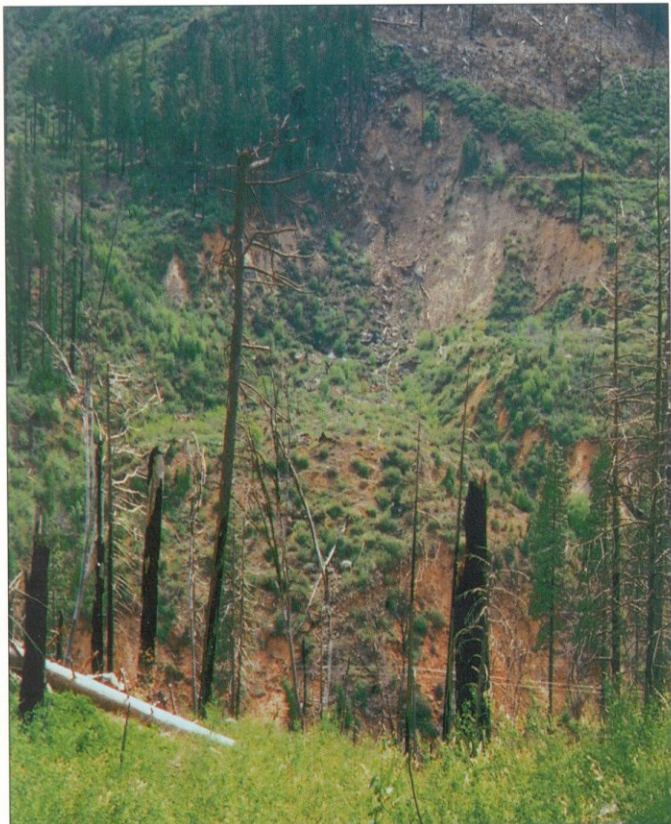
Photo 8. The 1983 Highway 50 landslide 15 years later. The lower bench formed when a mass of earth slowly moved downslope while rotating back. *Photo by Tom Spittler.*
