# Montecito 2023 Storm Response

## Mission Task #2023-SOC-94072

## MEMORANDUM

**SUBJECT:** Montecito 2023 Storm Response – Cal OES Mission Task #2023-SOC-94072

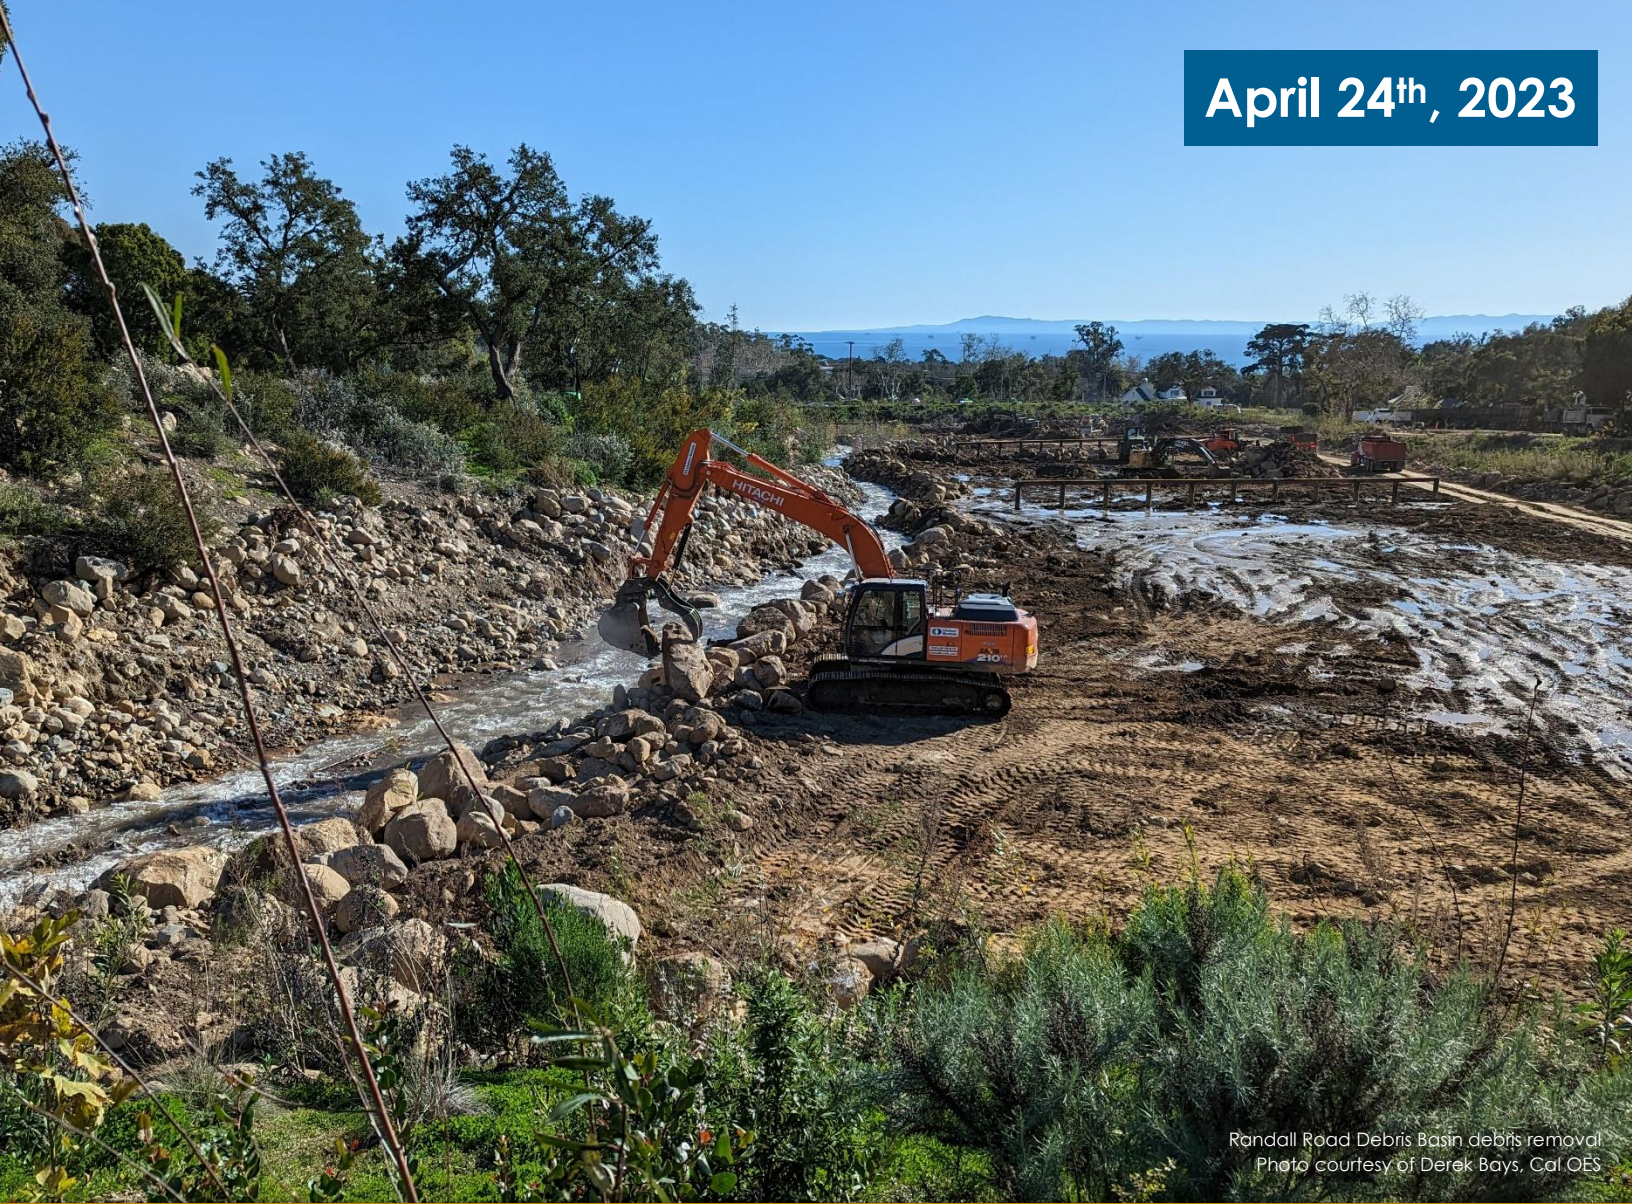
Randall Road Debris Basin debris removal  
Photo courtesy of Derek Bays, Cal OES

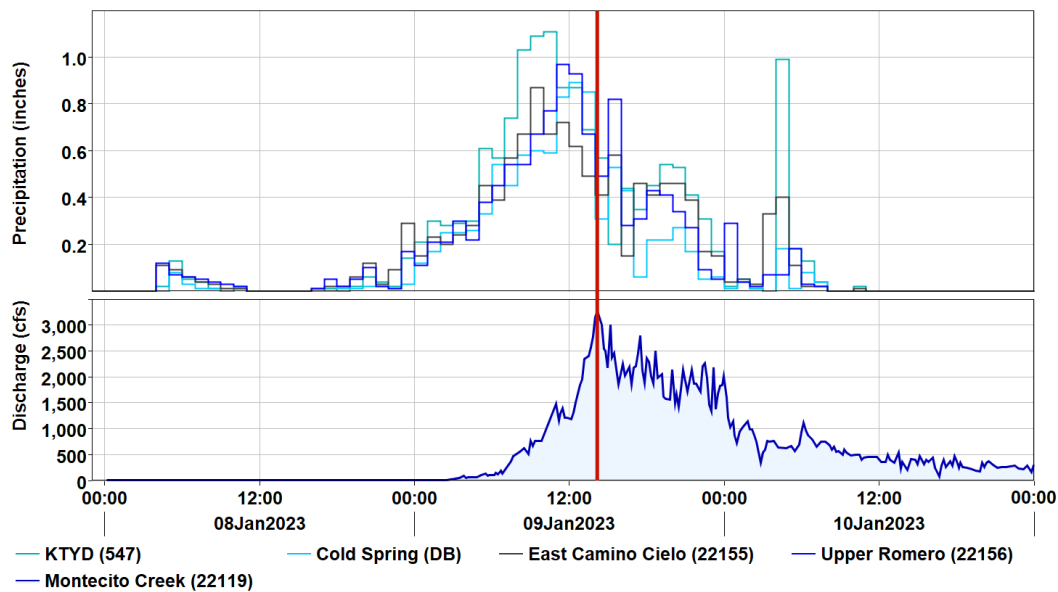
Figure 4. Hourly rainfall accumulation from January 8 to 11, 2023 at rain gages distributed throughout the study area (Figure 1; SBC, 2023). Red vertical line indicates the timing (i.e., 14:10:28) of peak flow (i.e., ~3,200 cubic feet per second) that occurred at the downstream Montecito Creek gage (22119) approximately 1 hour after peak rainfall occurred within the upslope watersheds.

southwestern extent of the study area. The KTYD gage experienced a secondary peak rainfall accumulation of 0.99 inches during the evening on January 10, 2023, associated with an isolated thunderstorm. Most landslides are presumed to have occurred sometime on January 9 based on the timing of slide movement and impacts documented in 911 records and in time-stamped imagery and video provided by Santa Barbara County and Montecito Fire Department.

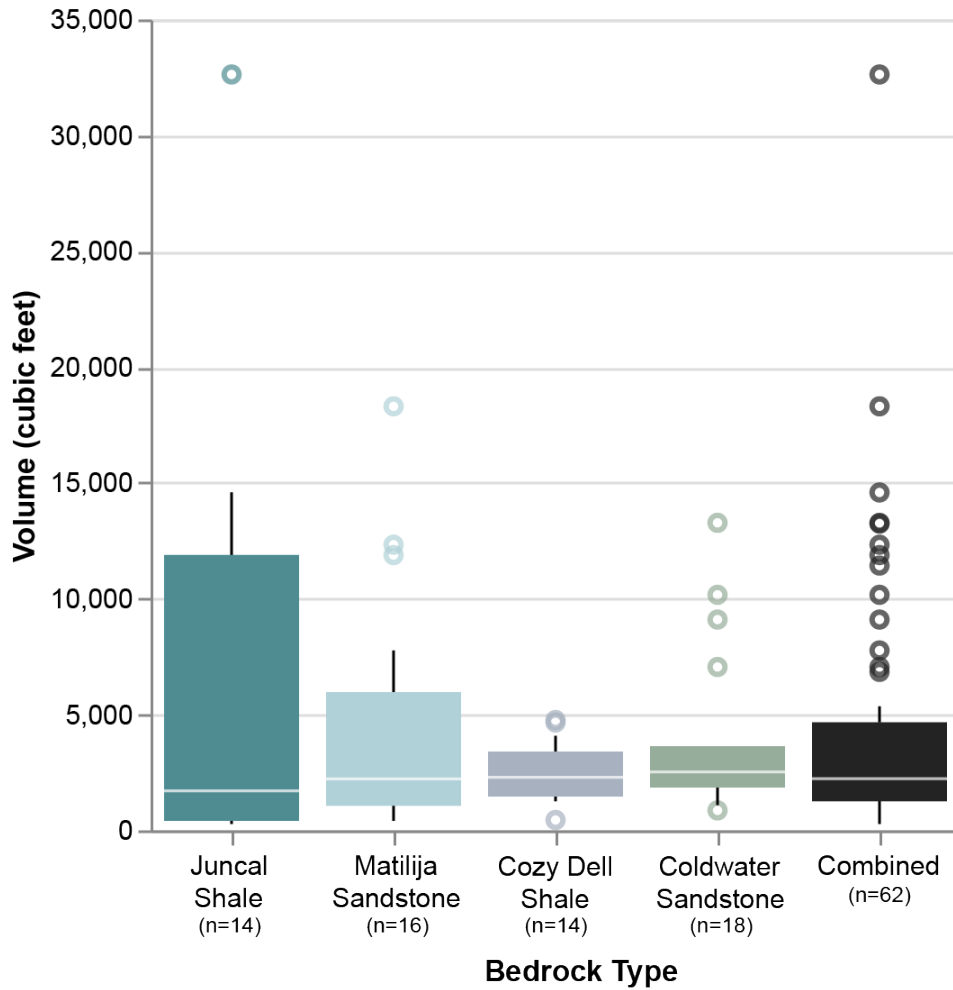
Figure 7. Box-and-whisker plots showing distribution of landslide volume measurements across the different bedrock types that were calculated from field measurements (e.g., n = 14 measurements for landslides in the Juncal Shale) of average source area width, length, and depth. Circles indicate volumes that are located 1.5 x interquartile range below the first quartile or above the third quartile of the distributions. Horizontal white line represents the median value. The combined bedrock types includes volumes derived from all of the field measurements (n = 62).

An average depleted landslide sediment volume for each bedrock type was estimated based on field measurements of average width, length, and depth of natural landslide sources across the study area (Figure 7; Table 3). These averages vary by bedrock type. For example, the Juncal Shale, which contains a relatively low landslide density, resulted in the highest average volume per landslide of 6,824 cubic feet. Whereas the Cozy Dell Shale, which contains a relatively high landslide density, resulted in the lowest average volume of 2,524 cubic feet. Combining all measured volume estimates across all bedrock types yields a combined average volume of 4,408 cubic feet per landslide.

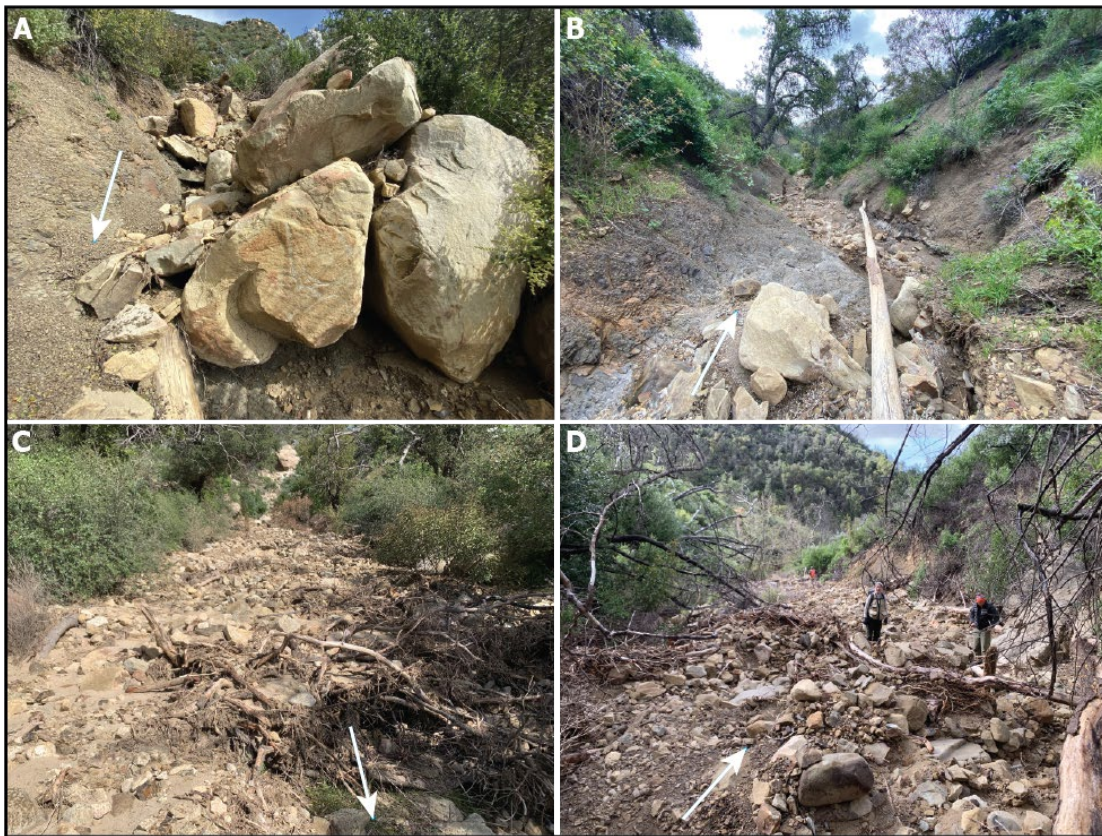
The distribution of recently deposited and reworked colluvial sediment following the January 2023 AR varied throughout tributary channels across the study area. Observations made along San Ysidro Creek and Cold Spring Creek appeared representative of conditions over the broader study area. Tributaries to San Ysidro Creek showed the presence of recently deposited and reworked colluvial sediment trapped directly upstream of channel blockages, such as keystone boulders (Figure 8A) positioned high within first-order channels. In lower elevations, channels showed evidence of reworked alluvium and scoured sediment indicating more scour than deposition (Figure 8B). And downgradient of depleted landslide scars, a few channel reaches contained extensive volumes of recently reworked, colluvial sediment deposits that were observed within tributaries of San Ysidro Creek (estimated volume of 5,000 cubic feet; Figure 8C) and Cold Spring Creek (estimated volume of 19,000 cubic feet; Figure 8D).

Figure 8. Amount and distribution of available sediment throughout low-order channels. A. Recently deposited and reworked, colluvial sediment within a tributary of San Ysidro Creek following the January 2023 AR event. B. Reworked channel-bed sediment within a tributary of San Ysidro Creek. C. Recently deposited and reworked, colluvial sediment within a tributary of San Ysidro Creek and (D.) Cold Spring Creek. Arrows in the photos indicate flow direction; channel widths are approximately 7 ft (A), 15 ft (B), 17 ft (C), and 30 ft (D).

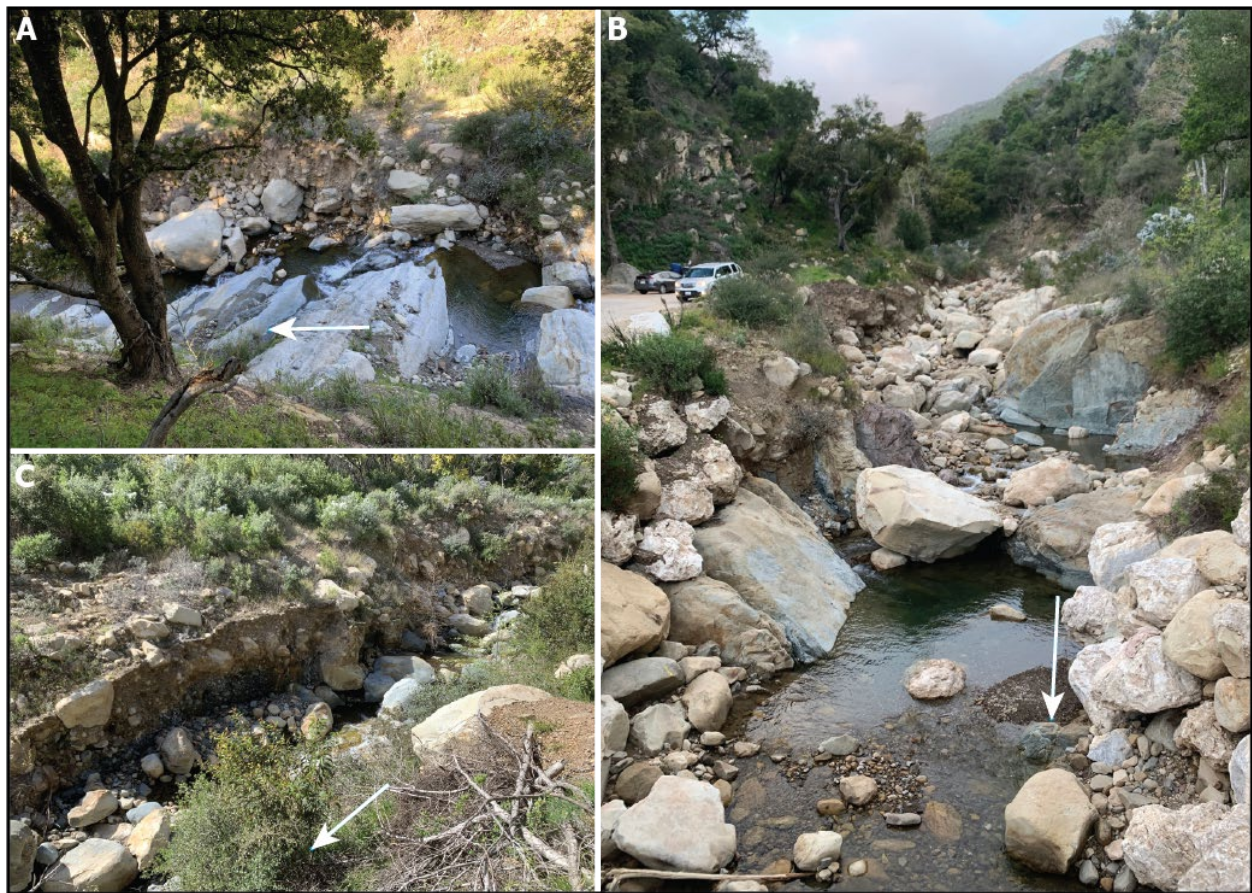
The mainstem channels showed more evidence of recent bed and bank scour than deposition. Both Cold Spring and San Ysidro Creeks have recently scoured down to bedrock in many locations (Figure 9A). However, there is evidence of erodible sediment remaining within the channel and along oversteepened banks that could be entrained and transported downgradient during future runoff events. Examples of sediment currently stored within the channel bed and banks are shown in San Ysidro Creek (Figure 9B and Figure 9C) and Romero Creek (Figure 10A and Figure 10B).

Figure 9. Amount and distribution of available sediment throughout the mainstem channels. A. More evidence of scour within mainstem channels than deposition in San Ysidro and (B) Cold Spring Creeks. C. Easily erodible sediment currently located in mainstem channels is available to transport in San Ysidro Creek. Channel widths are approximately 50 ft (A and B), and 30 ft (C).

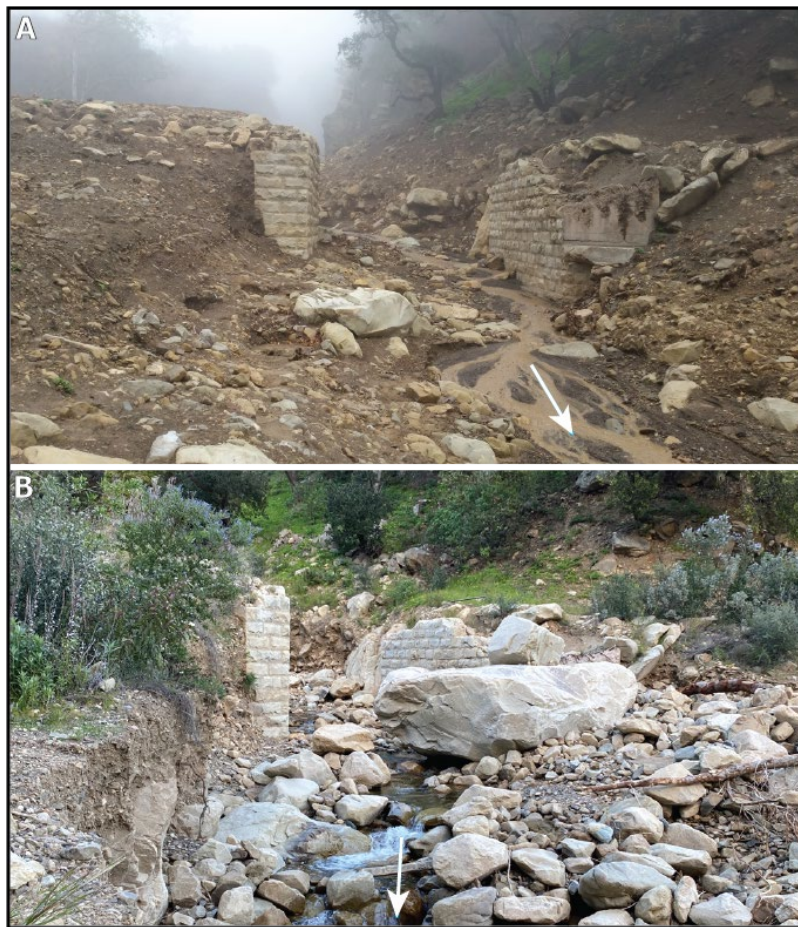
Figure 10. A. Before photo of bridge abutments in Romero Creek shortly after 1-9-2018 debris flow event. B. After photo following 1-9-2023 flood of bridge abutment showing aggregated alluvium downstream. For scale, the large boulder in (B) is approximately 15 feet wide. Arrows in the photos indicate flow direction.

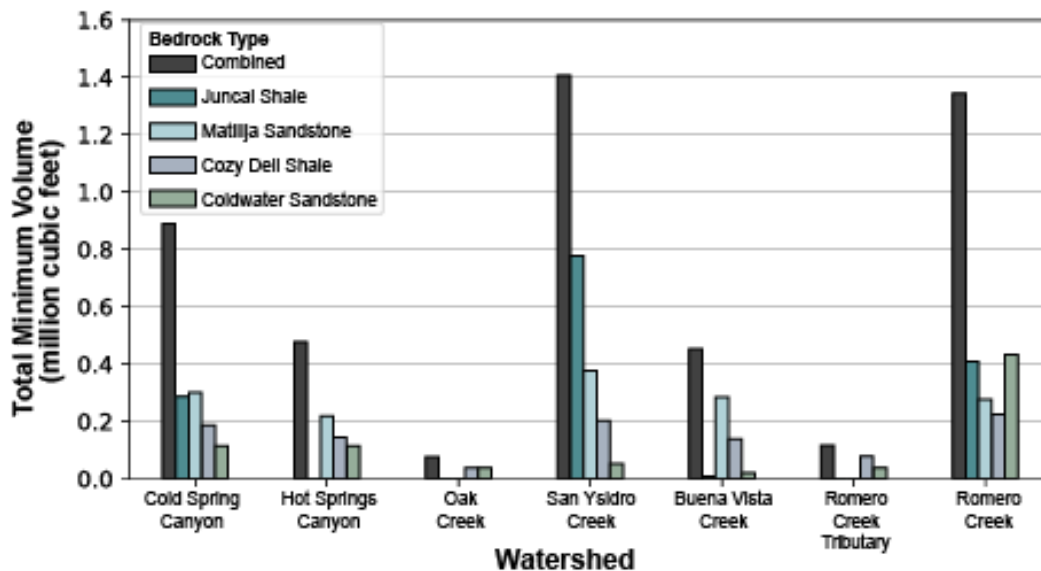
The total minimum volume of landslide-derived sediment sourced in each watershed was estimated by adding sediment contributions by bedrock type within each watershed (Figure 11). Summing the sediment contributions across the seven principal watersheds provides a total minimum volume estimate of 4.8 million cubic feet of sediment. Approximately ~77% of this total volume is contributed from the three largest watersheds (San Ysidro Creek: ~30%, Romero Creek: ~28% and Cold Spring Canyon: ~19%). However, once the total minimum volume of landslide sediment within each watershed is normalized by watershed area, we find that Romero Creek Tributary, Buena Vista Creek, and Romero Creek watershed contain the highest yield rates between 717 and 920 thousand cubic feet per square mile (Table 4). The high sediment yields in Romero Creek Tributary and Buena Vista Creek watersheds are attributed to the high density of landslides within the Matilija Sandstone and Cozy Dell Shale bedrock types. The high sediment yield rate in the Romero Creek watershed is attributed to higher landslide density within the Coldwater Sandstone bedrock type.

Figure 11. Total minimum volume of landslide sediment by bedrock type within each watershed. Combined bedrock type is the total minimum volume summed from all bedrock types within each watershed.

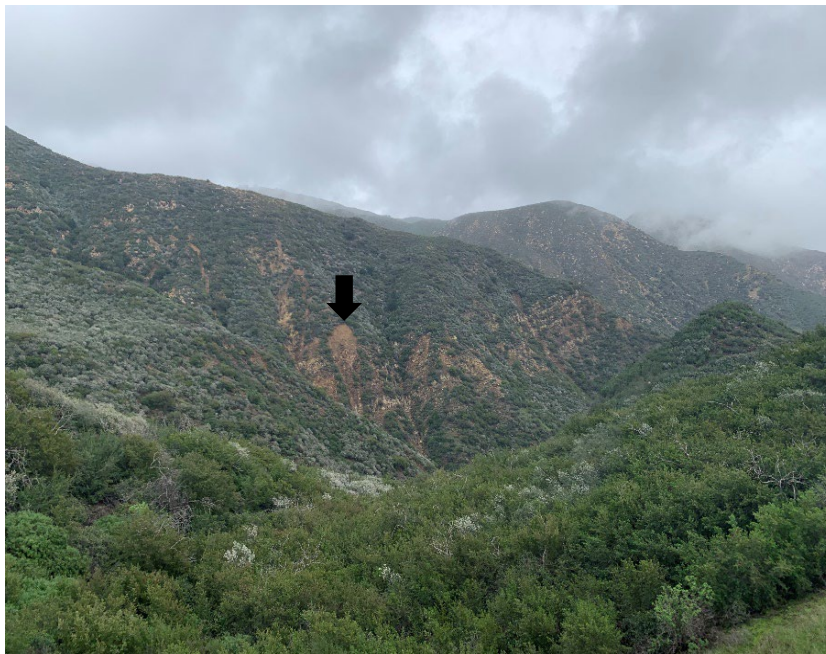
Figure 5. Representative photo of shallow landslides (arrow) that deliver sediment into upland swales and creeks.

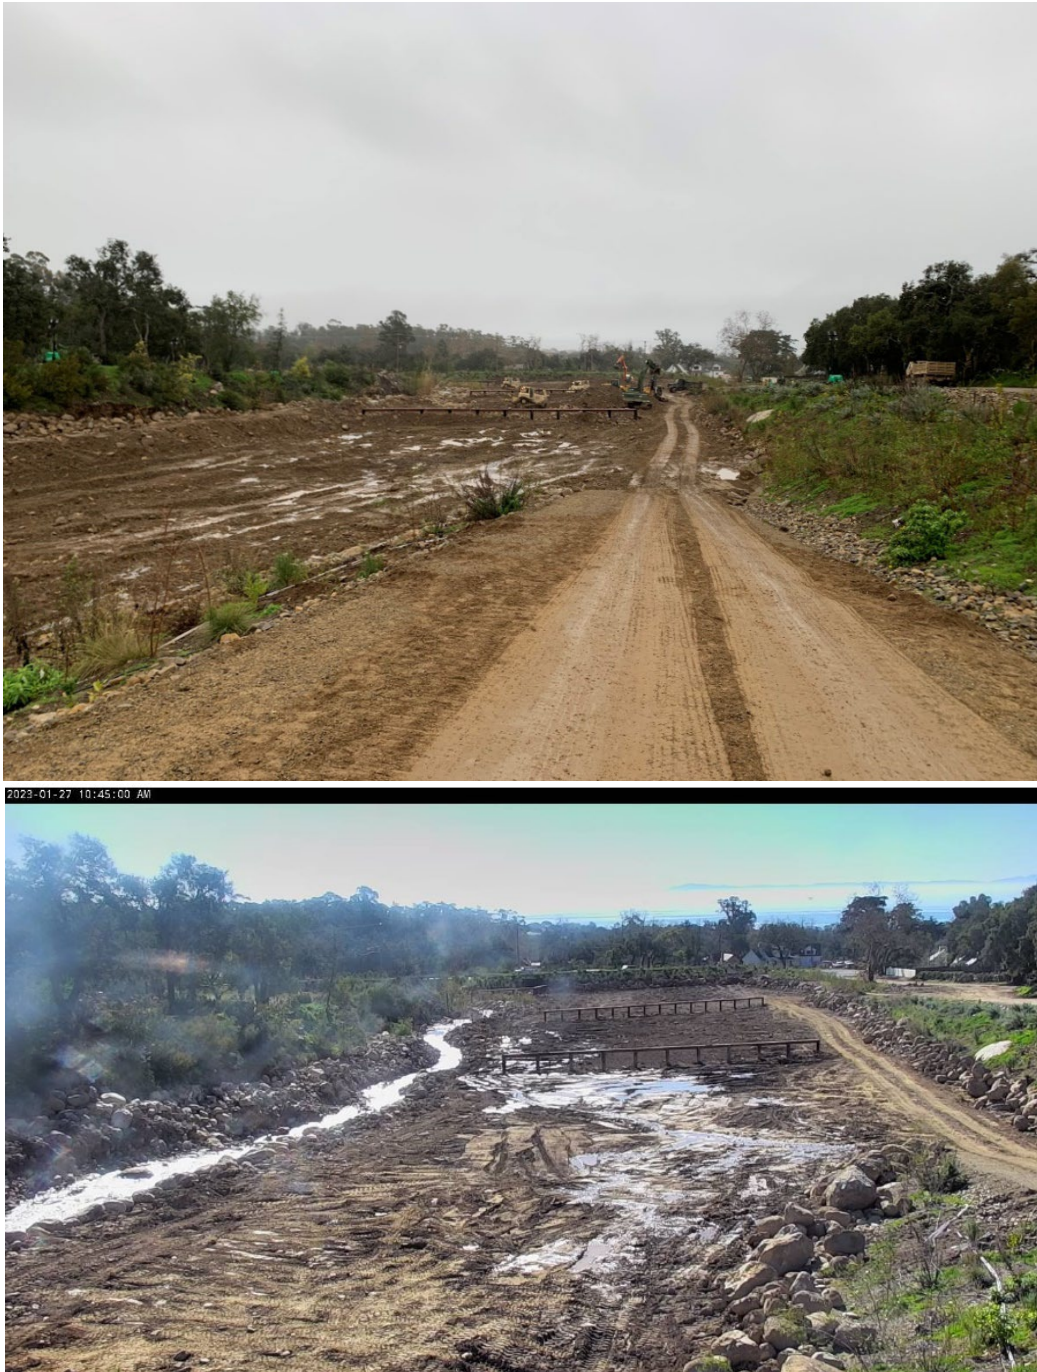
Initial reports following the January 9, 2023, event indicated the San Ysidro debris basin was reported 100% full, and the Randall Road debris basin was reported approximately 40 to 50% full. Given the extent of debris loading and the loss of capacity, to mitigate flood and debris hazards during subsequent storms, Santa Barbara County requested assistance to remove debris from the Randall Road basin. As a result, CalOES mobilized the California National Guard and tasked them to remove the accumulated debris from Randall Road basin and re-establish the basin back to its pre-event condition. The CNG mobilized and arrived on-site on January 12, 2023, two days prior to a storm that was forecast to arrive on January 14, 2023.

Figure 6. Photo of CNG actively excavating material from basin on January 14, 2023 (Top) and basin completely empty of debris and returned to near-previous conditions on January 23, 2023 (Bottom)

CGS staff mobilized on January 13, 2023, met CNG and SBC representatives on site, and worked on developing an emergency response plan to ensure worker safety. The plan formulated and agreed by the CNG included setting up a direct line of communication with weather forecasters who monitored developing storms and with forward scouts positioned upstream to communicate changes in flow within San Ysidro Creek. Activation of the emergency action plan would begin if rainfall rates greater than about 0.6 inches an hour were measured at the Cold Springs gage, or if rapid rising stream

flow was observed; the on-site commander would then be notified, and equipment and personnel would stop operations and move to pre-identified safe areas positioned on high ground west of the basin. The CNG constructed a temporary berm along the creek to facilitate dry operations in the debris basin. The emergency plan included maintaining the integrity of the debris basin by ensuring that the temporary berm along the creek was capable of being breached to allow filling of the debris basin should a flood stage runoff event occur prior to completion of excavation.

Fortunately, the January 14, 2023, storm was small and the CNG were able to continuously perform excavation and off-haul operations 24 hours a day, starting on January 13, 2023, and continuing to January 23, 2023. During this period, approximately 15,000 cubic yards of material were removed, and the basin was returned to pre-event conditions (Figure 6). The work performed by the CNG was critical to protect downstream property, life, and natural resources.

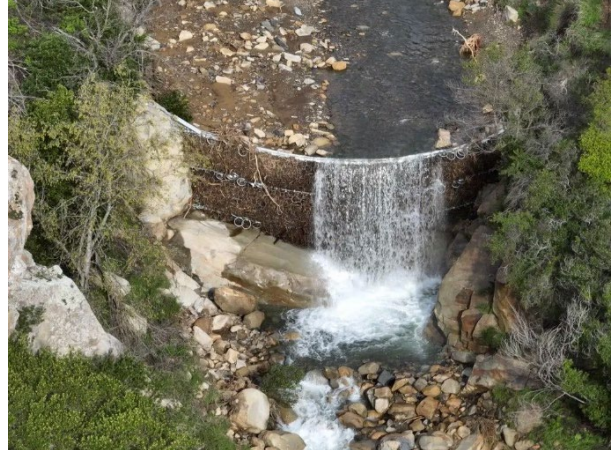
*Image of Upper Debris Flow net in San Ysidro Canyon (FIRIS, 2023)*
