Watershed Emergency Response Team (WERT) 2025 Gifford Fire

CA-LPF-002181

September 17, 2025

REPORT TITLE: Watershed Emergency Response Team (WERT) Evaluation – 2025 Gifford Fire

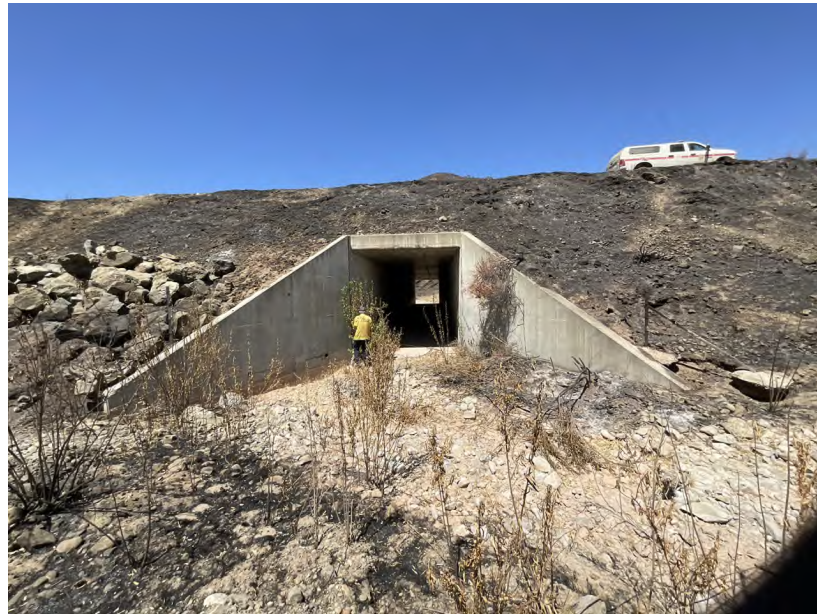
Field Observation or Potential Hazard: Increased postfire runoff and sediment transport will increase the potential of blockage at the culvert inlet. Possible probability of occurrence with minor consequence = LOW RISK.

Box culvert 12 x12 ft with flared headwall inlet. Aggradation directly upstream of culvert, indicating backwater effect.

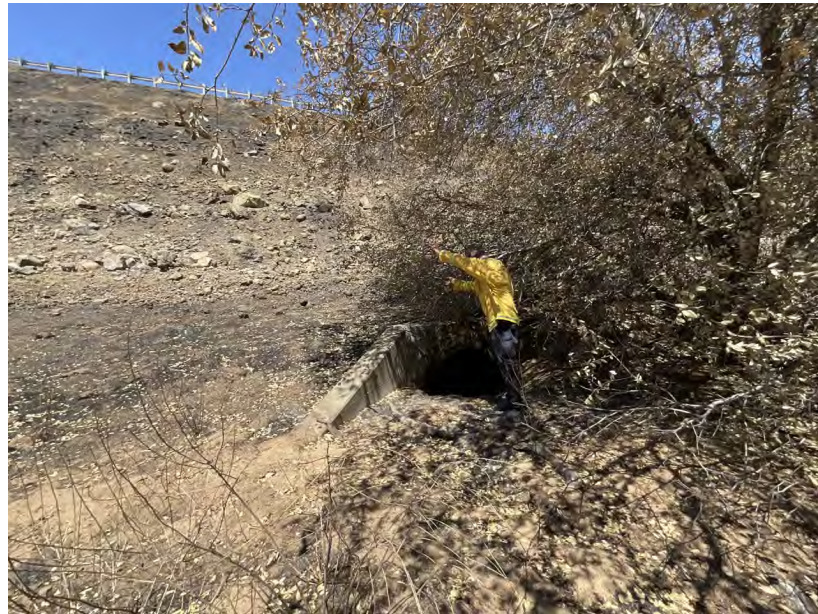
Field Observation or Potential Hazard: Potential blockage of culvert could cause flows to back up before draining through secondary culvert.
Likely probability of occurrence with minor consequence = LOW RISK.

5 ft CMP with headwall that is partially plugged by 3 ft of aggraded sediment.

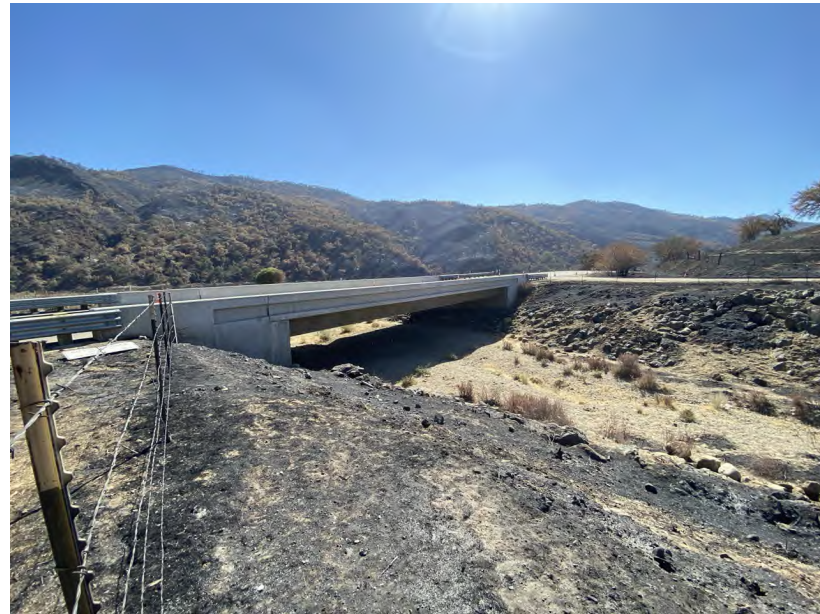
Field Observation or Potential Hazard: Increased postfire runoff and sediment transport will increase the potential of flooding to bridge. Unlikely probability of occurrence with minor consequence = VERY LOW RISK.

Free spanning bridge that spans full channel and contains 6-8 ft of freeboard. Recently built bridge with no evidence of recent overtopping.

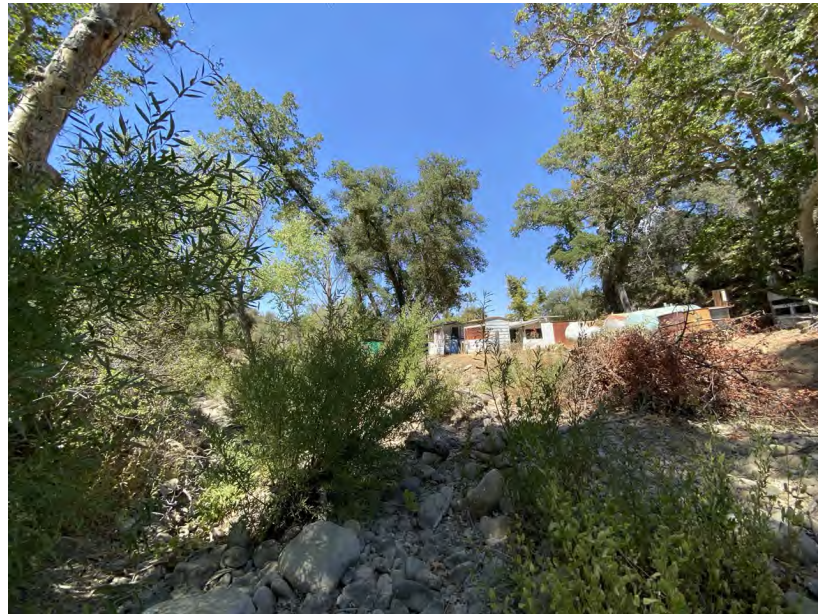
Field Observation or Potential Hazard: Increased postfire runoff and sediment transport will increase the potential of flood or debris flood impacting propane tanks and house located at top of bank. Possible probability of occurrence with moderate consequence = INTERMEDIATE RISK

Clear large woody debris in channel.

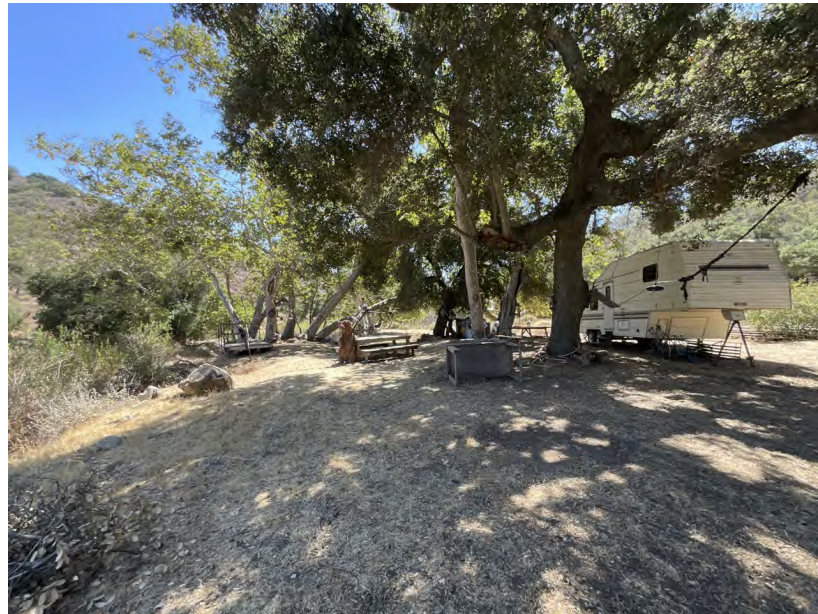
Field Observation or Potential Hazard: Increased postfire runoff and sediment transport will increase the potential of flooding to RV trailer/picnic area. Possible probability of occurrence with minor consequence = LOW RISK.

Channel and bank have been modified to increase channel capacity. RV trailer is elevated above incised channel bank. Mapped in DWR 100 year floodplain.

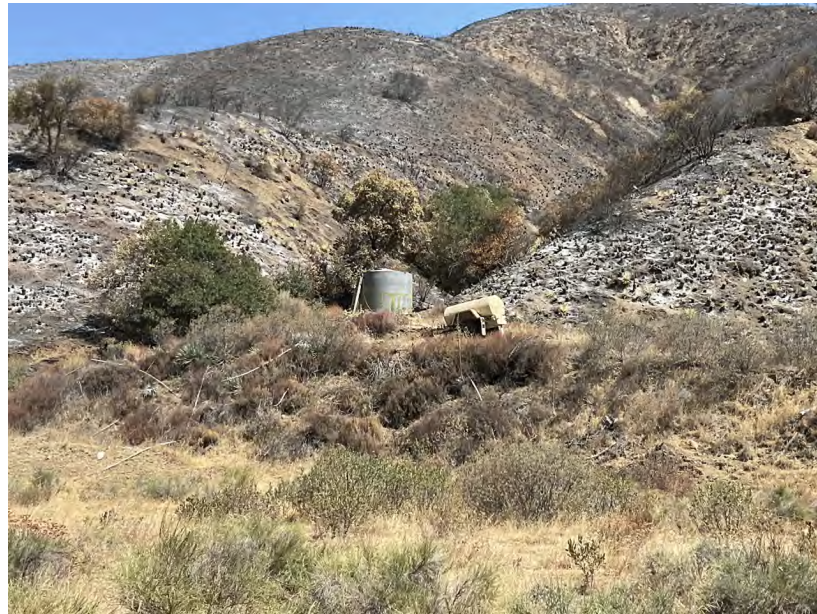
Field Observation or Potential Hazard: Increased postfire runoff and sediment transport will increase the potential of flooding/debris flow to water tank at outlet of burned drainage. Possible probability of occurrence with minor consequence = LOW RISK.

Adjacent channel is incised. Shallow slope instability upslope of tank.

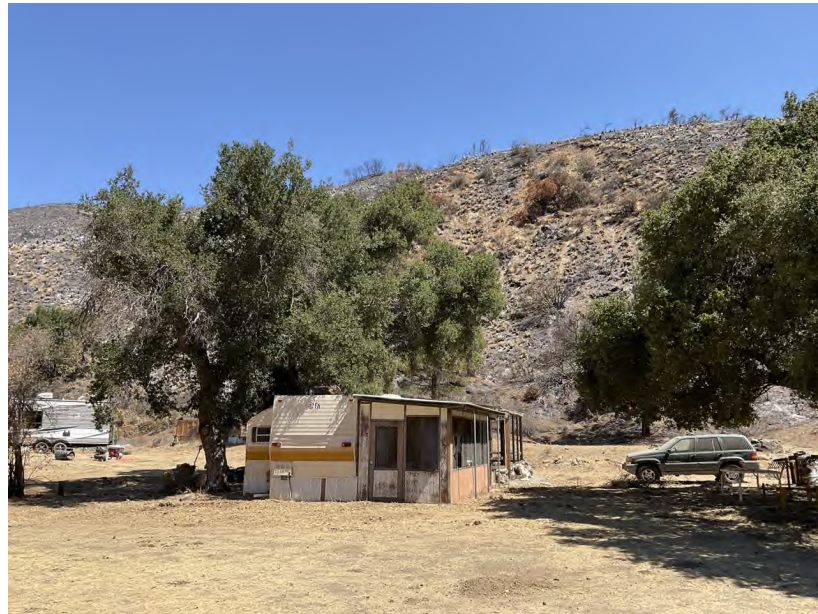
Field Observation or Potential Hazard: Shallow slope instability upslope of mobile home. Possible probability of occurrence with minor consequence = LOW RISK.

Mobile home at base of shallow translational slide that likely had failure pre-fire.

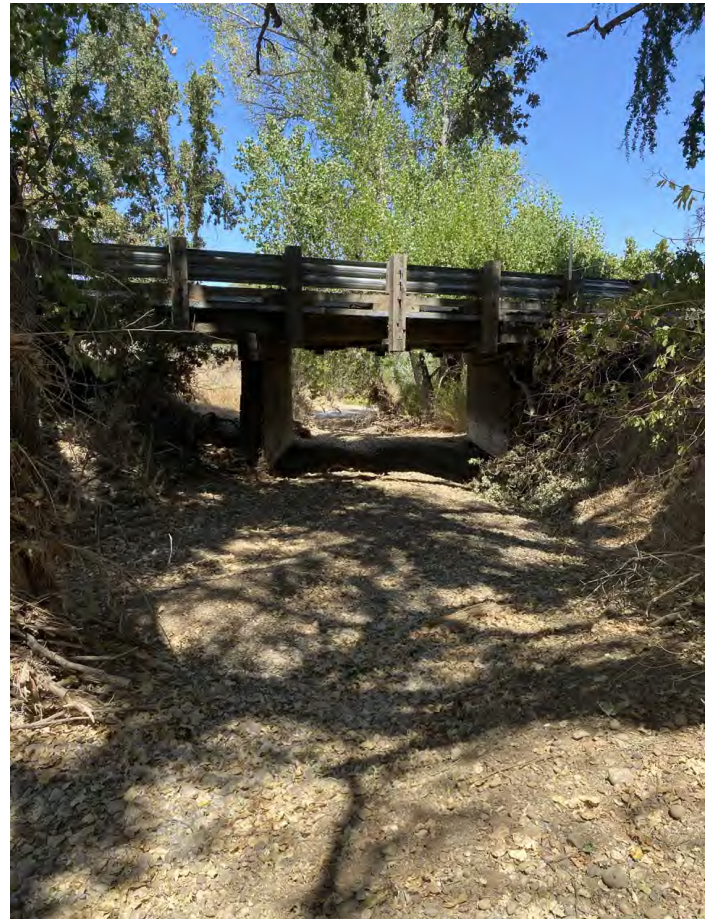
Field Observation or Potential Hazard: Increased postfire runoff and sediment transport will increase the potential for overtopping or damage to bridge. Possible probability of occurrence with minor consequence = LOW RISK.

Bridge was previously flooded (storm on ~9 January 2023). Increased postfire runoff, sediment and woody debris transport will increase the potential of damage to the bridge.

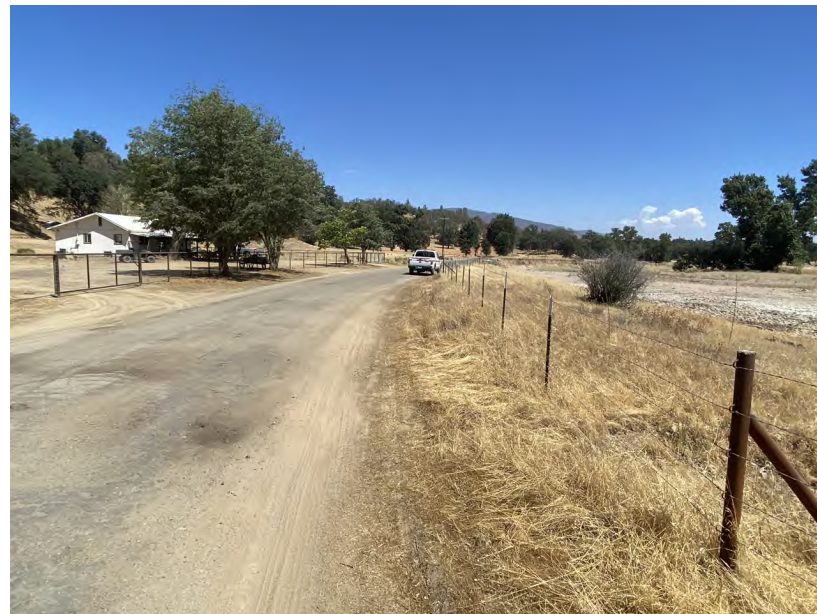
Field Observation or Potential Hazard: Low increase in postfire runoff expected for the Salinas River. Unlikely probability of occurrence with minor consequence = VERY LOW RISK.

A house is located on the outside bend of the Salinas River and the channel bank has been reinforced. There is approximately 5-10 ft of elevation difference from the channel to the terrace surface where the house was built. The house is mapped just outside the DWR 100 yr floodplain. Because the majority of the upstream area is not burned and the drainage area is high, increases to postfire runoff are expected to be low. Future flooding potential should be considered slightly elevated relative to prefire conditions.

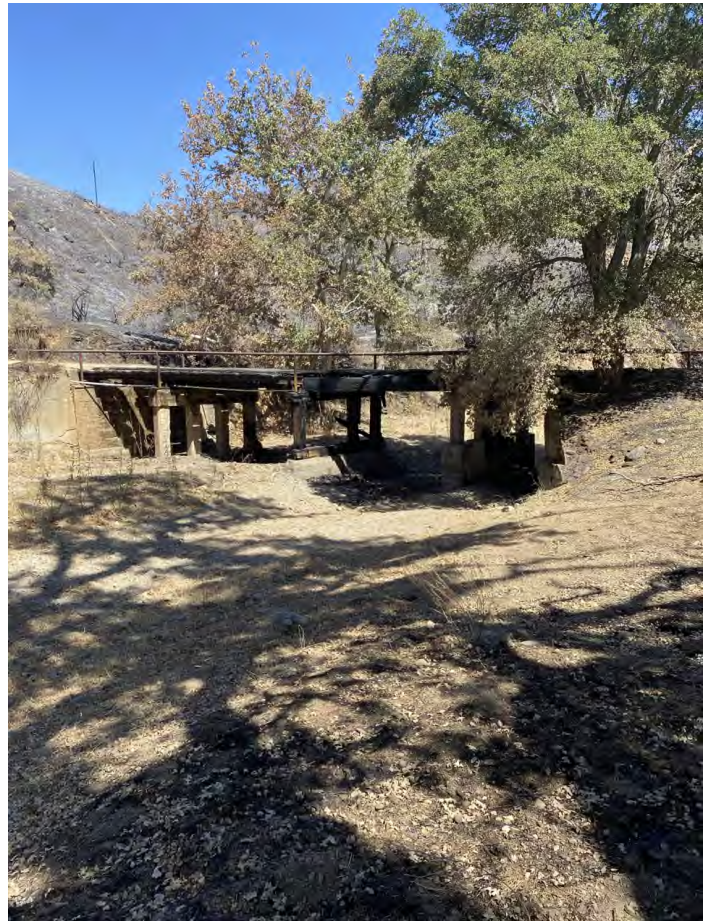
Field Observation or Potential Hazard: Damage to bridge on Avenales Ranch Road. Unlikely probability of occurrence with moderate consequence = LOW RISK.

The bridge was damaged and partially burned in the fire. The Salinas River was dry in August 2025 and vehicles were able to drive across the channel. Access will be blocked when the Salinas River is flowing. Bridge could experience additional damage due to its burned state.

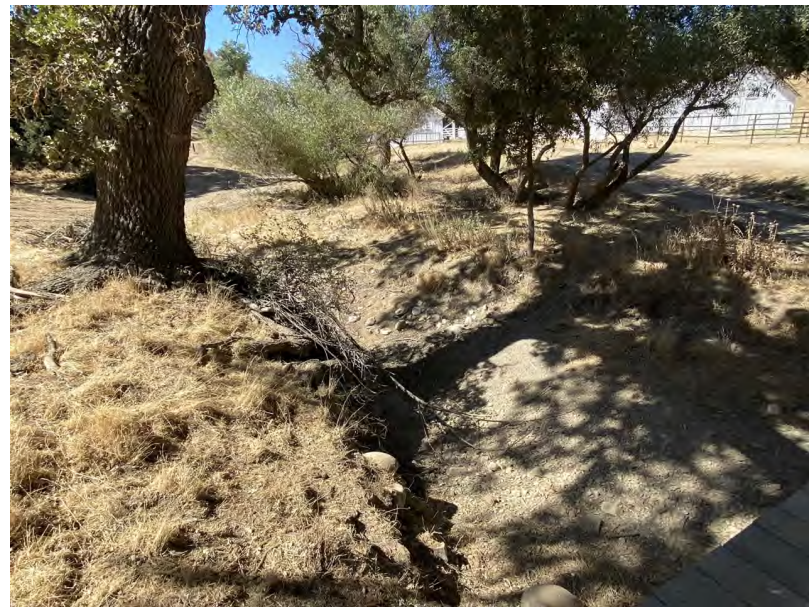
Field Observation or Potential Hazard: Increased postfire runoff and sediment transport will increase the potential of flooding to homes and outbuildings. Possible probability of occurrence with moderate consequence = INTERMEDIATE RISK.

Alamo Creek is immediately behind homes and outbuildings. No evidence of recent flooding to structures.

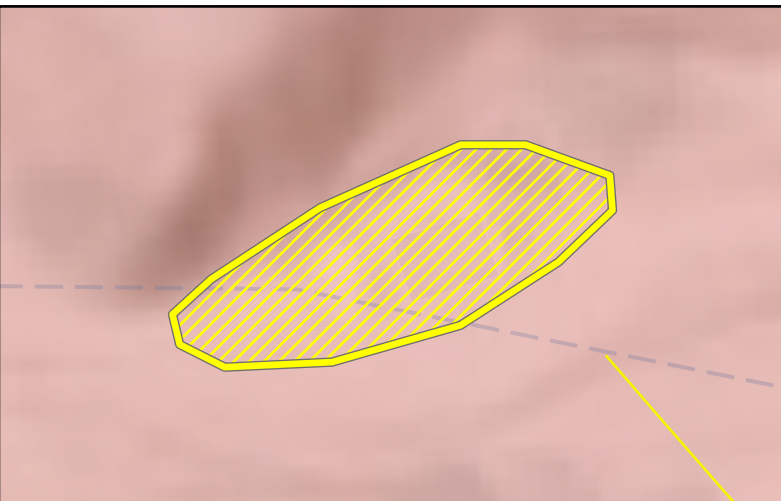
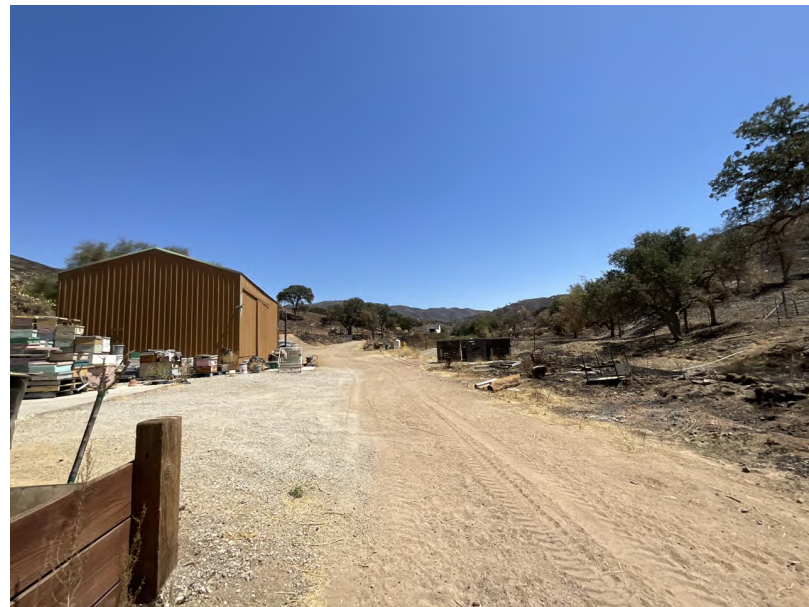
Field Observation or Potential Hazard: Increased postfire runoff and sediment transport will increase the potential of flooding to base of barn and fence. Unlikely probability of occurrence with minor consequence = VERY LOW RISK.

If downstream culvert becomes blocked and back water occurs the risk to barn could be elevated.

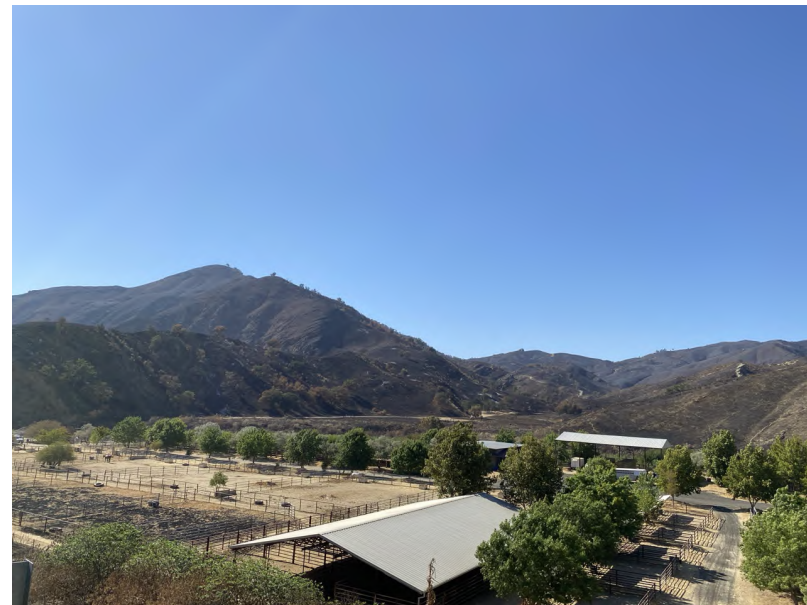
Field Observation or Potential Hazard: Increased postfire runoff and sediment transport will increase the potential of flooding horse stables/corrals. Unlikely probability of occurrence with minor consequence = VERY LOW RISK.

Multiple structures above channel on terrace are located within the DWR 100 year awareness floodplain.

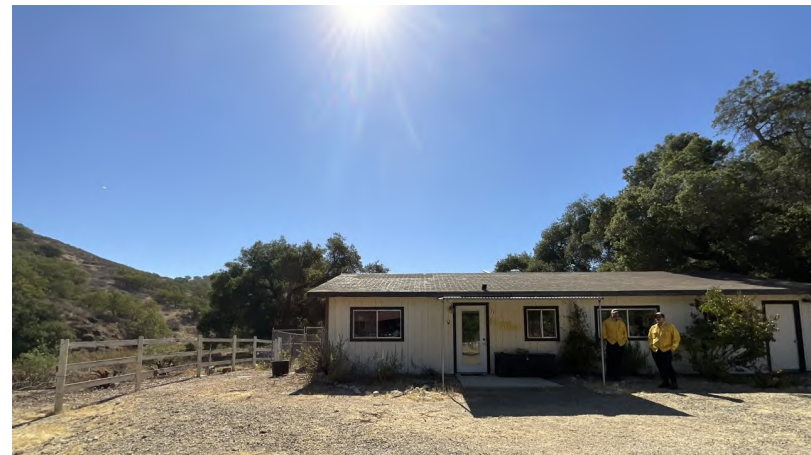
LOCATION AND PHOTO

Structures elevated above active channel on floodplain terrace. Large portion of upslope drainage area burned. Mapped in DWR 100 year floodplain.

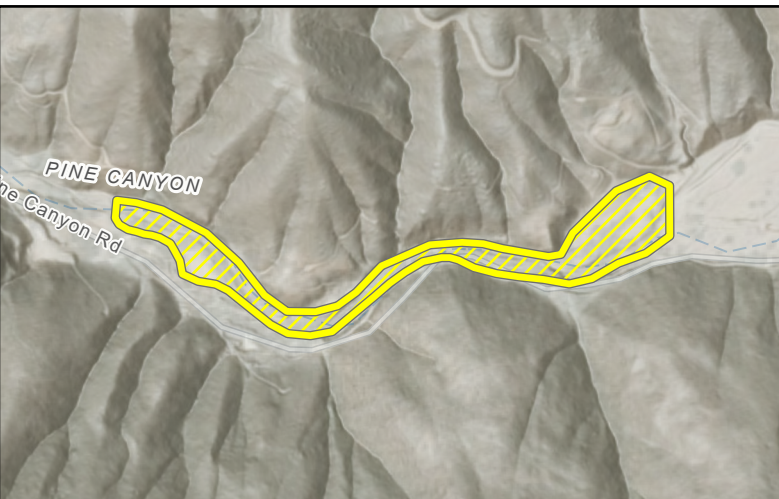
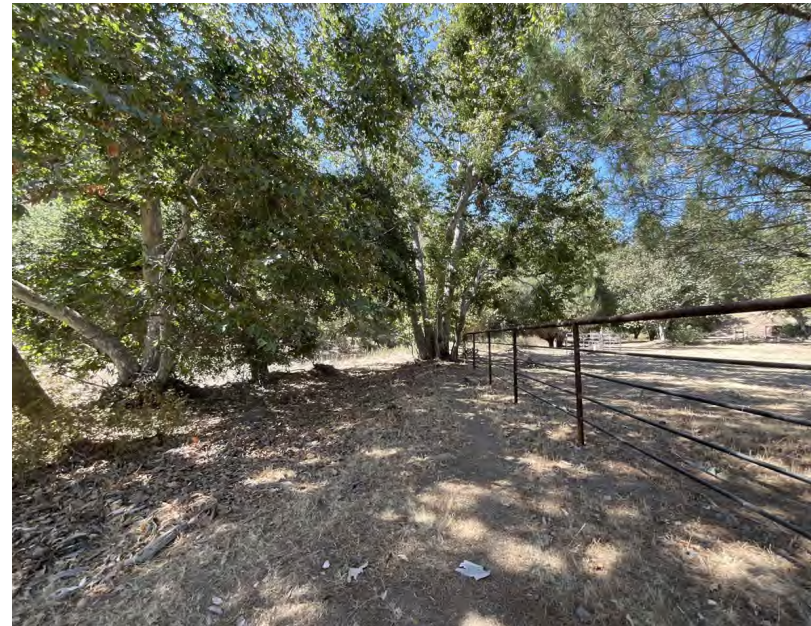
LOCATION AND PHOTO

Field Observation or Potential Hazard: Increased postfire runoff and sediment transport will increase the potential of flooding to outbuilding, fences, and cattle corral. Possible probability of occurrence with minor consequence = LOW RISK.

Multiple features within potential flow paths include shade structures, cattle corral, and fencing adjacent to active channel.

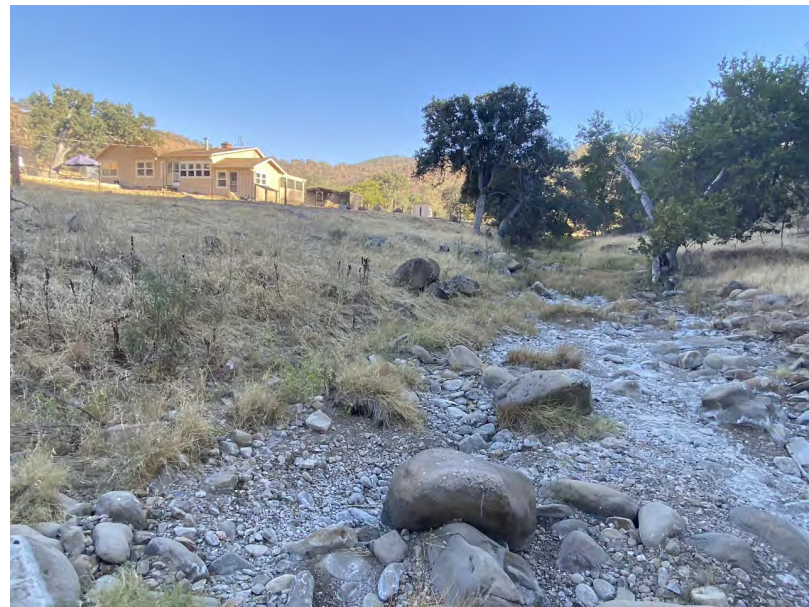
LOCATION AND PHOTO

Field Observation or Potential Hazard: Increased postfire runoff and sediment transport that will increase the potential of flooding to homes and outbuildings. Unlikely probability of occurrence with minor consequence = VERY LOW RISK.

Minor flooding in January 2023 that did not impact structures. A large portion of the upstream area was burned at moderate.

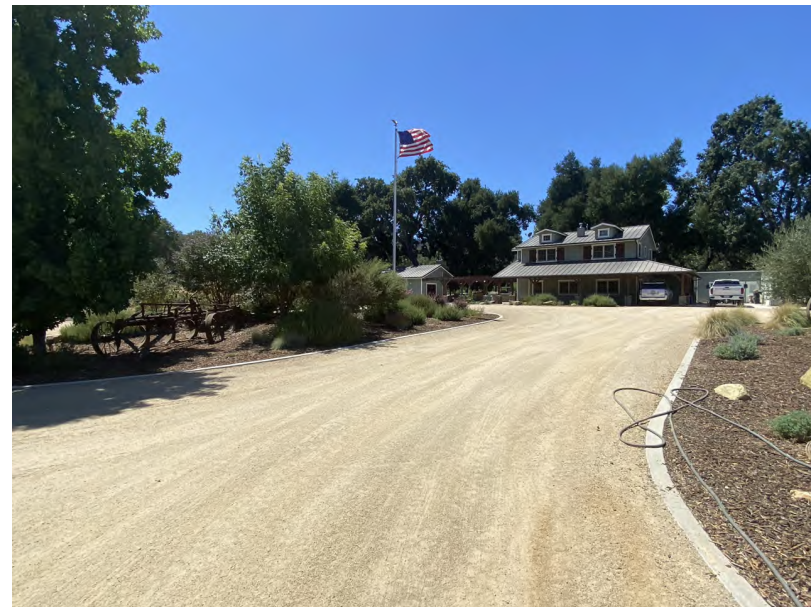
LOCATION AND PHOTO

Field Observation or Potential Hazard: Increased postfire runoff and sediment transport will increase the potential of flooding to house and outbuildings. Possible probability of occurrence with moderate consequence = INTERMEDIATE RISK.

Two outbuildings were flooded during the 9 January 2023 storm. One was flooded by Dry Creek and the other was flooded by the Salinas River. Flooding possible from both Salinas River and Dry Creek. Increased postfire runoff and sediment transport will increase the likelihood of flooding. Multiple outbuildings are mapped within the DWR 100 yr floodplain.

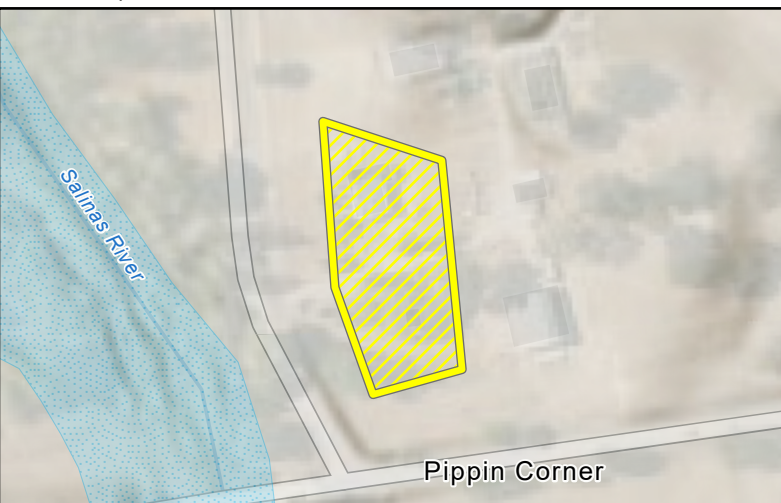
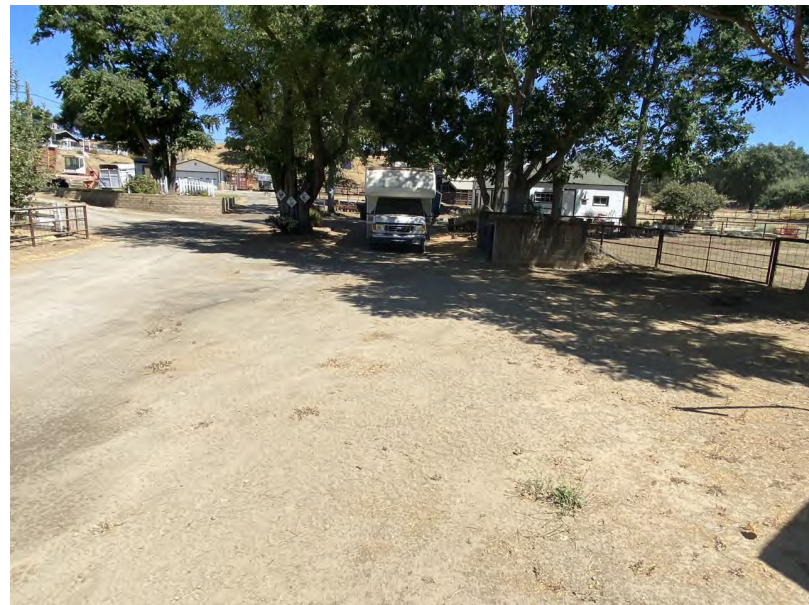
LOCATION AND PHOTO

Field Observation or Potential Hazard: Increased postfire runoff and sediment transport will increase the potential for flooding of home and well site. Unlikely probability of occurrence with minor consequence = VERY LOW RISK.

Driveway and well flooded in January 2023 storm. Flooding occurred up to house. Water was a couple feet deep in driveway.
